## Spark Ignited Direct Injection (SIDI) Engines

GM *TechLink* is a monthly magazine for all GM retail technicians and service consultants providing timely information to help increase knowledge about GM products and improve the performance of the service department.

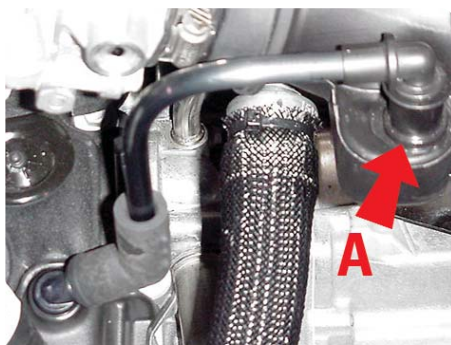
**Disconnecting PCV tube**  
**A Do not attempt to disassemble this connection**

On the Acadia, OUTLOOK and Enclave, the positive crankcase ventilation (PCV) fresh air tube is difficult to remove from the outlet duct. It is very easy to damage the outlet duct to PCV tube interface

point when attempting to remove the tube. Once the upper intake manifold sight shield is removed, the tube can be easily disconnected at the camshaft cover fitting and repositioned out of the way, without having to remove it from the outlet duct assembly.

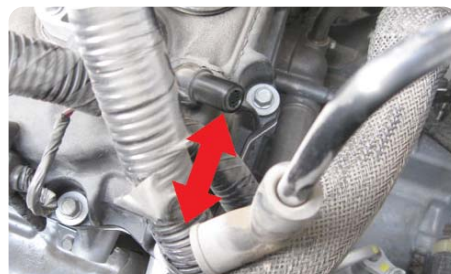
**Rubber tube disconnected from cam cover fitting**

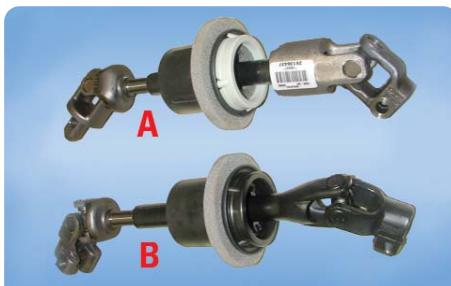
An article in the November *TechLink* introduced intermediate steering shafts for the 2009 Malibu, G6 and AURA that do not use grease at the sliding interface. The new service shafts should never have grease applied to the sliding interface. The photo in the article was incorrectly labeled. Both intermediate shafts in the photo are the new greaseless type.

**A New I-shaft for vehicles equipped with Hydraulic Power Steering**  
**B New I-shaft for vehicles equipped with Electric Column Power Steering**

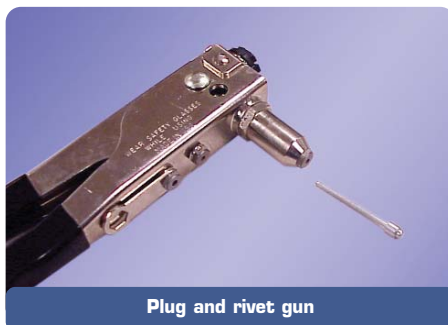
Plug and rivet gun

If one of these plugs needs to be replaced in service, the rivet can be installed using any commercially available hand-held rivet gun.

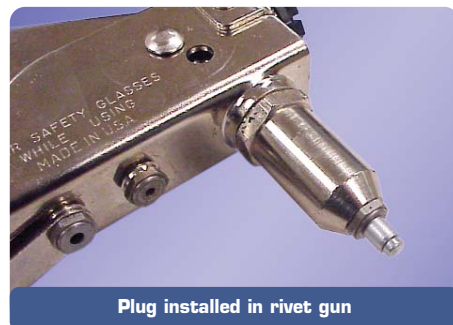
Plug installed in rivet gun

Insert the plug into the rivet gun, insert the plug into the bore, and activate the rivet gun to seat the plug.

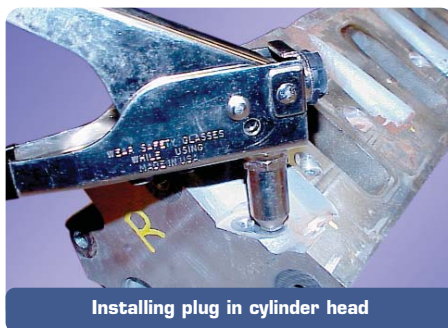
Installing plug in cylinder head

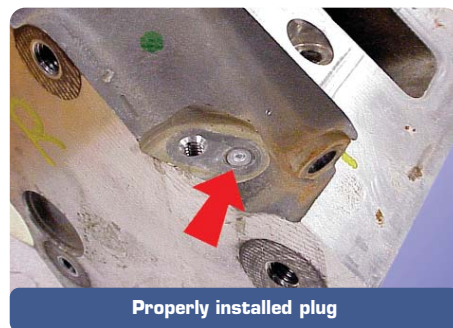
Properly installed plug

A properly installed plug should be installed flush with the surface of the head.

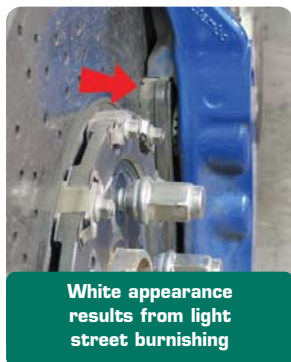
White appearance results from light street burnishing

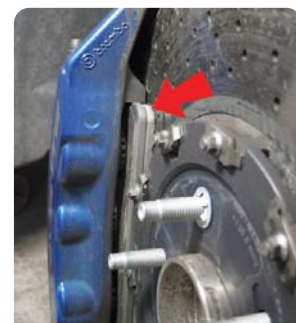
White appearance results from heavier track burnishing

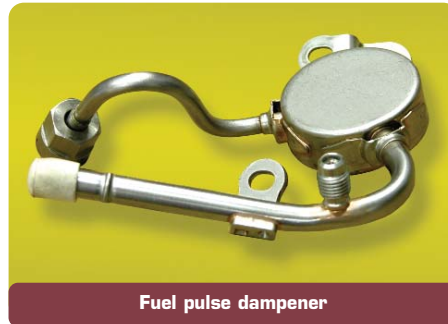
Fuel pulse dampener

**TIP:** The fuel pulse dampener may have an audible clicking sound when the engine is idling.

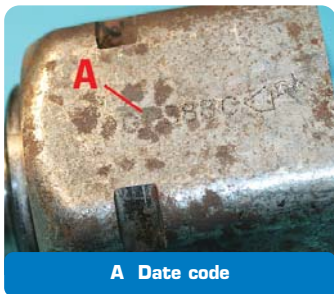
from the driveline when accelerating from a stop, or low speed acceleration, typically 20 to 40 mph (32 to 64 kph). This concern may be more noticeable when the vehicle is loaded, such as with four passengers.

Verify the concern by duplicating the condition on a vehicle road test. The condition may be caused by a tripot joint on the right front wheel drive shaft (halfshaft) that was improperly heat treated. Inspect the tripot joint housing on the right front wheel drive shaft. If it has the date code G0388C, replace the right front wheel drive shaft tripot joint.
