Differential Cooler	1
TIS 2 Web Update	1
Tech 2 Navigation Changes	2
Armrest Angle	3
Navigation Disc Update Program	3
EGR Valve Kit and Reprogramming	3
Remote Unlock Inoperative	3
Hood Closing	3
Water Leaks	4
Underhood Lamp	4
MAF Sensor	5
Inflatable Restraint Module Coil Noise	5
Truck Z Height Revisited	6
Rear Main Oil Seal Leak	6
Fold and Tumble Seat	6
4WD Models with Noise, Vibration	7
Camshaft Actuator System Debris	7
Code P0171 and No Performance Concerns	7
Fix It Right the First Time	8
Know How Broadcasts for May	8

TECHLink GM

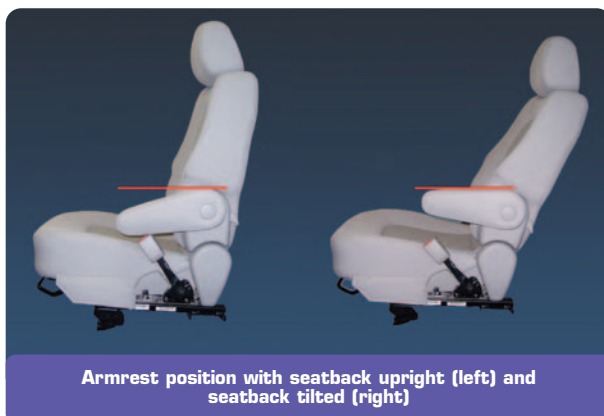
On the Chevrolet HHR, the armrest attached to the seatback has two positions, up and down. In the down position, the angle of the armrest depends on how much or how little the seatback is tilted. There is no independent adjustment for the armrest position.

Armrest position with seatback upright (left) and seatback tilted (right)

This is normal operation and no repair should be attempted.

TIP: The armrest is guided by a pin-in-slot arrangement. If the pin comes out of the slot due to overloading, the pin can be returned to the slot and the armrest becomes fully functional again.

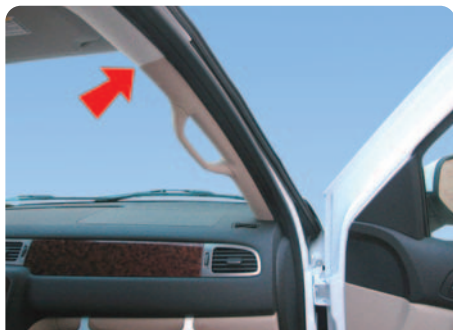
A-Pillar — moisture between the top of the A-pillar trim and headliner.

Location of moisture

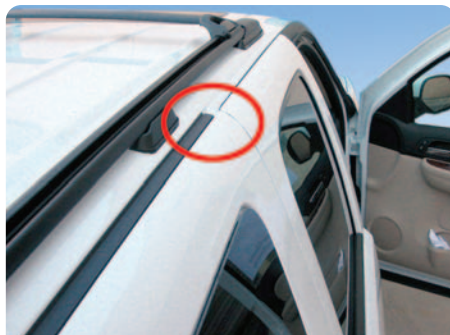
Location of water test

Run water over the front of the rubber roof ditch molding. If a leak is observed, remove the ditch molding and look for a void in the sealer between the roof ditch sealer melt strip and the sealer patch. If a void exists, fill the void with sealer and retest with running water.

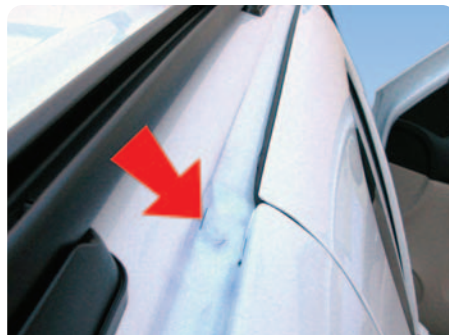
Location of sealer void

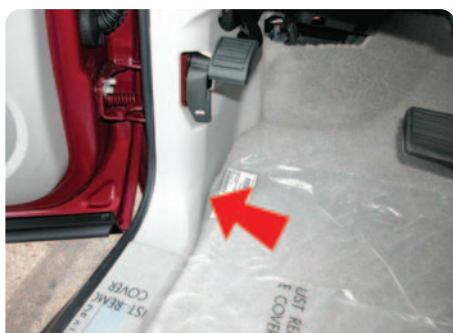
Kickpad Carpet 1 — moisture in kickpad area.

Moisture location at kickpad

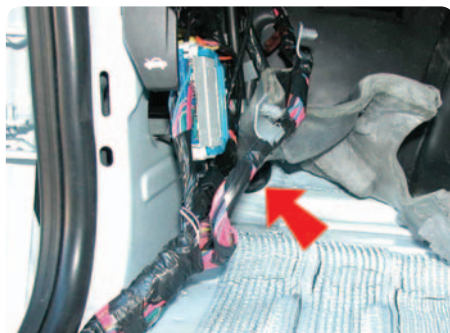
Location of park brake grommet

Run water on the outside of the park brake grommet in the engine compartment. Run water onto the center of the cowl screen between the windshield wipers at the base of the windshield.

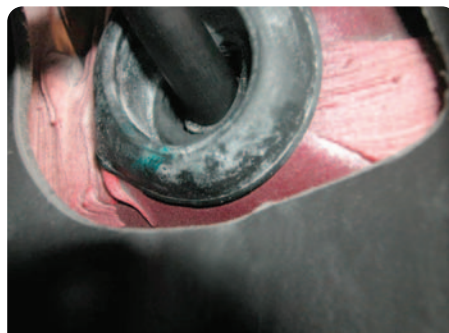
Sealer in contact with grommet

Remove the kickpad and sill plate. Lift the carpet. Look for sealer in contact with the park brake grommet. Remove sealer and replace the grommet.

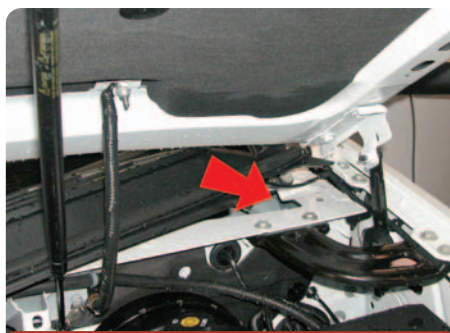
Remove the cowl screen and look into the top of the plenum, using a shop light. Observe the sealer in the fore/aft seam between the cowl side and plenum lower.

View into plenum

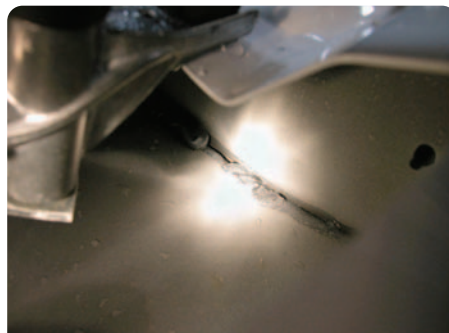
Location of sealant voids

If there are voids in the sealer, add sealer as necessary and retest with running water.

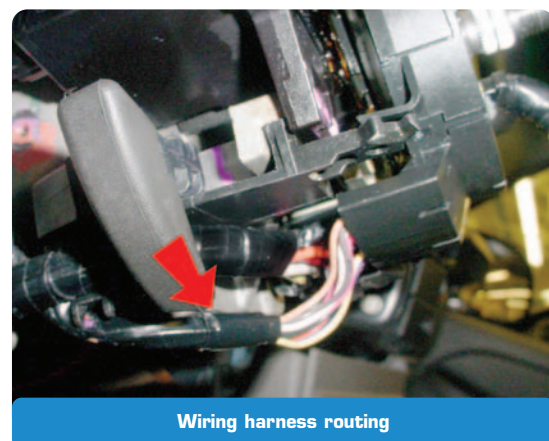
6. If the retaining ring and all wiring is installed correctly and noise is still present, perform the coil centering procedure (SI document 822781). Re-install the coil and re-check for noise.

TIP: A coil that is off center by as little as 1 or 2 revolutions could be the source of the noise.

7. If the noise has not been eliminated by following the steps above, only then should the coil be replaced.
