For the 2001 model year, a supplemental inflatable restraint (SIR) system featuring dual-stage air bags is installed in the Oldsmobile Aurora, Buick LeSabre, Pontiac Bonneville and Chevrolet Impala and Monte Carlo.

### Dual-Stage System

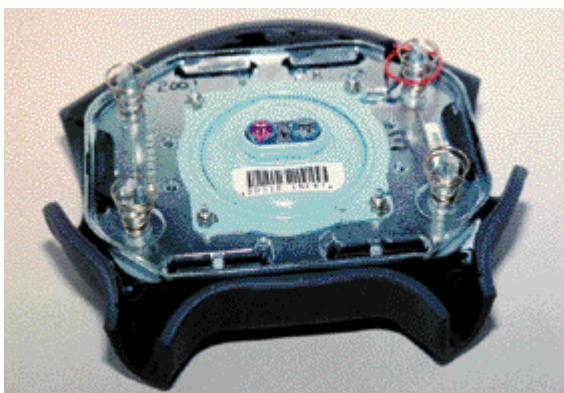
Dual stage airbag is identified by having two electrical connections.

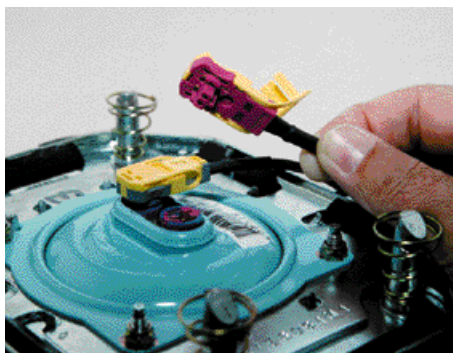
**Connectors of the Deployment Harness J-38826-75 are color-keyed.**

This means that you cannot dispose of a dual-stage module until you have energized both initiators. The procedure is spelled out in detail in the service manual. It involves use of a special Deployment Harness J-38826-75, which has two connectors, one for each initiator. And if you are handling an instrument panel inflator module, you must first attach it to the J-39401-B Deployment Fixture.

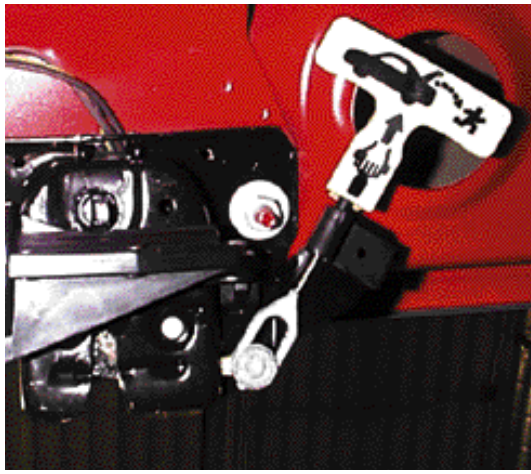
Trunk release handle now in production
