## XM Satellite Radio is Coming

## Contents

## TECHLink

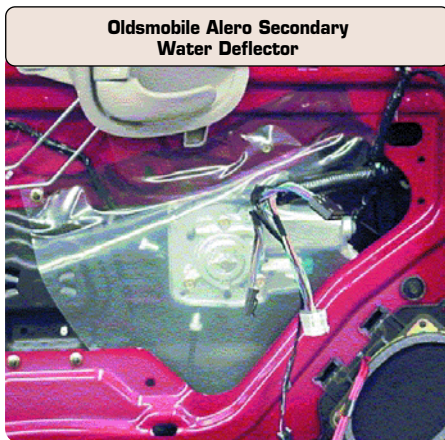
Oldsmobile Alero Secondary Water Deflector

Owners of some 1999-2001 Alero, Grand Am and Malibu models may comment about a mildew odor or wet carpet. This may be caused by voids, buckles or other areas

where the door water deflector is not properly adhered to the door.

Remove and discard the door water deflector. When removing the door water deflector for any reason, do not reuse it.

**IMPORTANT:** On the Grand Am and Alero 4-door models, install a secondary water deflector as shown in the photos before installing the main water deflector. At present, this secondary water deflector is

available only for the front doors of 4-door models. Contact Technical Assistance to obtain parts.

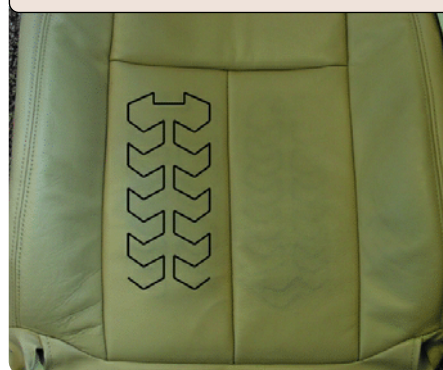
Some leather seat covers have been returned in which the heated seat grid shows through. It appears that the leather seat cover has been burned by the heater grid. However, this is not the case.

This condition is actually caused by dye transfer from the passengers' clothing, which discolors the leather and is more noticeable on lighter colored leather. Dye transfer is an industry-wide concern and will occur on any leather product. Blue jean material is notorious for leaving blue dye on leather.

Seat heater usage tends to bake the dye into the seat cover in a visible pattern of the seat heater element. Once the seat heater pattern has been baked in, it may not be possible to remove.

Dye Transfer Appears as Grid

Cleaning the leather on a regular basis with mild soap and water as recommended in the owner's manual is the only prevention. Just like the paint on the exterior of the vehicle, regular maintenance will increase the life of the product.

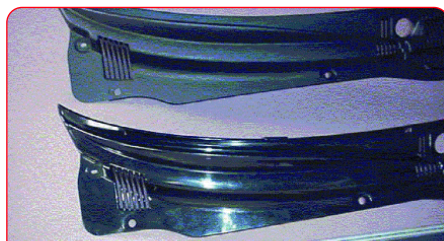
The captions on this photo were reversed in the Water Leak article on page 6 of the August issue.

With new style panel (top), use 25 mm foam.  
With old style panel (bottom), use 18 mm foam.
