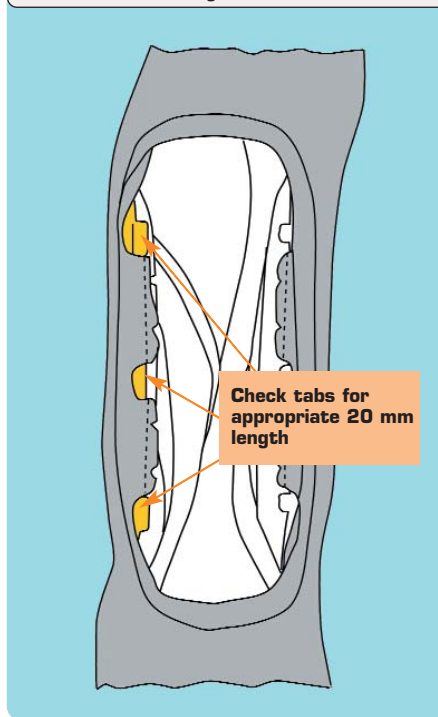
On a 2001 Monte Carlo equipped with leather seating, a gap may develop between the driver's seat back trim and the Side Impact Airbag (SIAB). This condition is caused by the lack of tension between the seat trim and the airbag bezel (white plastic cup attached to the seat frame).

View of driver's seatback with Side Impact Airbag removed

Several improvements were implemented midway through the 2001 model year to eliminate this condition. To correct a vehicle exhibiting this condition, check the bezel slot width (slots located on the forward edge of the bezel), and replace the part if it is 5/16-inch (7.94 mm) or greater. The new bezel, part number 88951498, has a slot width of 3/16-inch (4.76 mm).

Next, measure the tabs on the seat trim plastic reinforcement that engage into the revised bezel slots, located on the forward edge of the seat trim opening, to determine if the vehicle has the revised seat trim. The revised seat trim has a tab length of 20 mm. The seat trim should be replaced if the tab is any shorter than this.

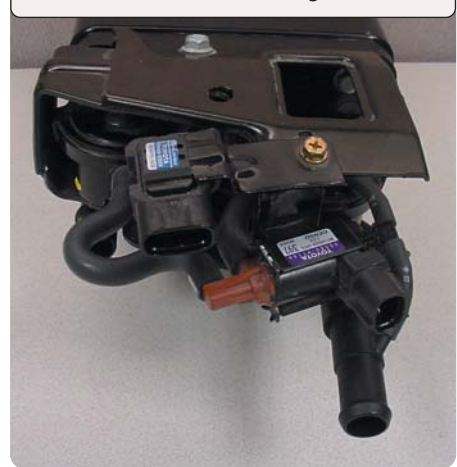
EVAP Pressure Switching Valve

The pressure switching valve may be defective. You should hear a clicking noise when you command the PSW on and off using the Tech 2. If you cannot hear the valve click, make sure there is 12 volts at the solenoid, and that the PCM is supplying the ground to the circuit when you command the valve on. If the power and control sides of the solenoid are working properly, replace the pressure switching valve.

The EVAP system Pressure Switching Valve is attached to the vapor canister by a single screw. Do not replace the complete canister assembly. The PSW can be replaced separately. The part number for the valve is 94859365.

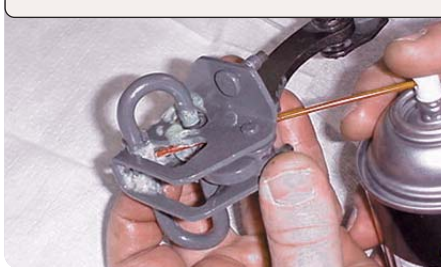
Link removed to show lubrication location

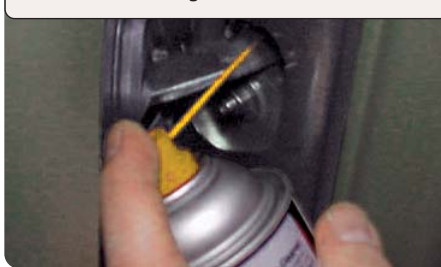
Lubricating check link saddle

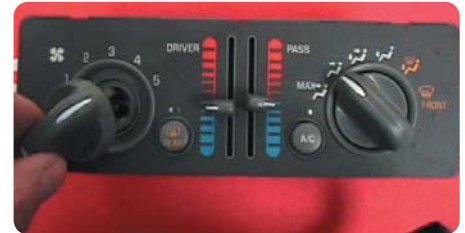
On 1999-2002 Pontiac Grand Am and Grand Prix, the mode control or blower speed control knob is replaceable individually, if the knob becomes stripped or broken. It is not necessary to replace the entire control head in these cases.
