Electrical Terminal Update

Tracker Dome Lamp Conditions

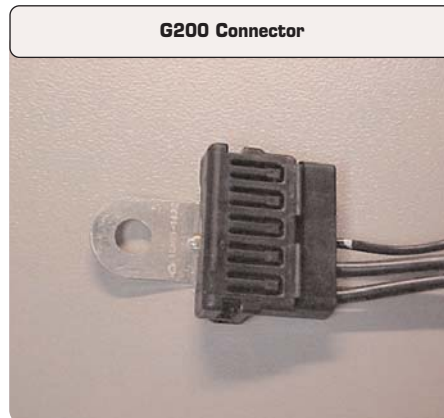
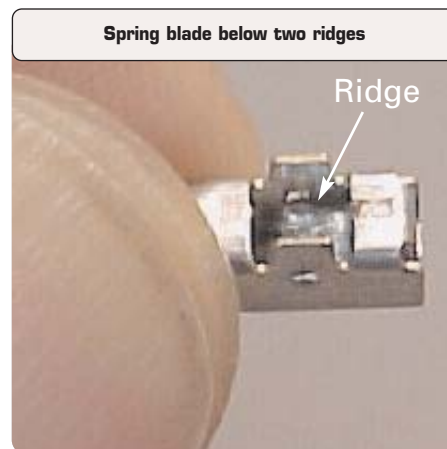
The likely cause for these combined malfunctions is the common ground, G200, which is located behind the driver side kick panel. The G200 ground is a silver colored metal tab, extending from a black plastic connector, which is screwed to the body. Remove the screw and release the tabs on the plastic connector, which will allow the silver tab portion to be removed.

At this point you can feel how well the wire terminals grip the common ground spades. If all the terminal ends are loose on their respective ground spades, the ground tab will fall out of the connector. Without proper tension, the circuits mentioned will

lose their ground. The dome light will illuminate when the door is opened because it will make a ground at each door switch.

Loose ground connections internal to the connector are caused during assembly by pulling on the wires while lining up and driving the fastening screw. The spring blades are pushed out and become stuck open, leaving no spring tension on the ground spades.

To correct the condition, remove the terminals and wires from their cavities, with an appropriate tool. Looking at the terminal, you can see the spring blade is stuck open, above two ridges in the terminal. Apply a light pressure to the back side of each spring blade, pushing it below the ridges, back into the original position, providing grip on the ground blade. Reinsert the ground spade to test the grip of the terminal. If it now functions correctly, reassemble the G200 ground and fasten it to the body in its original location.
