## Techline News

## OnStar Service Issues

## Malibu Exhaust Rattle

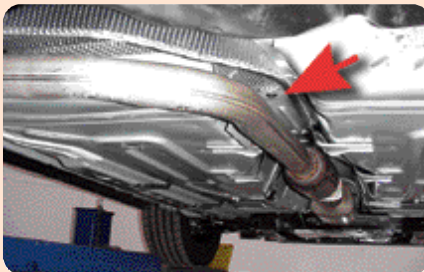
Some owners of 2001 Chevrolet Malibus may comment on a rattle from under the car. This may be caused by insufficient clearance between the exhaust pipe and the screw that secures the fuel tank heat shield at the front. There should be a minimum of 15 mm clearance between the exhaust pipe and the head of the screw. If the clearance is less than 15 mm, place a suitable tool on the head of the screw and push upward until there is at least 15 mm of clearance between the exhaust pipe and the screw head.
