## Generator Operation and Troubleshooting

GM TechLink is a monthly magazine for all GM retail technicians and service consultants providing timely information to help increase knowledge about GM products and improve the performance of the service department. This magazine is a companion to the GM Edge publication.

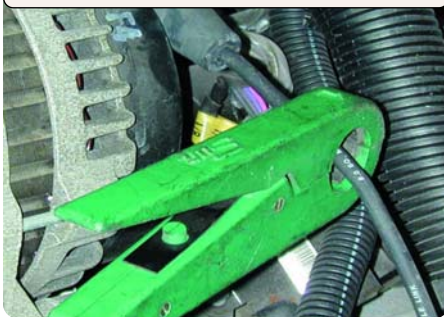
When measuring generator output amperage, make sure you are measuring DC amps in the cable attached to the generator B+ stud and that the current probe is fully

closed. Do not measure generator current at the battery. Also make sure your voltage measurement is correct and that the meter is operating properly.

Correct current probe connection at generator

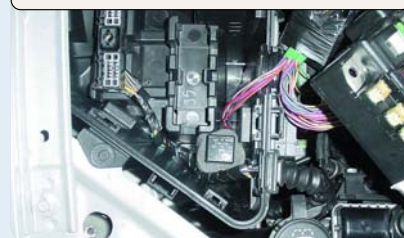
## Location of relay in early vehicles

Early production vehicles built before VIN break point 1G6DM57N030105858 have the headlamp washer relay connected to a remote wire harness. It is located beneath the underhood fuseblock in the left front corner of the fuseblock case. For these vehicles, a jumper wire is located in the underhood fuseblock between cavities 67 and 68. This is the location indicated for the headlamp washer relay on the underhood fuseblock label.

The jumper provides battery positive voltage from the HDLP WASH C/B – OPT circuit breaker to the switch side input circuit of the headlamp washer relay.

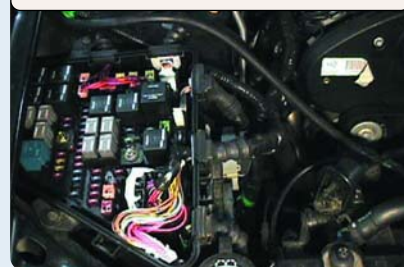
## Location of relay in later vehicles

After the VIN breakpoint listed above, the headlamp washer relay is located in the underhood fuseblock. This is the location indicated for the headlamp washer relay on the underhood fuseblock label.

The two configurations are not interchangeable, but are functionally the same. Follow published service manual diagnostics for both configurations. Before attempting to diagnose inoperative headlamp washers, ensure the washer fluid is above the minimum level and the headlamps are ON.

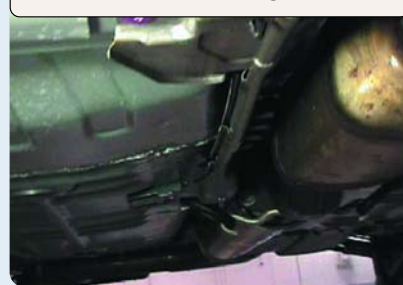
**Harness in Trough**

On some 2001-02 Buick Century and Regal, Chevrolet Impala and Monte Carlo, and Pontiac Grand Prix, the oxygen (O2) sensor wiring may be damaged. The location is on the engine harness, on the harness side of the rear O2 sensor connector. The wires are covered in plastic conduit.

Alternating pressure and vacuum conditions occur inside the wire insulation when the engine is operating and allowed to cool down. Water can literally be pumped inside the insulation by these pressure/vacuum cycles. If the wire insulation is perforated, water can travel inside the wire insulation into the O2 sensor and to the PCM.

The harness lies in a trough which may collect water from the HVAC evap core drainage or from the environment.

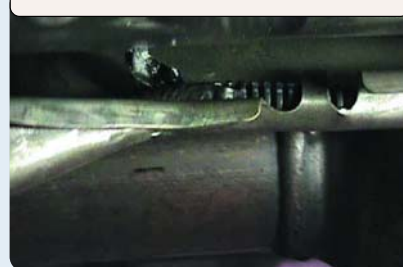
**Location of damage**

Water damage to these components can cause engine stall, general driveability problems, P0141 (HO2S2 Heater Performance) and others.

Water-damaged components must be replaced. To prevent the problem from recurring, put a length of 5/8-inch hose on the A/C drain elbow. Route the hose down so water drains properly, and secure as necessary with tie straps.
