## Techline News

### Comparison of Multec 1 and Multec 2 Injectors

## Transmission Shift Conditions

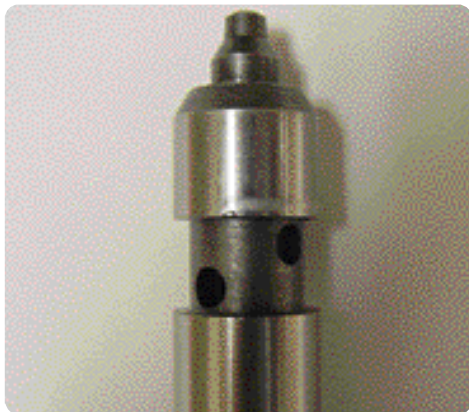
### No Forward, Delayed Forward, Transmission may Lock Up in Reverse, Intermittent

Vehicles with the subject condition will exhibit no forward or delayed forward intermittently. Some will not move intermittently when placed in reverse. Putting the vehicle in drive and then back into reverse may alleviate the condition temporarily. This phenomenon has been observed in only a very small number of vehicles in the field.

The cause is a small nick on the forward band piston apply pin (21) that causes the apply pin to stick. Even though the nick may be quite small (no larger than the tip of a sharpened pencil), it may still be sufficient in size to cause the pin to stick. Replace the pin and any associated parts that are required to correct the condition.

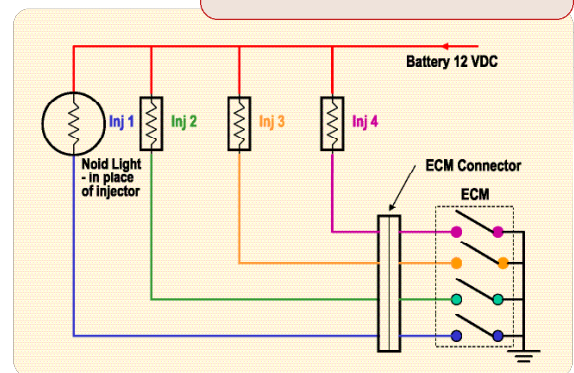
#### Using J-34730-405 noid light

Delphi also recommends using the injector noid light J-34730-405. When plugged into the connector in place of the injectors, the noid light permits you to verify that power is supplied to the injector and that the injector driver is functioning.

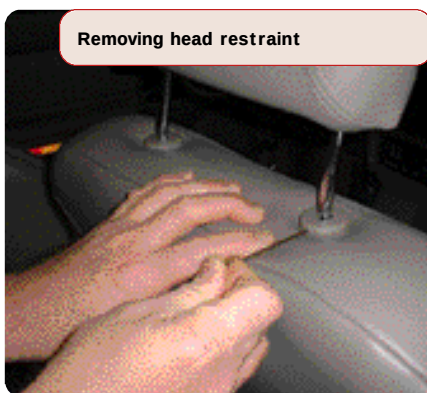
Removing head restraint

Owners of some 1997-2001 Buick Regal and Century, Pontiac Grand Prix, and 1998-2001 Oldsmobile Intrigue may comment that the head restraint does not stay in position on the seat, but migrates to the full-up position.

Remove the head restraint from the seat back by inserting a small diameter tool into the hole on each retainer and pressing.
