## Battery Charging Tips

## Techline News

GM TechLink is a monthly magazine for all GM retail technicians and service consultants providing timely information to help increase knowledge about GM products and improve the performance of the service department. This magazine is a companion to the GM Edge publication.

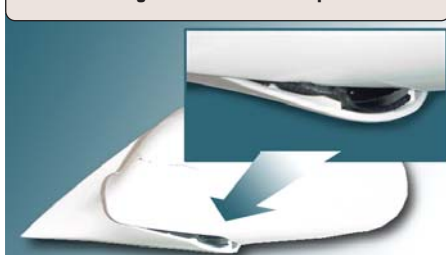
Beginning with the 2002 model year Buick Century and Regal, a gasket is installed in the fold line of the outside rearview mirrors. This addresses a

windnoise condition mentioned in bulletin 02-08-64-001.

Mirror gasket folded out of position
