What Happens When a Radio is Swapped?

GM TechLink is a monthly magazine for all GM retail technicians and service consultants providing timely information to help increase knowledge about GM products and improve the performance of the service department. This magazine is a companion to the GM Edge publication.

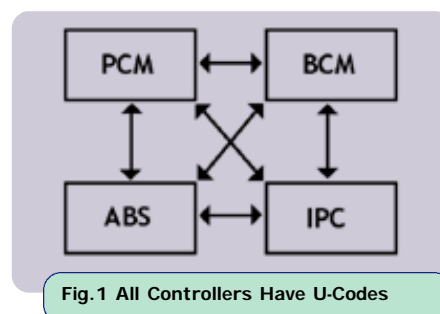
Fig. 1 All Controllers Have U-Codes

If after developing the list you notice that most or all of the controllers have

history U-Codes, then the following items are typically true of your situation.

The reason each controller has a number of U-Codes pointing at many other controllers is that the controller has come to expect a certain combination of controllers based upon the learned sources for messages which require fail-safe action. These are the State of Health messages (IDs) it has seen, and when these are no longer seen the controller sets the code(s). In this case, after properly initializing, the controller can't see anybody's State of Health message and therefore sets multiple U-Codes.

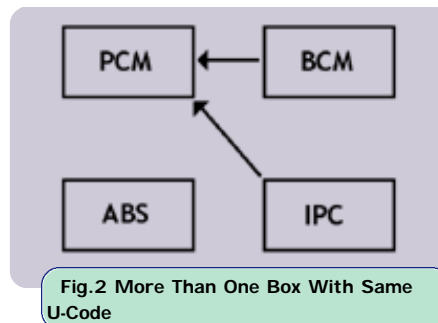
Table 2 - Scenario 2

If after developing the list you notice that a small percentage of the total num-

ber of controllers have U-Codes (Table 2), then the following items are typically true of your situation.

A. The problem is a hard fault.

cate with other controllers, the other controllers go into a default or fail-safe mode of operation. For example if the PCM can't send fuel level data, the IPC will default the fuel gauge to the Empty position and set a U1016. The customer's complaint will be Fuel Gauge Inoperative.

When you see the same U-Code stored in more than one box, most of the time it's due to the fact that the controller the DTC is pointing to is no longer able to communicate on the Class 2 bus. For instance if the IPC and the BCM have both stored a U1016 then the IPC and BCM are trying to point to the controller that is at fault, in this case the PCM. It's very important that under these conditions you look for common U-Codes stored among different controllers.

To correct the problem in this scenario you'll have to figure out which controller is unable to communicate on the Class 2 bus, but your detective work should have yielded a suspect. It's now a matter of deciding why the controller is unable to communicate - no power, no ground, open Class 2 circuit, incorrect power mode signals or a defective controller.

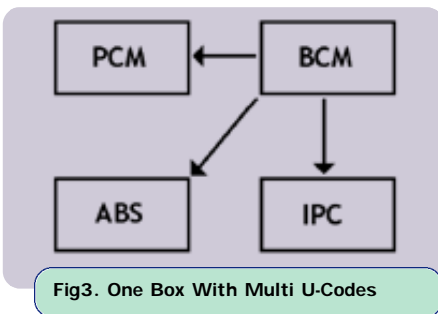
Table 3 - Scenario 3

There are multiple U-Codes stored in only one controller, no other controllers have any U-Codes stored. See Table 3

and Figure 3. Of the three scenarios this one tends to be the most difficult to figure out, so a good understanding of what happens here is critical. The following items usually surround this scenario.

A. With ignition on, the U-Codes stored will go to history. These codes may return to current once the ignition is turned to the off position and the other controllers have had a chance to power down.

supposed to be, the problem is usually a hard fault. The fault can be caused by a short to power on the ignition feed circuit of the offending controller, a power feed-back through another component, or it can be a problem within the controller itself, whereas the controller is unable to power itself down. This can be confirmed by comparing who is communicating in RUN with who is communicating in OFF.

Because a controller is remaining alive after the ignition has been turned off, the battery will slowly drain. Most controllers can pull in excess of 1 amp when powered up and if the vehicle hasn't been driven for a couple days, the customer may have a no start condition.

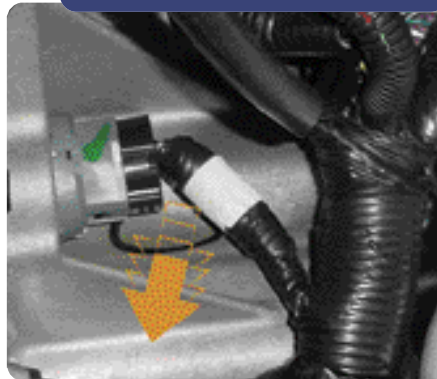
The subject codes may be caused by the wire harness leading to the main transmission connector being routed such that the connector is side loaded. This is analogous to grabbing the harness near the connector with one's hand and pulling to one side. The terminals can get mis-positioned in the connector

Aztek harness indicating direction of side load

and not make good contact. This may result in the codes mentioned. The correction is to re-route the harness such that the connector is not side-loaded.

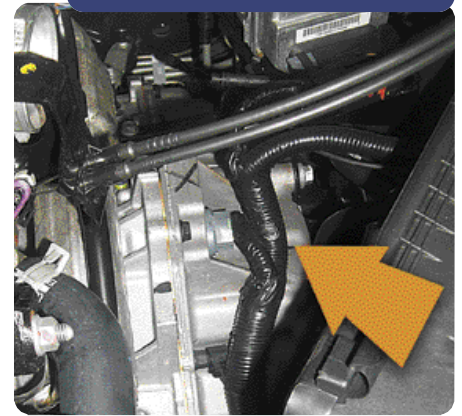
Mis-positioned harness
