## Terminal Repair Kit Update

## Techline News

GM TechLink is a monthly magazine for all GM retail technicians and service consultants providing timely information to help increase knowledge about GM products and improve the performance of the service department. This magazine is a companion to the GM Edge publication.

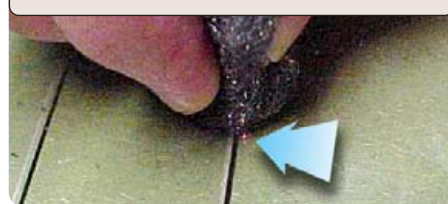
### Demonstrating spark in laboratory

This condition may result from break(s) in the rear defogger grid. Begin by inspecting the grid for scratches. A fine crack may develop over time and may not be readily visible. On Impalas, a likely location is one of the three lower grid lines, on the driver's side, approximately 385 mm (15 in.) from the inboard edge of the bus bar. No specific locations have been identified on the Monte Carlo.

**TIP:** A diagnostic tool may be made by loosely twisting steel wool into a 2-inch strand. With the rear defogger turned on, pass the steel wool LIGHTLY along the grid lines. When the steel wool bridges the gap in the grid, it will emit a visible spark, and will eliminate the static in the radio.

If you can locate a break in the grid, repair it according to SI procedures, following this path:

- Body and Accessories
- Stationary Windows
- Repair Instructions
- Grid Line Repair

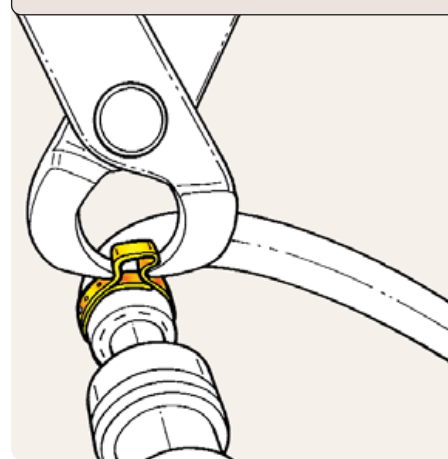
**Crimping Oetiker clamp**

A fuel pressure gauge adapter J-42982 was recently shipped as part of the 2003 Pontiac Vibe essential tool package. This tool may require repairs before use, to prevent pressurized fuel from being released.

- be missing
- be installed but not crimped
- be incorrectly crimped.

You must inspect the hose fittings, install missing clamps, and crimp/recrimp all hose clamps using J-43218 or equivalent Oetiker clamp crimping tool, to ensure that all four clamps are fully crimped.

A notice is being sent to all dealers, along with a supply of replacement Oetiker clamps.

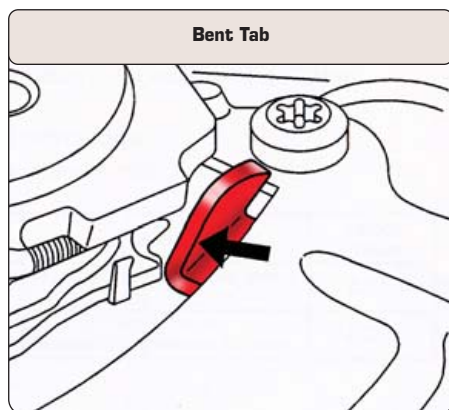
Owners of some 2002 Buick Century and Regal, Chevrolet Impala and Monte Carlo, Oldsmobile Intrigue, or Pontiac Grand Prix may comment that the windshield wipers park in the vertical (outwipe) position.

This may be caused by a bent park tab on the windshield wiper motor bracket.

If the tab is bent, you will need to install a new wiper motor crank arm 12494832 and motor bracket service kit 88958149 (88958260 in Canada). Instructions are included in bulletin 02-08-43-002.

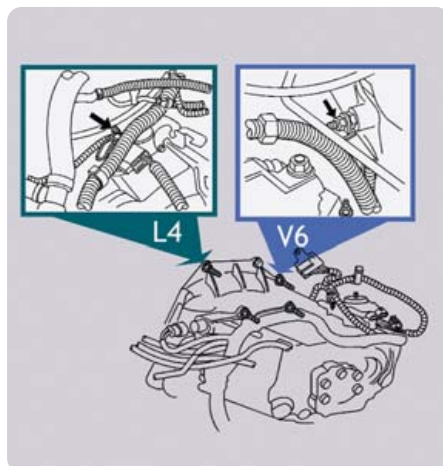
This condition may be caused by a loose G103 ground connection. To correct it, refer to recently released bulletin 02-08-45-002 and follow the procedure to install a flat washer (p/n 15650963) to the G103 ground stud to gain proper eyelet clamping.
