## Articulating Running Boards

GM TechLink is a monthly magazine for all GM retail technicians and service consultants providing timely information to help increase knowledge about GM products and improve the performance of the service department.

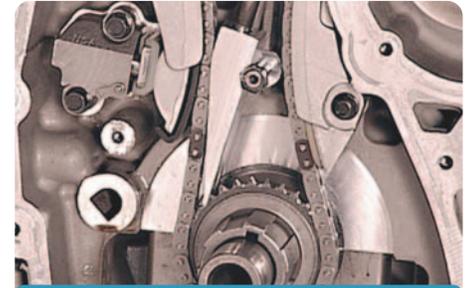
Tool wedged against chain (front cover removed for photo)

EN-48468 is wedged between the timing chain and the front cover center bolt, by very lightly tapping on it with a plastic or brass hammer. The narrow ramp of the tool wedge faces the chain, and the wide ramp faces the bolt.

**TIP:** Avoid excessive force when wedging the tool into place, to prevent damaging the chain tensioner or front cover bolt.

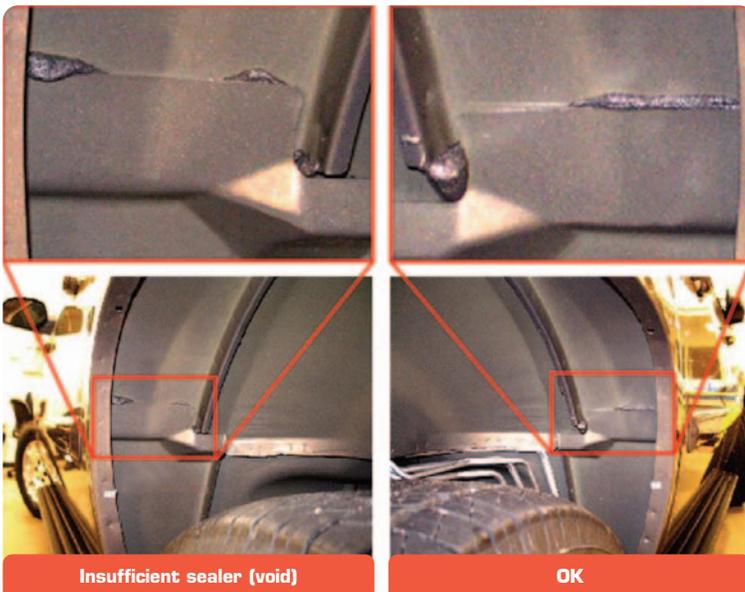
Owners of some 2007 full-size utilities may comment on a creak or squeaking noise coming from the left or right rear wheel well area. This may be caused by insufficient sealer in the body seams in the front portion of the rear wheel wells.

Insufficient sealer (void)

OK

If you experience this concern, locate and repair the void in the sealer.
