Brake Service Part 1 – Background, Measuring, and Cleaning

Earlier this year, bulletin 00-05-22-002D was released for the purpose of updating and centralizing all of GM's standard brake service procedures and policy guidelines for brake rotor and brake pad service and wear. If you haven't already done so, refer to this bulletin before performing your next GM brake service.

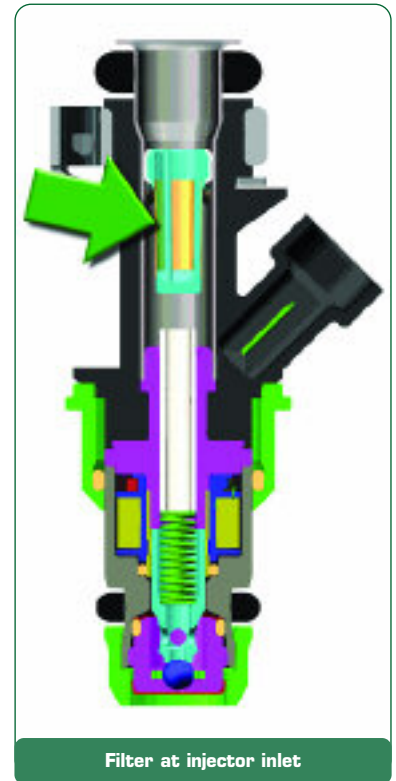
Any contamination (including rust) that is built into or forms in the fuel line will find its way to the fuel injectors. A filter at the inlet to the fuel injector filters out small contaminants, including rust. If enough debris accumulates on the injector filter, it will start to restrict flow. This will have a negative effect on performance and driveability.

For the 2004 model year, there has been an increase in the number of injectors returned with rust in the injector filter. The rust appears to be coming from several sources:

Filter at injector inlet

When diagnosing driveability symptoms due to clogged fuel injectors, follow the procedures outlined in bulletin 03-06-04-030A. If the bulletin procedures lead to replacing an injector, inspect the removed injector for evidence of rust contamination. If rust is plugging the fuel injector, replace it, because a procedure for removing rust from the injector filter has not been developed.

If rust remains in the fuel line, there is a chance that the injector filter will plug up again. Whenever rust is observed in an injector, flush the fuel lines. If the fuel line cannot be completely flushed of rust, replace it.

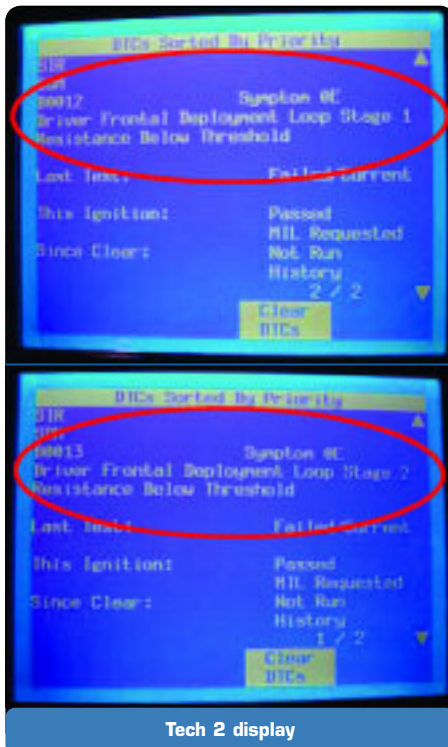
Tech 2 display

During SIR system diagnosis, the Tech 2 may display "driver frontal deployment loop stage 1 resistance below threshold," along with "driver frontal deployment loop stage 2 resistance below threshold." These are diagnostic codes B0012 and B0013 with symptom code 0E.

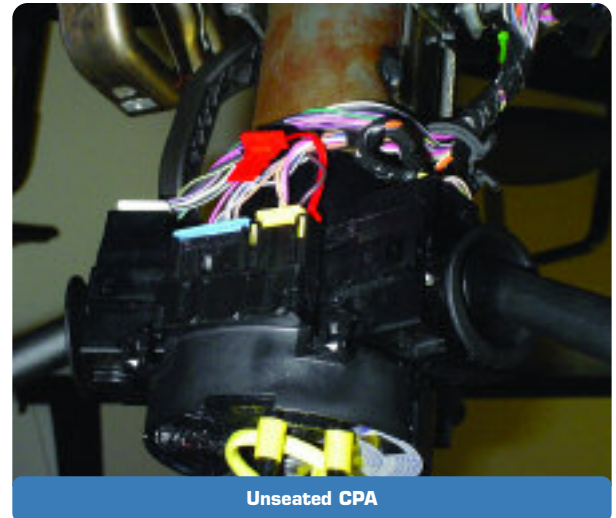
If this condition exists, it may be caused by a missing or incorrectly installed connector position assurance (CPA) in the steering wheel module coil connector. When the CPA is removed, the shorting bars that "safe" the driver airbag from deployment make contact to both circuits causing the below-threshold DTCs to set.

Unseated CPA

This is the connector on the top of the steering column that connects the steering wheel module coil to the vehicle harness.

TIP: Be sure to follow the instructions for disabling and enabling zone 3 in the SIR system while servicing the coil connector.

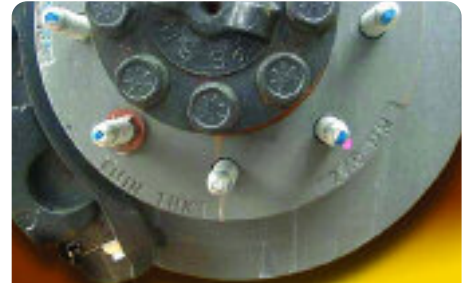
Discard thickness

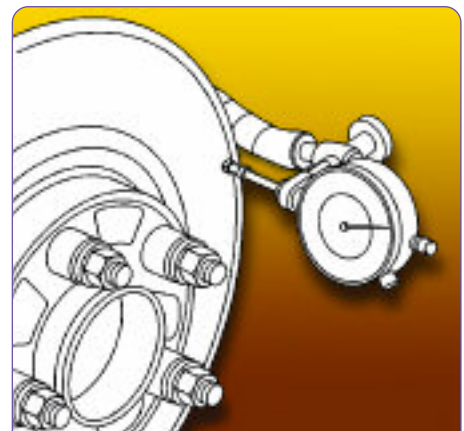
Checking lateral run-out

On most GM passenger cars, if LRO is 0.002 inch (0.050 mm) or less, no correction is necessary.

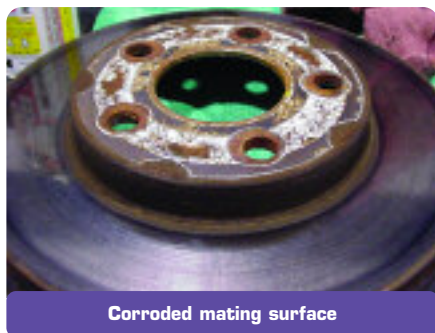
One of the causes of excess lateral run out is foreign material between mating surfaces of rotor, hub, and wheel. These include debris, corrosion, flaking and grease.

Corroded mating surface

You need to obtain clean metal-to-metal contact to get repeatable results. Pits aren't so much of a problem as raised surfaces.

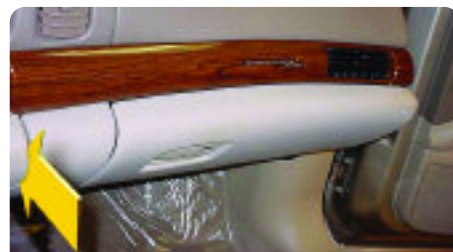
Owners of some Buick LeSabres may encounter noises. GM's Squeak and Rattle Task Force has identified the following areas.

Place clear plastic tape in location shown (typical)

Instrument Panel Squeak – Applying clear plastic tape or equivalent between the trim panels will eliminate the noise.

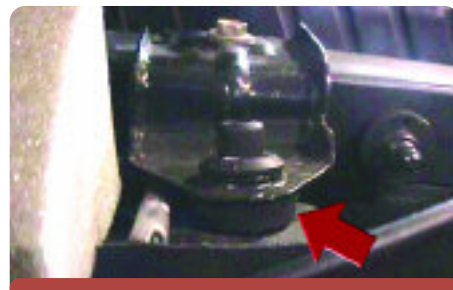
Under-Hood Clunking Noise – This noise may be caused by excessive clearance between the radiator hold down retainer and bushing. To correct this condition, split another bushing and install to eliminate the excessive clearance.

Add bushing in location shown.

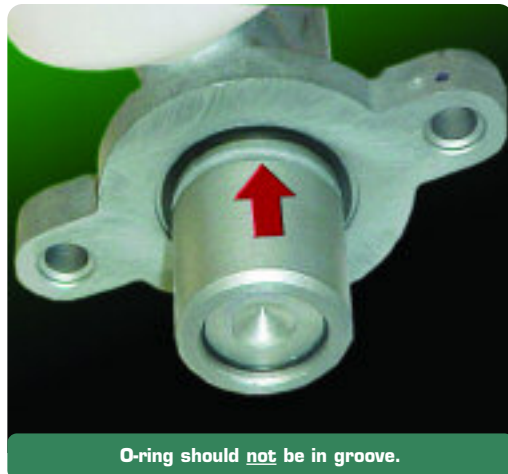
Owners of some 2005 Sierra or Silverado 1500 trucks may comment that they have a Service Engine Soon light illuminated. DTC code P0171 and/or P0174 (Lean Fuel Trim) may be set.

The cause may be a damaged or missing seal (O-ring) between the master cylinder and the brake booster. At idle, the vacuum leak may be audible.

O-ring should not be in groove.

If the seal is missing or damaged, replace the seal (p/n 89059131). When installing the master cylinder, hold the master cylinder flush to the brake booster and torque the nuts to 36 Nm (27 lb ft).
