TECHLink

GM
December 2005
Volume 7, No. 12

A Monthly Publication for GM Dealership Service Professionals

Fuel Pump Modular Reservoir Assembly

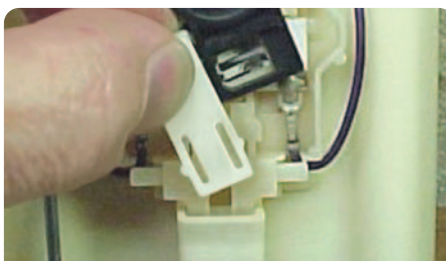
A Removing lock from fuel level sensor

The fuel level sensor also uses a position assurance lock (A), which is removed much like those used in electrical connectors.

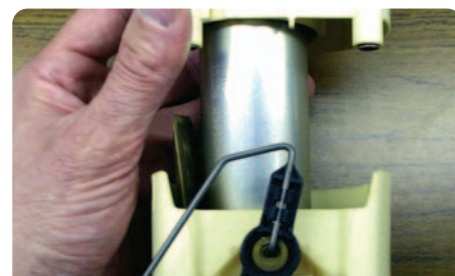
B Sliding module from reservoir

To gain access to slide the fuel level sensor from the reservoir, you must slide the fuel pump module partway from the reservoir (B). This involves carefully depressing two plastic tangs (C).

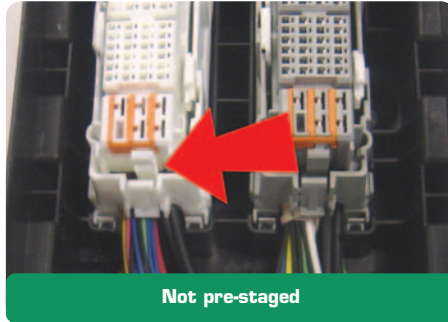
Before plugging the connectors into the Junction Block, be sure the connectors are in the pre-staged position. If this is not done, the Junction Block and connector will be damaged when the connector is plugged in.

Not pre-staged

If there is downward movement, use a hook tool or your hand to pull the connector up to the pre-staged position. You will hear a click. Then recheck the pre-staging.

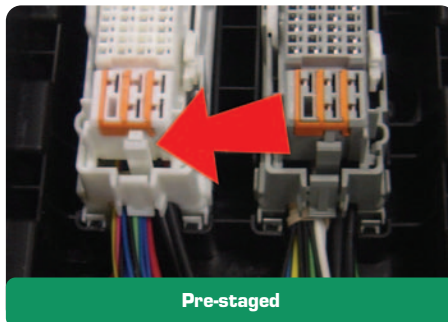
Pre-staged

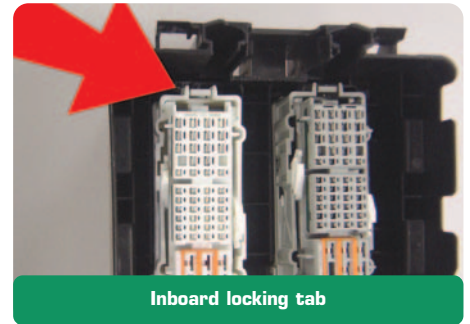
Inboard locking tab

Begin by removing the connector from the mounting cover. Remove the most inboard locking tab first and then the two most outboard locking tabs.

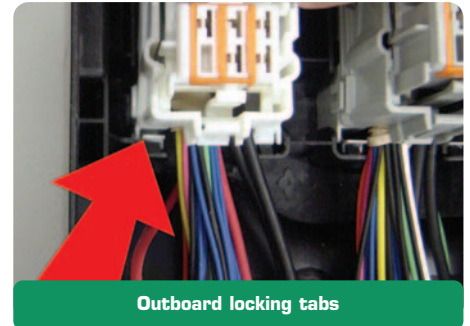
Outboard locking tabs

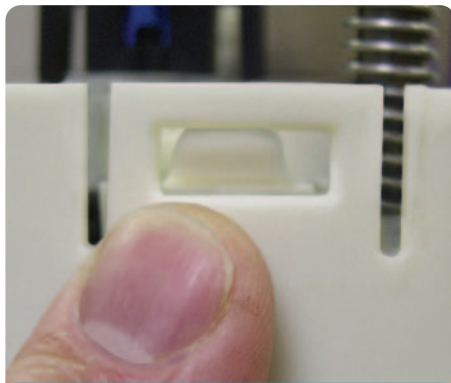
C Location of tang

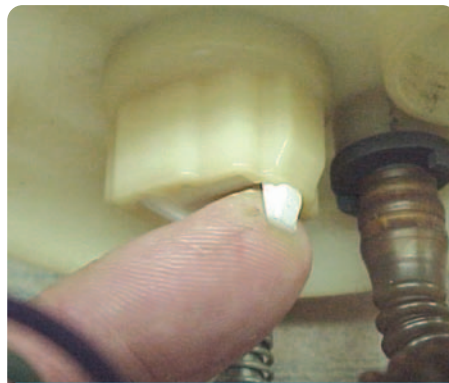
G Checking locking tab

IMPORTANT: Be sure the connector is properly aligned with the opening in the cover, then use finger pressure to install the connector into place until the tab clicks. Check the connector for proper installation (G).

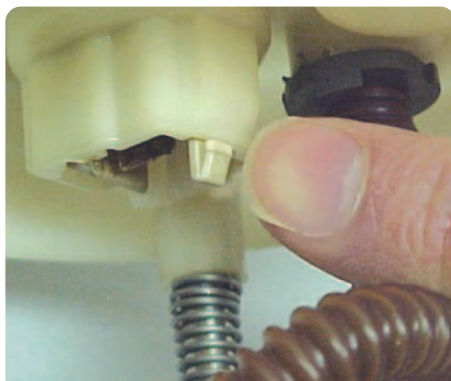
D Depressing lock tab on connector

tab, which you can loosen with finger pressure (D).

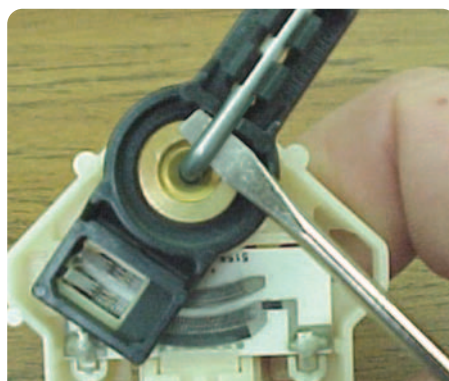
H Removing float arm

TIP: When removing the float arm from the old fuel level sensor, twist a small screwdriver under the float arm, which will push the arm from the retainers (H).

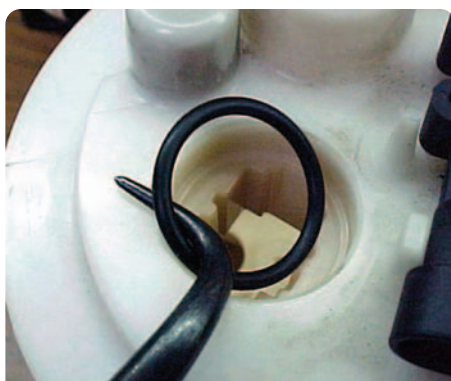
E O-ring

TIP: After removing the connector, be sure the O-ring does not remain in the cover (E).

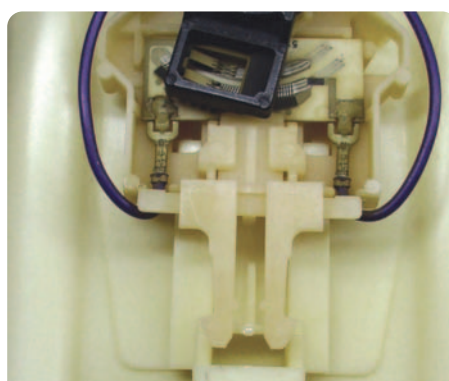
J Installing sensor

TIP: When installing the new fuel level sensor to the reservoir, be sure the tabs on the sensor align with the slots in the reservoir (J).

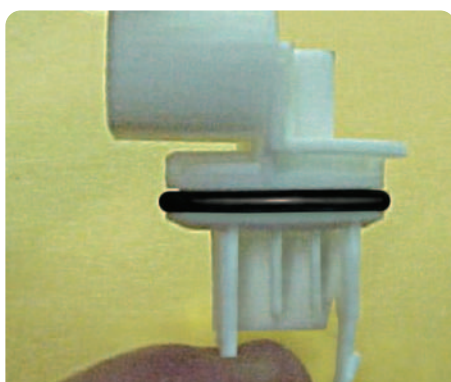
F O-ring installed and lubricated

- Be sure all dirt and debris are cleared from the cover.
- Be sure the O-ring is properly seated on the connector and properly lubricated using the oil in the kit (F).

IMPORTANT: The O-ring may be damaged during installation if it is not properly lubricated.

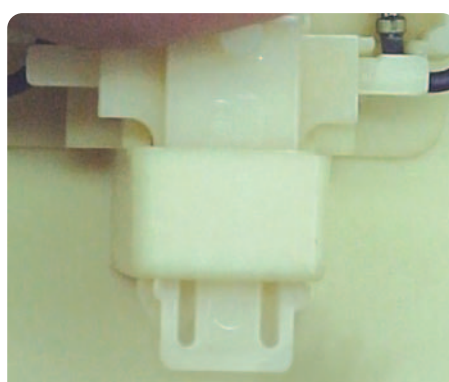
K Installing lock

Press down until the sensor tabs snap into place. Then install the assurance lock from the top (K).

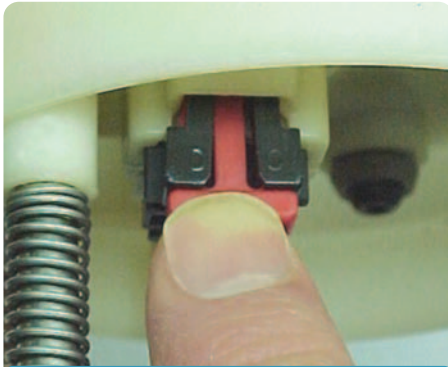
L Assurance lock on fuel level sensor connector

After plugging in the fuel level sensor wiring connector, be sure the assurance lock snaps into place (L).

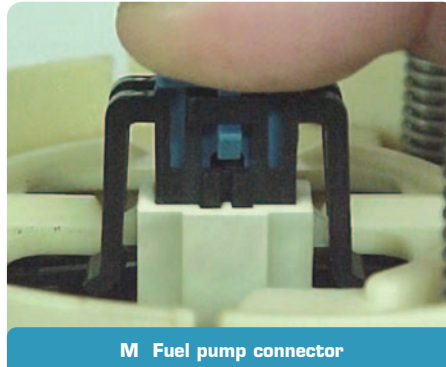
M Fuel pump connector

When plugging in the fuel pump connector, be sure it's seated and the locking tabs click into place (M).

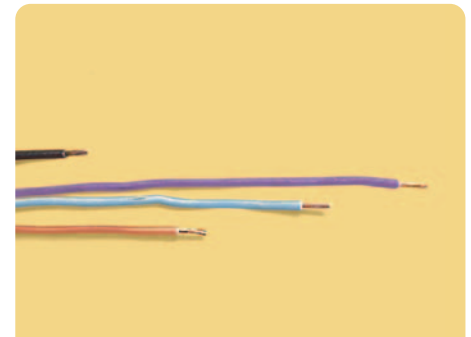
N Staggered wire cuts

IMPORTANT: Stagger the cuts by 1.5 inches (40 mm) so the splices will not overlap (N).
