TECHLink

GM
December 2006
Volume 8, No.12

A Monthly Publication for GM Dealership Service Professionals

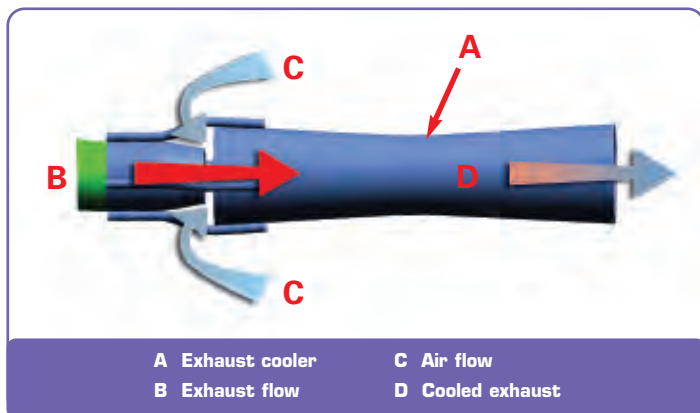
The exhaust system has been designed to deal with the temperatures involved in the regeneration process. On long wheelbase models, for instance, a heat shield protects the rear axle shock absorbers. All models have an exhaust cooler at the end of the tailpipe. A vacuum created by the exhaust passing through the openings draws in cool air, which mixes with the exhaust gases. Cooled exhaust exits the tailpipe.

IMPORTANT – There are times when a DPF service regeneration must be performed at the dealership. THIS MUST BE CONDUCTED OUTDOORS. The shop exhaust system will not handle the heat.

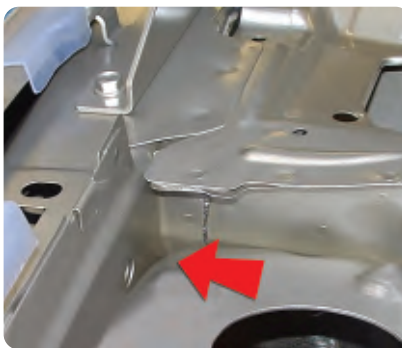
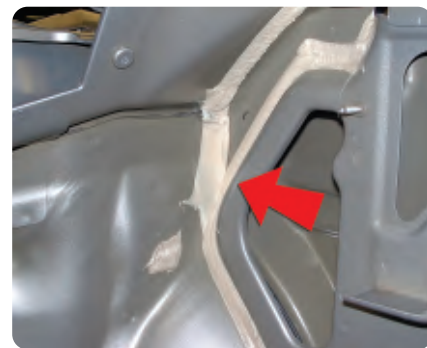
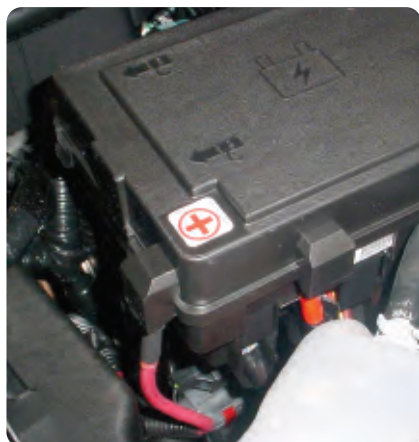
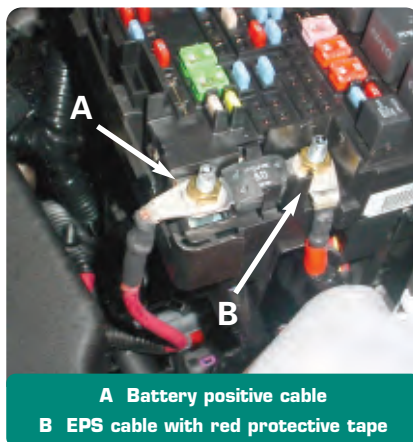
The owner of an Equinox or Torrent may comment about wet carpet in the front passenger area.

The body sealant between the sidebody and cowl may be misplaced, allowing water to pass from the top of the right front strut tower into the cabin.

To check for this leak, apply water at the corner of the strut tower. With the passenger side carpet pulled back, look for water to enter. To repair, apply body sealant at the strut tower to dash panel area.
