Terminal Repair Kit Update J-38125-710

Techline News

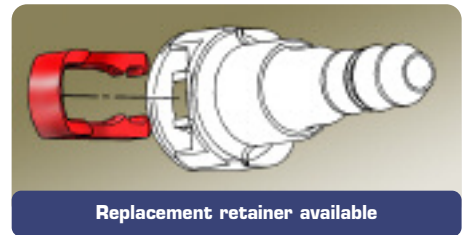
TI Group Global – If the retainer is broken, it is not necessary to replace the

Replacement retainer available

entire fuel line and attached component to repair it. Three sizes of replacement retainers are available.

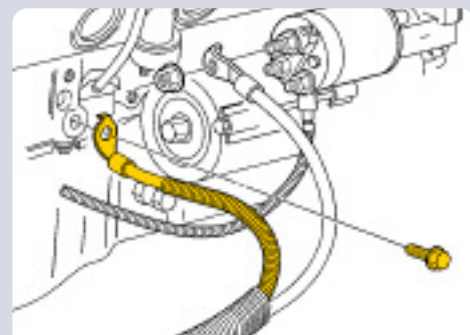
Bolt at engine block ground G101

If the owner of a 2004 LeSabre or Park Avenue/Ultra built before December 19, 2003 experiences a no crank, no start condition, check the negative battery cable torque at the engine block. The negative battery cable may be loose or not torqued to specification. The ground location (G101) may not be drilled or tapped deep enough into the engine block to allow the bolt to achieve the recommended torque.

original bolt	12556062
shorter bolt	11517862

To correct this concern, install a shorter bolt or add two star washers to reduce the height of the bolt.

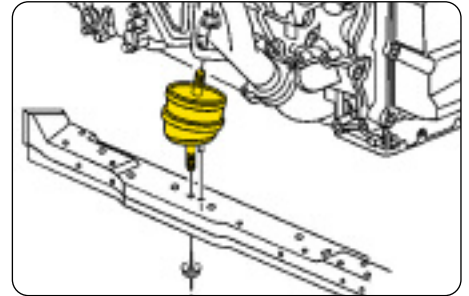
On the 2000-04 Cadillac DeVille, modifications to the front engine mount have resulted in the following changes:

- Front engine mount serviceable as a separate part, without bracket
- Revision of replacement procedure. In SI, refer to Engine Mount Replacement - Front in Engine Mechanical, or document 447931 (MY 2000) or 714354 (MY 2001-04).
- Revision of labor time

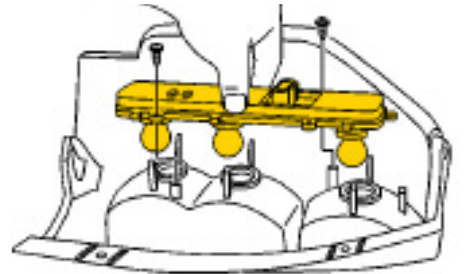
Bulletin 03-08-42-006A presents information about the circuit board used in tail lamps of 2002-04 TrailBlazer, Envoy and Bravada, and 2004 Rancier.

A new circuit board is available for repair if diagnosis leads to a failed tail lamp bulb. If the lamp is loose, or the board is failed, install a new circuit board on both sides.

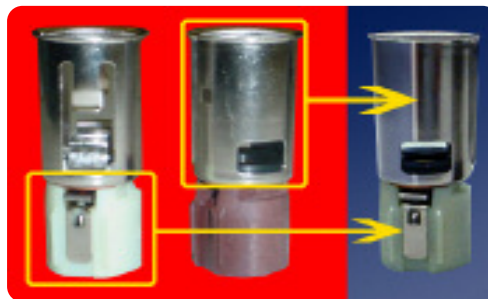
Cigar lighters and APOs use different electrical connectors. During the time while the electrical harness was being redesigned, Engineering created a hybrid APO. It consists of the body of a standard APO and the connector base of a cigar lighter housing.

10,500 Cavaliers were built with the hybrid APO (between VIN breakpoints 1G1JC52F947205493 and 232627). After the end breakpoint, the I/P wire

TIP: The hybrid part will not be available to service. Use only the cigar lighter housing to replace the hybrid.
