**Vac-n-Fill**  
GE-47716  
Coolant  
Refill System

## Techline News

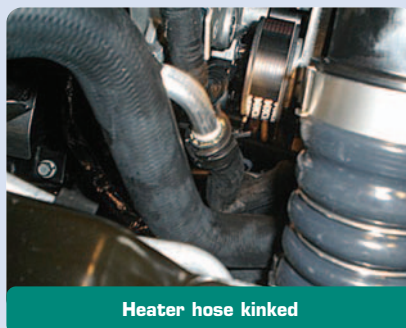
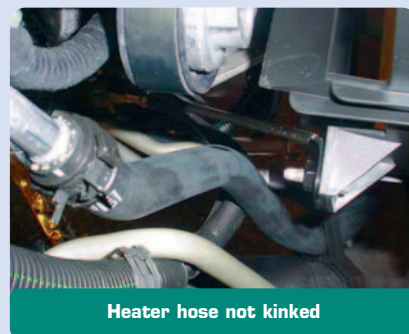
## Poor Heater Performance

Some owners of the 2006 Chevrolet Silverado or GMC Sierra with 6.6L Engine RPO LBZ may comment on poor heater performance. During normal diagnostics, both heater hoses may be cold. This may be caused by

the heater hose being pinched/kinked at the lower radiator hose.

To correct this condition, drain the coolant system and reroute the heater hose to eliminate the pinch/kink.

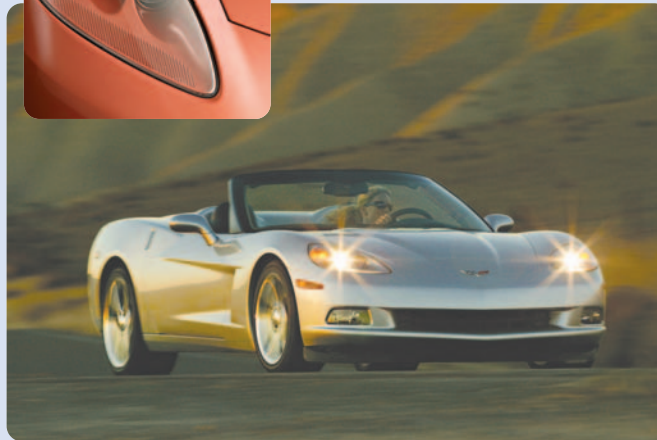
## Headlamp Fog

Owners of some 2005-06 Chevrolet Corvettes may note that when the headlamps are on, light fog or cloudiness is visible on the lenses. Some customers may also state that the headlamp lenses have condensation or moisture.

The light fog or cloudiness is caused by out gassing of the clear polycarbonate lenses and is a normal characteristic of the vehicle. The headlamps are also vented; some condensation or moisture may be seen when humidity is high or there is a change in temperature. The moisture should burn off after one hour of headlamp operation.

Don't replace the headlamp lenses for the above concerns.
