## J-44175 Fuel Composition Tester

J-44175 Fuel Composition Tester	1
Tire Pressure Monitor Tips	1
Coolant Fan Motor Replacement	2
Lifting and Jacking	2
Coolant Leak at Upper Radiator Hose	2
100% Caster/Camber Validation	2
Underhood Electrical Center Cover	4
Rear HVAC System Conditions	4
Programming Immobilizer Keys	4
Steering Wheel Position	4
Liftgate Creak Noise	5
Front Axle Switch Circuit	5
PTO Drive Applications	5
Center Cap Installation	5
Cup Holder Liner	6
Locating Unit Repair Information in SI	6
Torsion Bar Front Suspension	6
Musty Odor from HVAC	6
Pickup Box Dimensions	7
Remote Start Features Clarified	7
Voltmeter Fluctuation	7
Fix It Right the First Time	8
Know How Broadcasts for March	8

GM TechLink is a monthly magazine for all GM retail technicians and service consultants providing timely information to help increase knowledge about GM products and improve the performance of the service department.

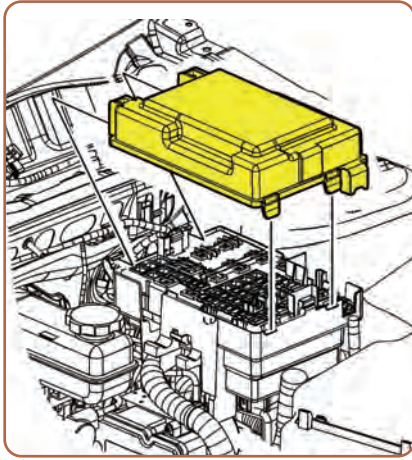
## Underhood Electrical Center Cover

On the 2007 Chevrolet Equinox and Pontiac Torrent, here's how to remove the Underhood Electrical Center/Junction Block Cover without damage.

To remove the fuse block cover, push in on the four tabs with a flat-bladed tool.

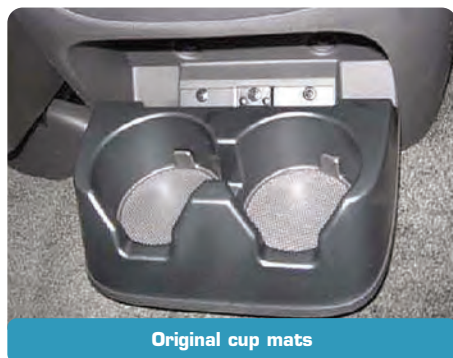
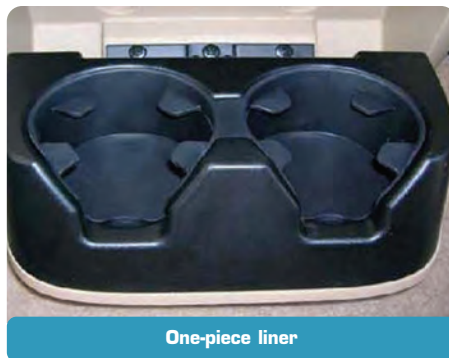
## Cup Holder Liner

The rear center console cup holders may not retain a cup properly when turning or accelerating. The original liners are cup mats with no retention tabs.

To address this concern, replace the cup liners with a new updated one-piece liner p/n 25793661.

Before installing the new one-piece liner, remove the 2 tabs located on the front and back of the rubber lining. This provides a better fit and prevents a gap between the liner and the cup holder bezel.
