## Integrated Center Stack (ICS)

GM TechLink is a monthly magazine for all GM retail technicians and service consultants providing timely information to help increase knowledge about GM products and improve the performance of the service department.

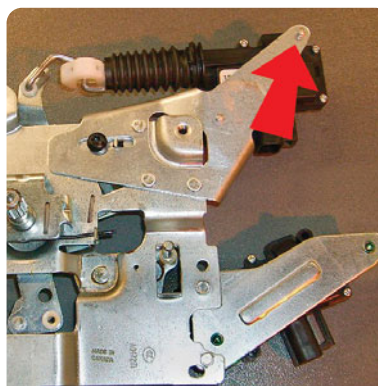
A protruding rivet on the outside of the interior latch assembly can contact the door sheetmetal, causing a rattle type noise. To repair, install foam tape to the door sheetmetal to insulate the rivet.

Rivet on power sliding door latch assembly

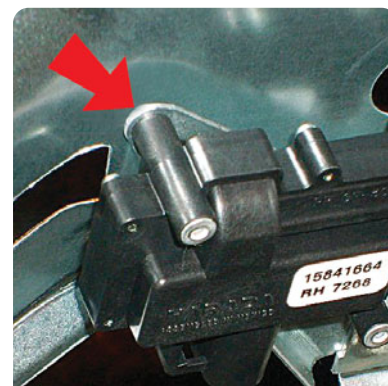
Mushroom end of rivet contacts sliding door inner panel

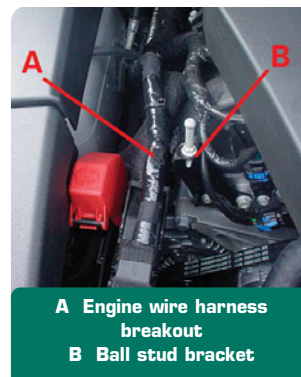
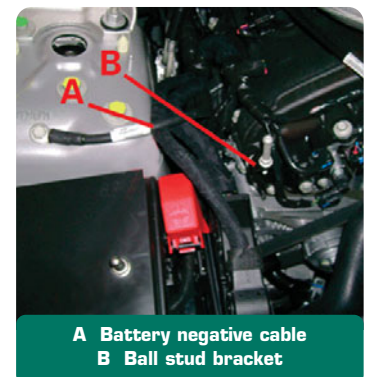
Some owners of a 2008 CTS may comment that the Malfunction Indicator Lamp (MIL) and or Reduced Engine Power is displayed on the Driver Information Center. Further investigation may reveal one or more of the following DTCs are stored: P0087, P0089, P0451, P0452, P0628. The cause may be the engine wire harness chafing on the passenger front engine cover/sight shield ball stud bracket.

Repair the wiring as necessary. Reroute the harness under the battery negative cable away from the passenger front engine cover/sight shield ball stud bracket.

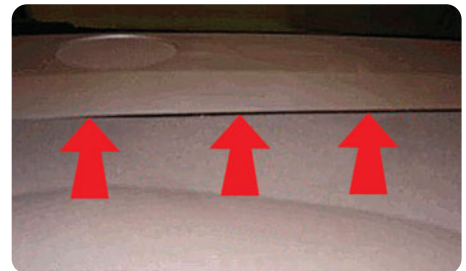
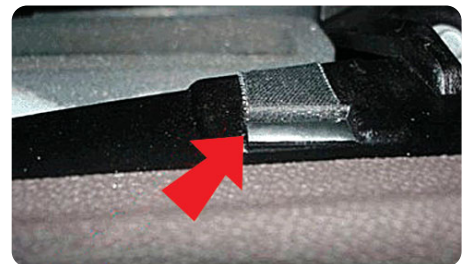
Some owners of a 2007-08 SRX may comment that the instrument panel (IP) upper trim panel has a gap to the IP. The cause may be insufficient friction between the retaining clip and the cut-out in the IP panel.

It is NOT necessary to replace the instrument panel upper trim panel. Apply one strip of 3M friction tape (p/n 03407NA) or cloth electrical tape to one side of the retaining clip opening. There are 6 openings that will need tape. After tape is applied, the effort needed to seat the clips is increased.

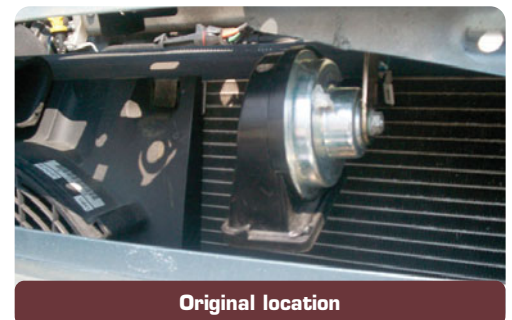
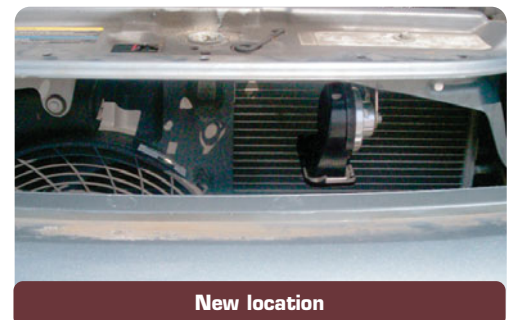
On a 2000-05 Saturn L-Series, the horn may be inoperative, weak or muffled. The horn may have been replaced previously with an updated unit.

These conditions may be due to water intrusion. Install the updated horn in the alternate location identified in the following procedure.

1. If the horn has not been updated to the latest part, it will need to be changed to insure clearance in the new location.
2. Remove the horn and bracket from the inner fender.
3. Remove the grill.
4. Using the existing bracket, mount the horn to the underside of the top radiator core support on the driver's side.
5. Lengthen the wiring as needed to reach the new location. Use splice sleeves from the Terminal Repair Kit.
