## Safe Multimeter Practices

### Contents

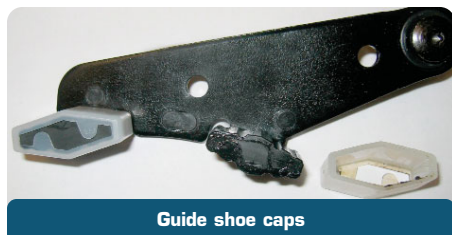
Guide shoe caps

The sunroof may stop and auto-reverse direction when the express open or closed feature is selected. The sunroof motor reverses when it experiences high current draw caused by excess friction in the guide tracks. Due to the size and design of the glass, the rear guide tracks may become dirty from exposure to environmental elements. Lack of proper maintenance, cleaning and lubrication may also be a cause.

Refer to bulletin 06-08-67-011D for several remedies. These procedures detail improvements that have been implemented in production.

- Clean the guide rails with brake cleaner, then lubricate with Rheosil 500F (obtained from TAI Lubricants at 1.302.326.0200). Rheosil 500F is the only lubricant GM recommends for the rear tracks.
- When the sunroof glass is removed, operate the sunroof drive system to confirm that there are no concerns with the front drive tracks or drive cables.
- Install softer durometer rubber guide caps p/n 25880591 to the white plastic guide shoes.
- If other remedies are not successful, replace the motor with a high-current version, p/n 15932104. It is not necessary to replace the drive motor in every case

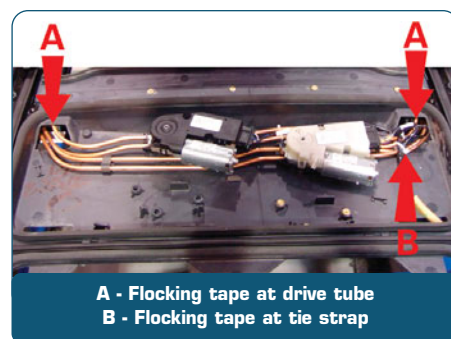
A - Flocking tape at drive tube  
B - Flocking tape at tie strap

- Sunroof module or glass panel fasteners may be loose. The specified clamp load is low and must be maintained. Also be careful not to overtorque. See the over-torque tip earlier.
- Sunroof frame alignment pins may contact the roof sheet metal. Refer to bulletin 06-08-67-012B for details.
- Rear roof rail airbag fastener may contact the side door ring sheet metal. Refer to PIC4359A for details of the condition and repairs.
- The sunroof module fasteners may contact the sunroof SMC frame, creating a noise. See PIC4359A for details.
- The copper drive cable tube may contact the SMC frame or a tie strap may contact the SMC. Isolate both contact areas with flocking tape.
- Conditions of wind noise at the leading edge of the glass may be corrected by following the procedures in bulletin 07-08-58-002.
