Cylinder Bore Liner Replacement

A new tool EN-45680-850 has recently been released to replace cylinder bore liners in the 2.2L Ecotec four-cylinder engine (RPO L61 VIN F or D).

GM TechLink is a monthly magazine for all GM retail technicians and service consultants providing timely information to help increase knowledge about GM products and improve the performance of the service department.

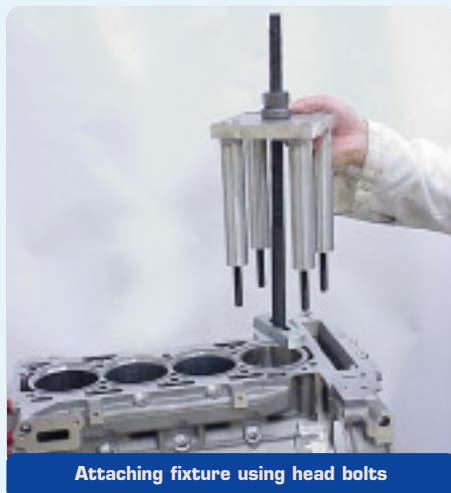
Attaching fixture using head bolts

The fixture assembly is attached above the cylinder bore with previously-used cylinder head bolts.

The fixture is installed from above, with the shoe positioned flat against the bottom of the cylinder liner.

A nut on the puller is turned to pull the liner from the block.

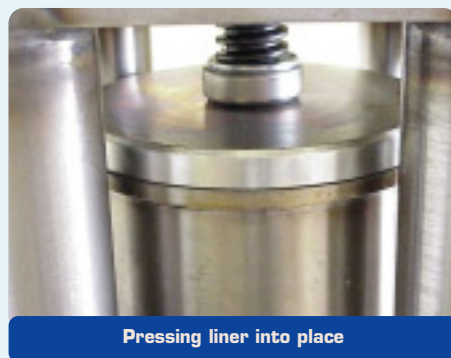
Pressing liner into place

An installation assembly is used to press the liner into place.

When the liner is installed to within 1/16-inch (1.6 mm) of the block deck face, use a torque wrench to tighten the arbor to specification. When the flange of the liner seats into the counterbore of the block, a minimal portion of the liner remains above the deck surface.

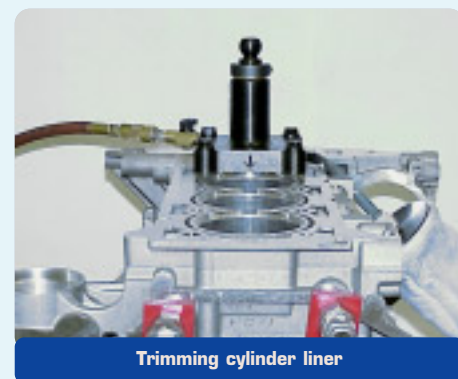
Trimming cylinder liner

installation, it's necessary to machine the top of the liner to production height specification, flush with the block deck to + 0.02 mm (0.0008 in.) above deck.

The cylinder liner trim tool is installed to the block over the affected cylinder. An electric drill motor with specific power rating and rpm must be used to operate

the trimmer. And compressed air operates the venturi vacuum that catches the metal shavings as the liner is trimmed.

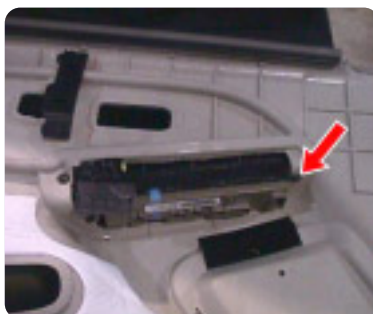
This is a reminder to follow the service procedure when removing the Switch Plate Bezel from the front doors of 2000-04 full-size Pickups and Utilities. Several door trims have been damaged by trying to take out the bezel incorrectly.

the top in an attempt to remove the switch. The bezel and/or trim panel could be damaged.

Refer to SI documents 849812 and 849813 for the correct way to remove the bezel.

1. Remove the front door trim panel.
2. Disconnect the electrical connectors.
3. Remove the screw that retains the switch panel bezel from the front door panel.
4. Remove the switch panel bezel from the door panel using a flat-bladed tool.

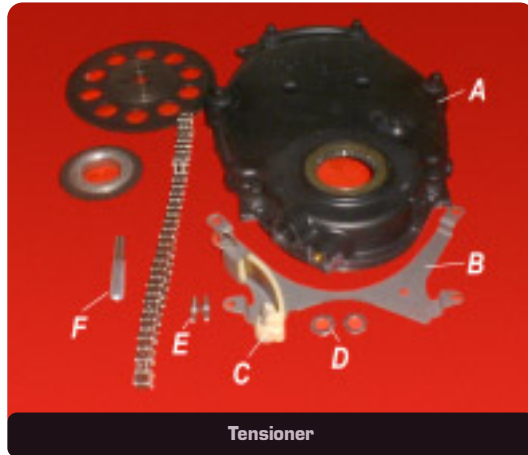
The rattle noise may be caused by torsional vibration of the balance shaft. A timing chain tensioner kit has been released to deal with this condition. The tensioner consists of a bracket which holds a nylon blade against the timing chain.

- A Front cover
- B Tensioner bracket
- C Nylon blade
- D Washer
- E Dowel pin
- F J-46165 Pin Driver

The engine front cover must be removed for access to the crankshaft and camshaft sprockets and chain. The camshaft chain must be removed. Depending on model year, either the cam gear or crankshaft sprocket must be removed to do this. Follow standard SI procedures.

The tensioner bracket fits over four existing holes. The upper two are the front cover center bolt holes. And the lower two are front cover alignment holes.

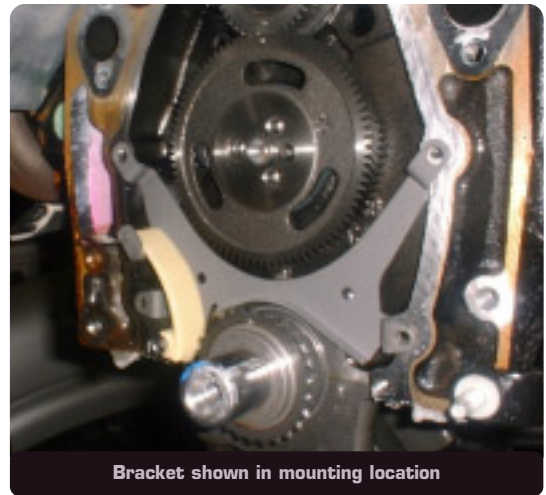
Bracket shown in mounting location

With the tensioner bracket in position, use J-46165 Pin Driver to drive dowel pins into the two bottom holes to retain the bracket.

TIP: The kit includes two washers. Place them under the two center cover bolts, which extend through the tensioner bracket. These are required to maintain proper crush on the engine front cover seal.
