## Battery Charger for Programming

### Techline News

GM TechLink is a monthly magazine for all GM retail technicians and service consultants providing timely information to help increase knowledge about GM products and improve the performance of the service department.

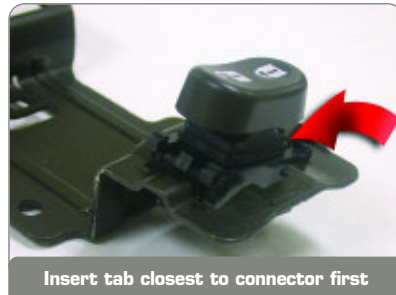
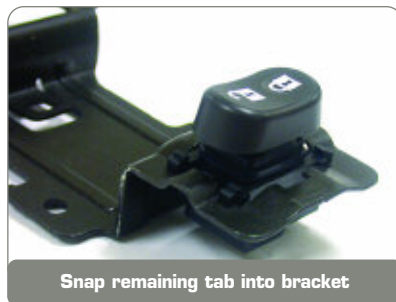
The door lock switch is retained in the bracket by two tabs. The tab closest to the electrical connector is less flexible than the other.

If disassembly and assembly are done incorrectly, you may break the lock tab on the side of the switch closest to the connector.

Apply pressure with finger or screwdriver on the locking tab that is furthest from the electrical connector

Don't apply pressure with finger or screwdriver to the locking tab that is closest to the connector.

Connect the electrical connector before installing the switch.

Insert the locking tab on the switch that is closest to the electrical connector into bracket hole. Then, place both thumbs on the switch and snap the remaining locking tab into the bracket.

Don't push both locking tabs at once.

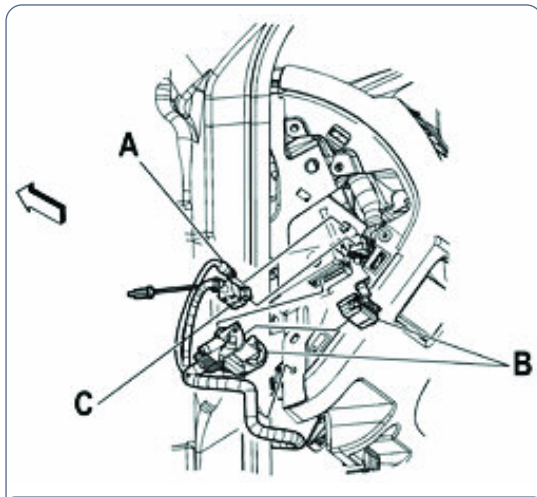
water intrusion. Water in this connector may cause SES, SVS, and APP codes, or other various codes to set. The predominant codes set are for the Accelerator Pedal Position Sensors. The diagnostic parameters for the pedal sensors are more sensitive to this condition and may be the first to show the concern.

The SES light may be on and/or various electrical concerns and multiple or repeat Accelerator Pedal Position Sensor (APP) codes: DTC P2125, P2120, and P2138.

If a vehicle is found to have multiple accelerator pedal codes or repeating codes for the ETC pedal system, check the in-line connector C206 on the left side of the instrument panel for

If you find water in connector C206, check for a possible water leak from the top of the A-pillar at the ditch molding or sunroof drain and reseal/repair as necessary.

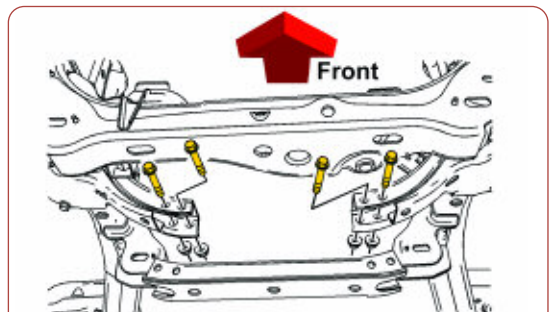
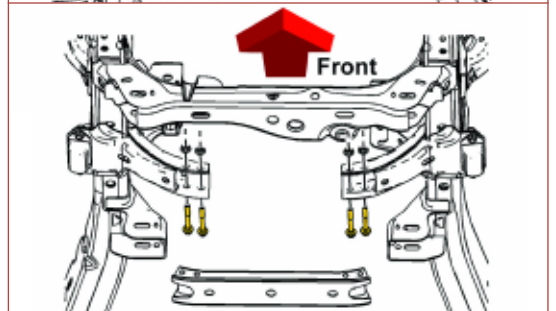
On the 2004 and early 2005 (before April 2005) Colorado and Canyon, the front crossmember-to-frame bolts were installed front-to-rear. This made crossmember removal more time consuming because it was necessary to rotate the steering gear out of the way.

Crossmember bolt installation  
(early version, top, and late version, bottom)

The SI procedure now recommends that when the front crossmember-to-frame bolts are reinstalled, they should be installed rear-to-front, so that if future crossmember removal is needed, the steering gear will not have to be rotated.
