Stretchy Belt Debuts in H3 V8

GM TechLink is a monthly magazine for all GM retail technicians and service consultants providing timely information to help increase knowledge about GM products and improve the performance of the service department.

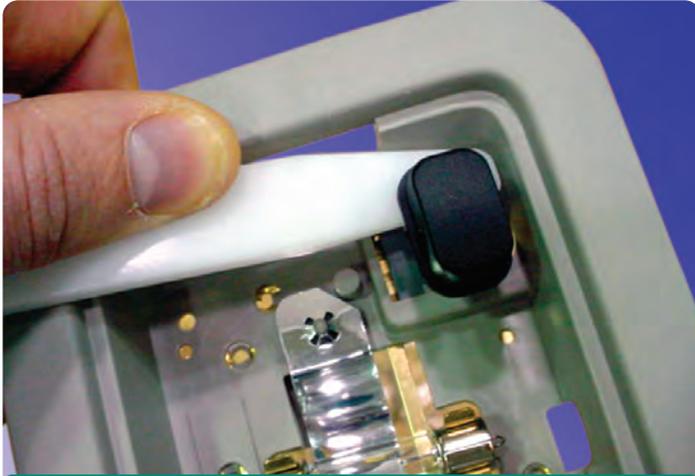
Removing button

It is no longer necessary to replace the entire lamp if the switch becomes inoperable.

Simply remove the lens and remove the pushbutton from the switch. Then use a suitable tool to pry the switch from the electrical contacts and remove the switch through the keyhole slot.

The new service switch assembly p/n 25877453 replaces the current switch assembly.

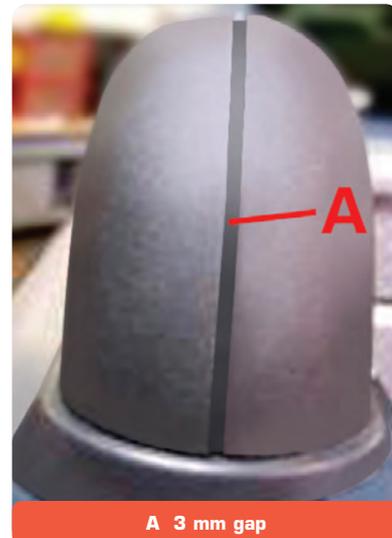
Some owners of a 2007 Silverado or Sierra pickup may comment on a poor appearance of the end caps used on Silverado/Sierra Accessories Tubular Bed Rails (p/n 19154652 and 19154653) where the end cap halves may not properly mate once installed.

To prevent this from occurring, the front and rear stake pocket bolts should be snug before installation of the end caps. If over-torqued, the inner and outer end caps will not properly close once the end cap fasteners are tightened. Once properly installed, a 3 mm gap should exist between the two end cap halves.
