Electronically Controlled Air Suspension (ECAS) Procedures

Techline News

GM TechLink is a monthly magazine for all GM retail technicians and service consultants providing timely information to help increase knowledge about GM products and improve the performance of the service department.

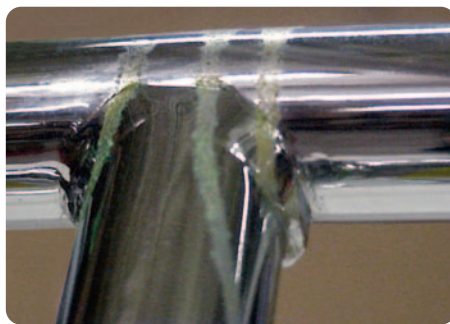
Owners of some 200307 Hummer H2 vehicles may comment about a discoloration or stain on their H2 Accessories Chrome Brush Grille Guard (p/n 17801174), particularly at the welds and drain hole locations. These stains are a result of residual fluid that has not fully escaped during the chroming process and may appear well after the product has been installed onto a customer's vehicle.

H2 Accessories Chrome Brush Grille Guards that have this condition should not be replaced under warranty. GM rec-

ommends the use of a standard chrome cleaner.

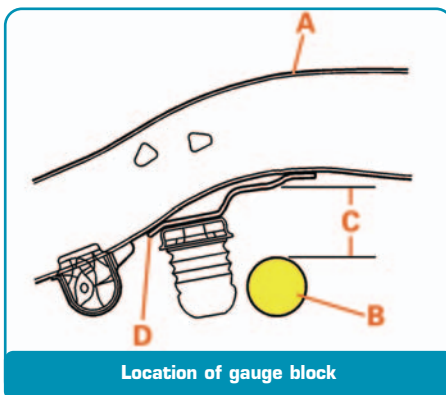
Create a D-height measurement gauge, using metal stock. Cut a block to 20 mm X 30 mm X the correct D-height specification. For the correct D-height specification, refer to Trim Height Specifications in SI.

TIP: Measuring from the ground is not the proper method of checking D-height. This will not account for surface variations. And specs are listed for D-height variation, not body variation.

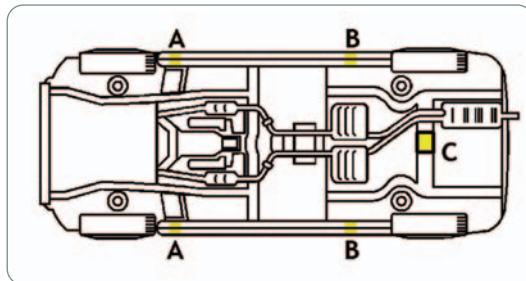
On the Pontiac G6, incorrect placement of the hoist pads to the underbody pick-up areas may cause a crack or leak in the plastic EVAP canister and eventually set one or both of the following DTCs:

DTC P0442	small EVAP leak detected
DTC P0455	large EVAP leak detected

To avoid this situation, particularly when using the type of hoist where the arms swing in and the pick-up pads swivel, be sure the pick-up pads are positioned correctly. Refer to SI document 1211728.

IMPORTANT: Placing the lift pads other than in the recommended locations can cause damage to underbody cross-members.

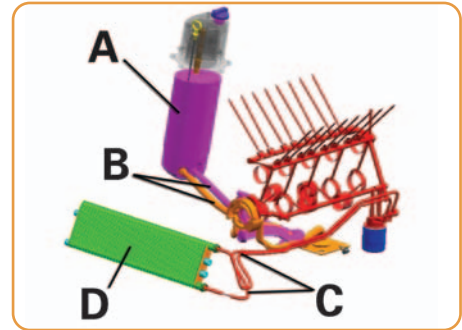
If an engine is being repaired or replaced due to a mechanical engine failure that deposited debris into the engine, clean the following components of debris before starting the engine:

TIP: There is a coarse wire-mesh screen at the interface between the dry sump tank and the oil return line to the suction side of the oil pump. This screen will prevent only large pieces of debris from flowing to the oil pump.

You must replace:

- both hoses connecting the dry sump tank to the engine oil pan
- the engine oil cooler
- the engine oil cooler lines

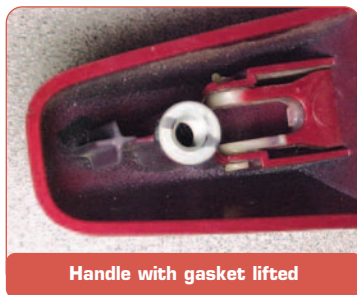
Handle with gasket lifted

With the blower on high speed, an increase in cabin pressure causes air to rush through the door handles.

Lay the handle gasket back down and reinstall the door handle.
