Injector Terminal Fretting – The Invisible Menace

Techline News

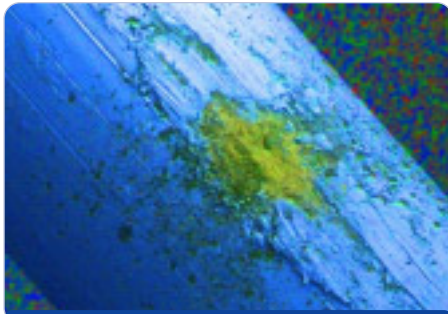
Microscopic view of fretting corrosion

A thin layer of oxide was found to be forming on the injector male pin terminal at the point where it contacts the female harness connection. Invisible to the naked eye, "fretting corrosion" was found on a majority

"Fretting" describes a tiny rubbing motion that occurs between two surfaces (usually on the order of 10-100 microns). "Fretting corrosion" refers to a build up of insulating, oxidized debris that forms on electrical connections due to a fretting action at the contact points. Injector vibration, engine vibration, and electrical harness movement are contributors to the fretting motion.

Using lubricant part number 12377900

to coat the terminals is the best preventative measure to take. This provides a lubricant for the terminals as well as providing an oxygen barrier to guard against oxide formation.

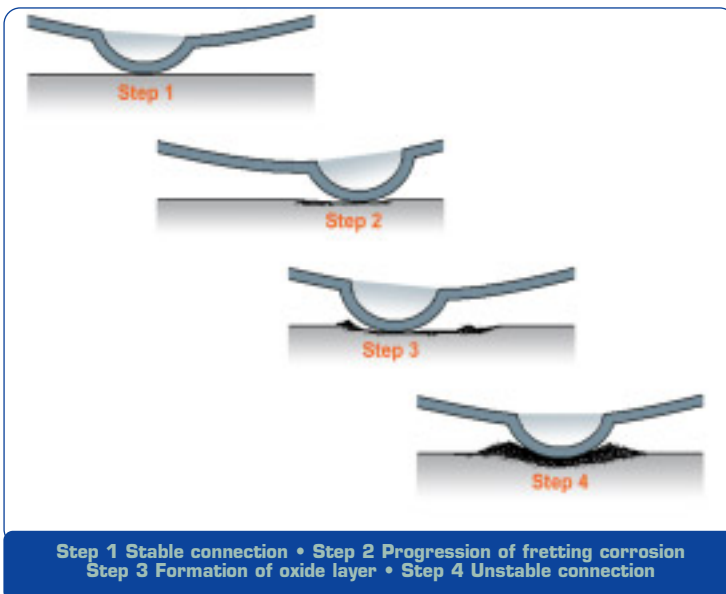
Refer to the accompanying illustrations.

Step one shows the tin oxide layer with clean tin-on-tin contact, resulting in a stable connection.

Step two and three show further progression of fretting corrosion (formation of oxide layer)

Step four shows the contact point after numerous fretting cycles, resulting in an unstable electrical connection.

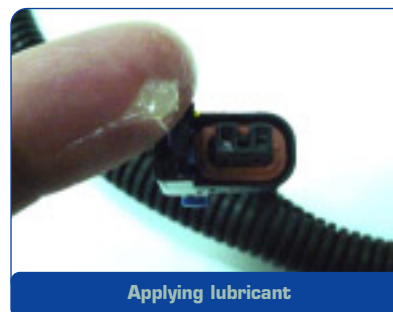
Applying lubricant

To apply the lubricant gather a small amount (about the size of a BB) on the end of your finger. Press it into the end of the disconnected female connector, making sure to cover both cavities. Reconnecting the harness connection onto the injector will wipe the lubricant onto the male terminal pins.

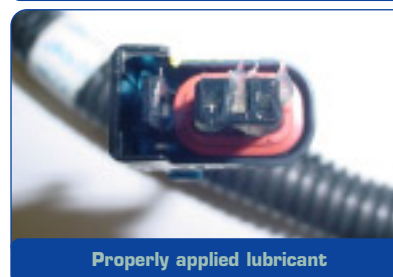
Properly applied lubricant
