## Techline News

# New Radio Antenna Connector

# STS Tire Pressure Monitoring System Issues

# Tire Pressure Monitoring Issues

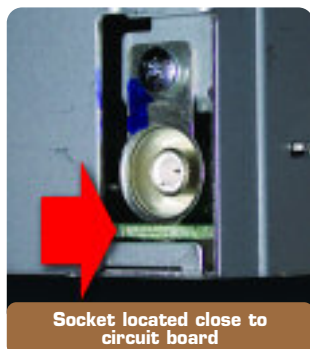
The antenna connector has internal fingers that grip the center portion of the socket on the rear of the radio chassis. The main circuit board can be damaged if you attempt to simply pull the antenna lead to disconnect it from the radio chassis.

Socket located close to circuit board

Instead, (1) slightly push the antenna lead toward the radio to relieve tension on the internal fingers. Then (2) pull back on the spring-loaded locking ring and remove the connector from the radio.

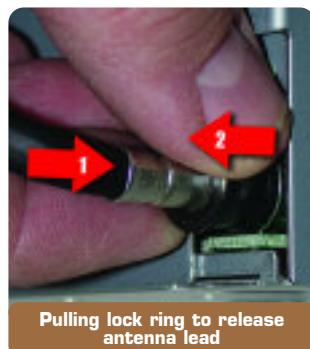
Pulling lock ring to release antenna lead

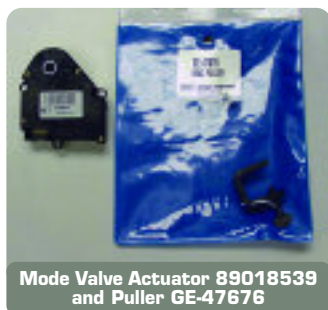
Mode Valve Actuator 89018539 and Puller GE-47676

According to bulletin 05-01-38-001A (SI document 1645422), there's a new procedure for HVAC Mode Door Actuator replacement. Refer to the bulletin for details.

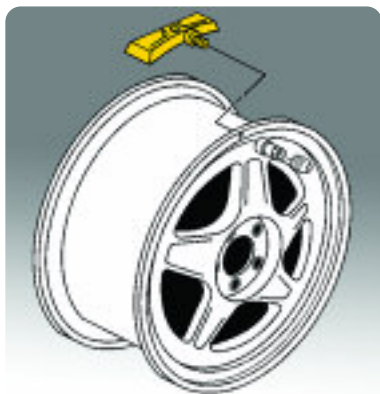
TPM sensor and valve stem

If the tire machine's bead breaking fixture is positioned too close to the TPM sensor, or pressed down directly on top of it, it may contact the sensor as the tire bead breaks away from the wheel rim. This can damage the TPM sensor and require the sensor to be replaced.

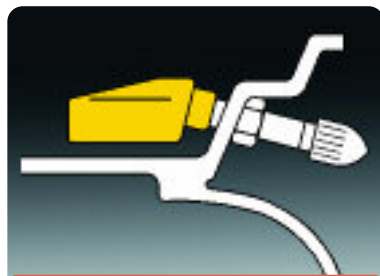
TPM sensor location on wheel rim

Also be careful when transferring the tire bead to the other side of the wheel rim. As the tire machine rotates and the tire bead is stretched around the wheel rim, the bead can come in contact with the sensor. This can also cause sensor damage, requiring replacement. Damage can be avoided by correctly positioning the wheel and tire in relation to the mounting/dismounting head.

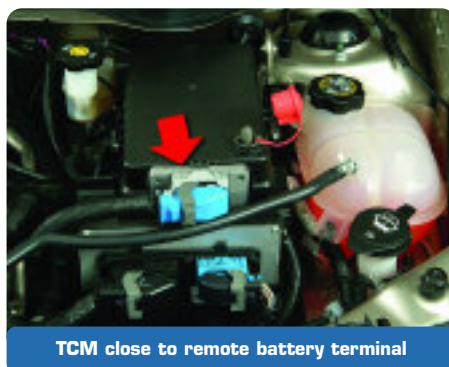
On these vehicles, the Transmission Control Module (TCM) is located in a plastic bracket mounted on the front of the Underhood Fuse Block/Electrical Center. The electrical center contains a remote battery (+) jump-start terminal. The TCM location is near the jump-start terminal. When the electrical center's plastic cover has been removed for diagnostic purposes, the TCM is very close to the exposed jump-start terminal. If the control module's metal case accidentally contacts any source of +12 volts (such as the jump-start terminal), the control module will

become nonfunctional. TCM-related DTCs will set that previously were not stored.

Field returns of the TCMs from these vehicles often display internal damage, likely due to accidental contact with the remote positive (+) battery jump-start terminal with the plastic cover removed. If the TCM is for any reason not installed into its bracket, and the vehicle battery is connected, the controller has enough wiring harness length to allow it to touch the jump-start terminal.

**NOTICE:** Control module damage may result when the metal case contacts battery voltage. DO NOT contact the control module metal case with battery voltage when servicing a control module, using battery booster cables or charging the vehicle's battery.

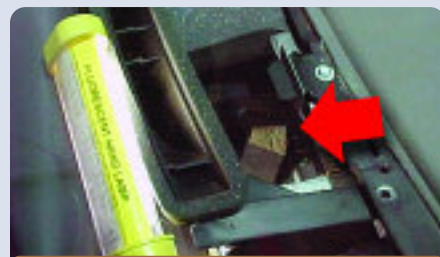
The noise may come and go with the fan speed. A possible cause of the noise is that the defogger vent assembly is not completely seated into the HVAC plenum.

Wedge between defogger and plenum

7. The wedges will keep the center defogger outlet vent in position and provide support once the upper trim pad is re-installed.
8. Reverse the first three steps and test the system to ensure that the concern is repaired.
