Multiple Diagnostic Interface Watch For It . . .

GM TechLink is a monthly magazine for all GM retail technicians and service consultants providing timely information to help increase knowledge about GM products and improve the performance of the service department.

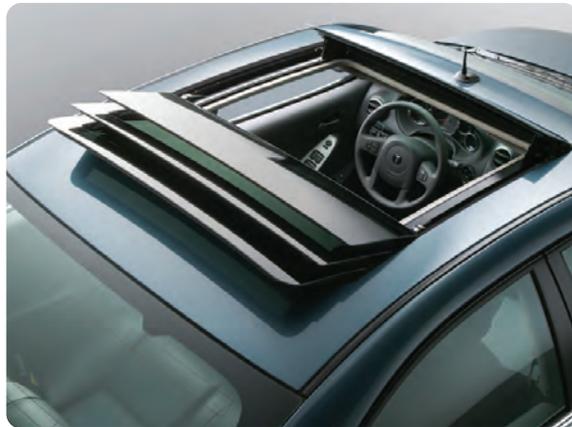
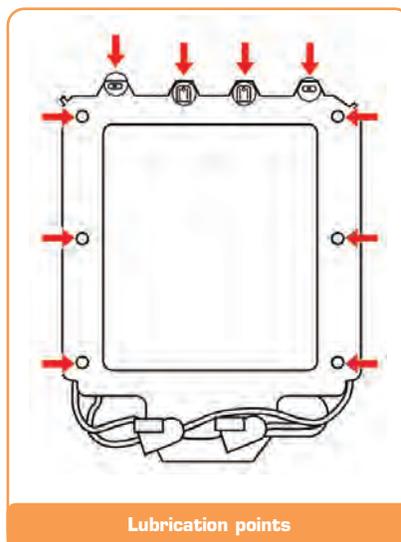
Lubrication points

This condition occurs while driving over bumps and comes from the sunroof module, and is usually caused by roof interaction with the fasteners.

TIP: The bulletin specifies slightly different repairs depending on whether the vehicle was built before or after January 1, 2006, when mylar washers were added to production. For vehicles without the washers, the bulletin explains how to install them.

For all vehicles, lubricate the 10 locations of the mylar washers using GM Super Lube (p/n 12346241).

TIP: Use Super Lube only. No fastener adjustments are necessary unless noise is still present after lubrication.

TIP: It is necessary to lower the headliner before spraying the lubricant. Follow the bulletin procedure to properly cover all interior trim to avoid damage from the lubrication process.

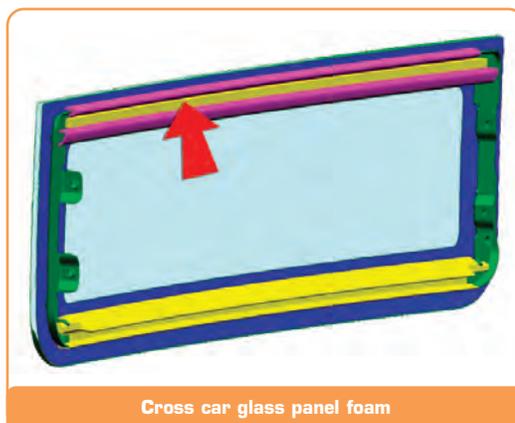
Cross car glass panel foam

From the front – could be leak from roof to seal or seal to front glass panel.

Refer to the bulletin for additional details on repair procedures and updated module seal and cross car glass panel foam part information.

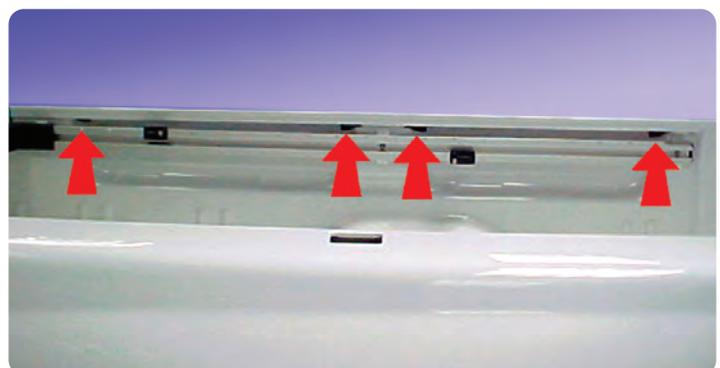
Some owners of a 2007 Silverado or GMC Sierra may comment on the openings under the bed rails near the stake pockets. While the openings on the new Silverado and Sierra are more visible, the Classic Silverado and Sierra had similar openings around the stake pockets. The openings are required for the unique forming process of the new pickup box side inner stamping. The new design has equivalent performance for dust and moisture intrusion when compared to the previous design.

TIP: The pickup box is not designed to be sealed completely from dust or moisture intrusion.

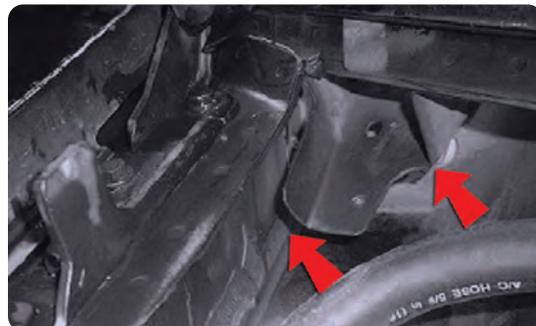
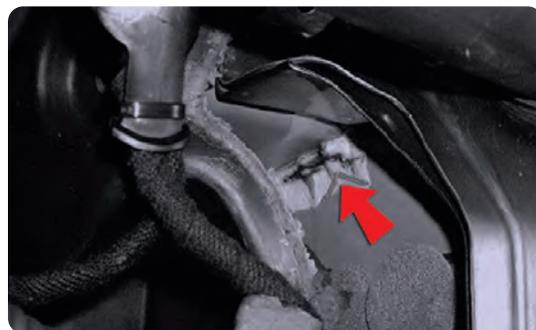
The owner of a 2003-07 Saab 9-3 may comment on wet carpet on the right side floor. An area under the bulkhead cover on the passenger side may have had sealer improperly installed.

This condition could cause a leak at the A-pillar that could allow water into the front foot well and rear floor. The leak path is down the A-pillar to the front floor and then rearward underneath the carpet and insulation collecting in the rear floor area, which is lower than the front.

Check the right rear corner of the engine compartment under the bulkhead cover for missing sealant. Also check the A-pillar behind the glove box from the passenger foot well side for missing sealant.

If no sealer is present at either location or there are skips in the sealant, remove the existing sealant, clean the surfaces and apply new sealant. Test for leaks.

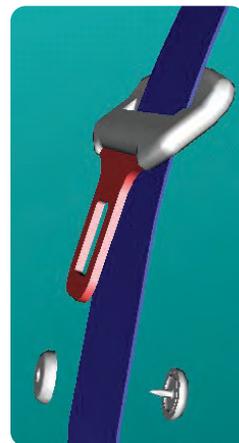
This information applies to all GM vehicles. All seat belt retractor assemblies contain a stop button. If a stop button becomes damaged, the button can be replaced by ordering a replacement button through the GM parts catalog. The seat belt retractor assembly does not need replacement.

Refer to document 1924486 in SI for the complete replacement procedure. If the replacement is a warranty claim, use labor code C9098 when submitting the claim.
