## Laser Assisted Belt Alignment

### Techline News

GM TechLink is a monthly magazine for all GM retail technicians and service consultants providing timely information to help increase knowledge about GM products and improve the performance of the service department.

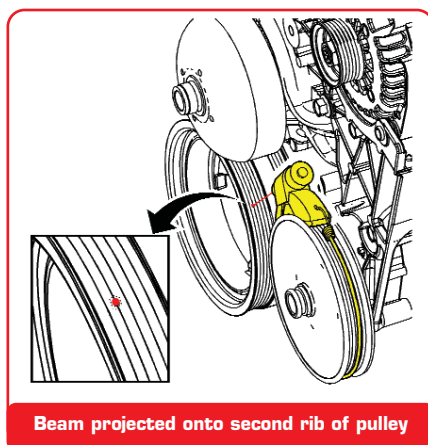
- beam onto the crankshaft balancer pulley grooves.
8. Inspect for proper power steering pulley alignment.
  - If the laser beam projects onto the second rib or raised area, the pulleys are aligned properly.
  - If the laser beam projects more than one-quarter rib 0.9 mm (0.035 in) misalignment, adjust the position of the power steering pulley as required.
  - Refer to SI for Power Steering Pulley Removal and Installation procedures.
9. Install the serpentine belt to the accessory drive system in the original orientation.
10. Operate the vehicle and verify that the belt noise concern is no longer present.

Beam projected onto second rib of pulley

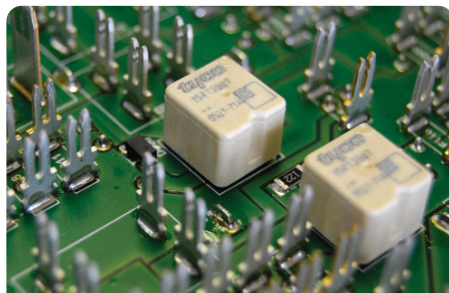
PCB relay

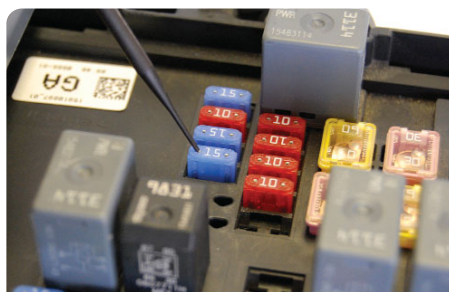
Fuse test point

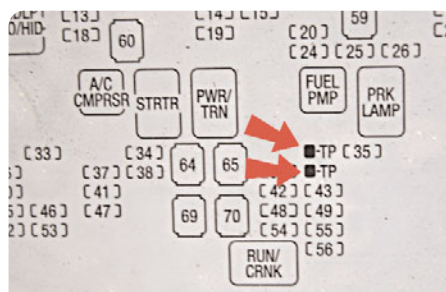
Test point callout on cover

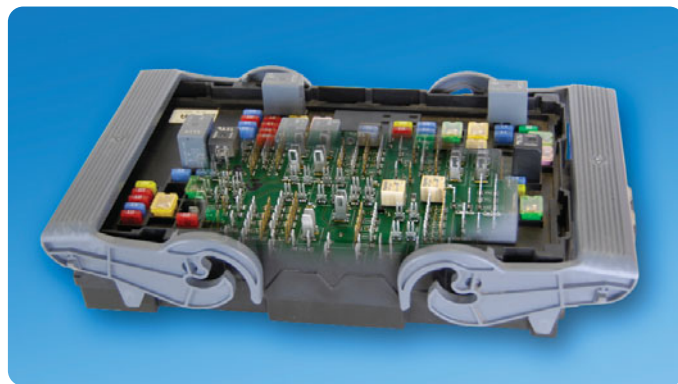
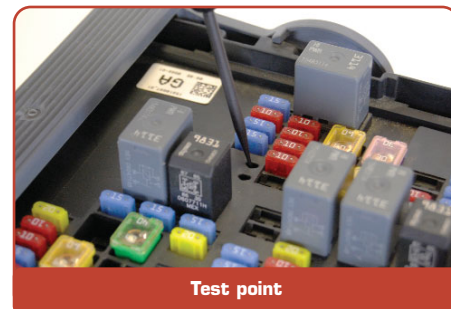
Test point

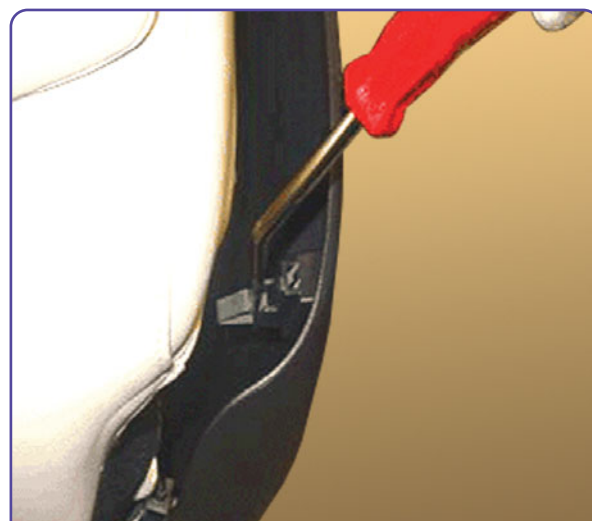
Releasing spring clip with trim tool

Release the two upper spring type clips, followed by the two side clips, then the lower bottom retaining hooks.

1. Push the trim cover forward at the upper right corner with your hand.
2. Insert a trim tool on top of the clip and push down on it to release the spring-type clip from the frame. Repeat for the other side.
3. Once the two upper corners are released, grab each side of the back panel and pull outward to release the side clips.
4. Place one hand at each bottom corner of the back panel (between the panel and trim), press in and pull upward to release the bottom retaining hooks.

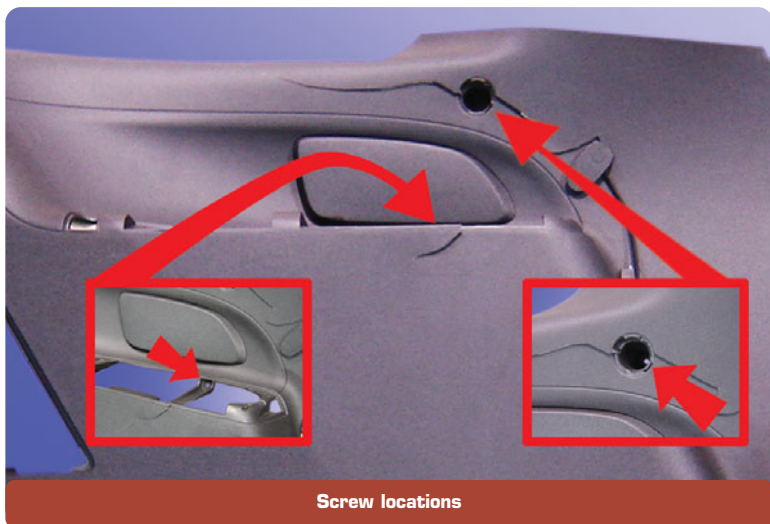
Screw locations

On the Acadia, OUTLOOK and Enclave, the quarter trim panel has hidden screw fasteners above the speaker grille and below the armrest that must be removed before attempting to remove the panel. If the screws are not removed, the panel will crack in the area around the fastener location.

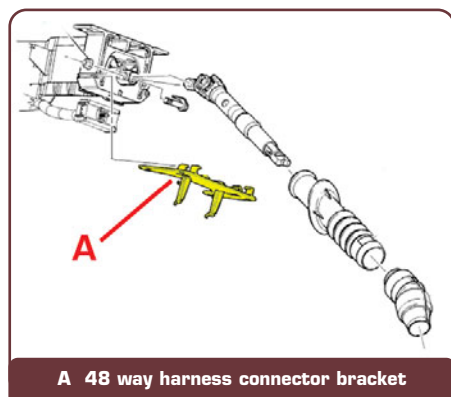
There may be a squeak/squeal noise from the steering column upon initial rotation of the steering wheel, either with the engine running or turned off. The noise is present if the intermediate shaft is disconnected for testing purposes. The source of this noise may be an interference contact between the 48 way harness connector bracket and the SWPS (Steering Wheel Position Sensor) and harness connector housing.

1. Remove the 48 way harness connector bracket.
2. Remove approximately 2/3 of the center rib material to make it flush with the bracket.
