## Why the GMLAN?

## Techline News

## Contents

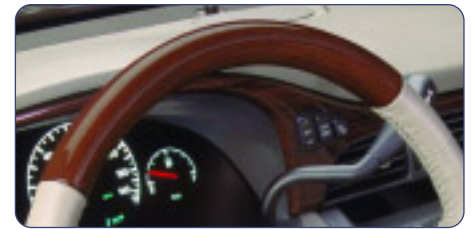
Use care when removing the protective wrap on steering wheels during Pre-Delivery Inspection. If the protective wrap is pulled or ripped away, it will scar the steering wheel with permanent scuff marks. If the wrap is cut away, the steering wheel will likely be cut as well. In an effort to improve customer satisfaction, follow removal instructions for the protective wrap by unwrapping the steering wheel.

**TIP:** To assist in unwrapping the steering wheel, look for a yellow starter pull-tab (**H**) on the plastic wrap.

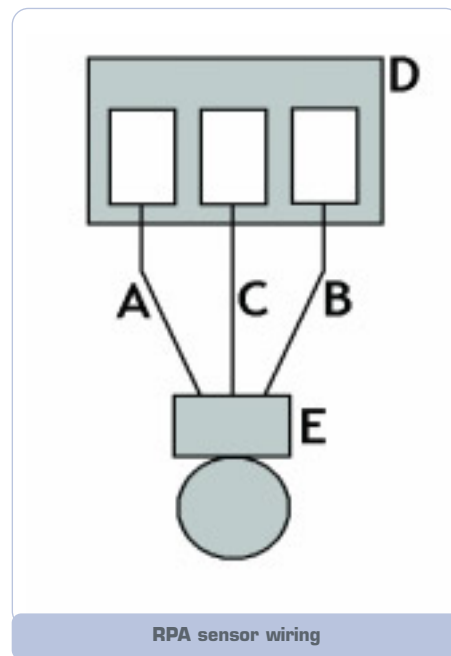
RPA sensor wiring

Refer to the illustration. Note that there are three wires at the sensor:

- A** 8 volt supply line
- B** low reference line
- C** sensor signal line

- D** RPA module
- E** RPA sensor

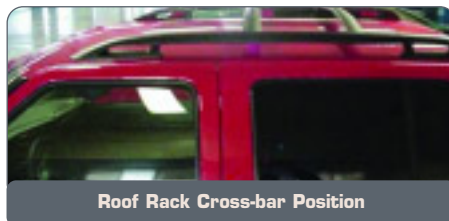
Owners of some S-10 Crew Cab pickups with ZR5 sports package may comment about a wind noise. This may be caused by the roof rack.

alleviate the sound pressure at the A-pillar, where it's most sensitive to driver and passenger.

All vehicles leave the assembly plant with the cross-bar in this position, but it may be relocated by the owner when the roof rack is used.

Check the position of the forward cross-bar of the roof rack. It should be slightly rearward of the B-pillar. This helps
