## Vehicle Interior Cleaning

Bulletin 06-00-89-029A has been released to update information about vehicle interior cleaning.

## Xenon Lamp Control Module

## Oil Filter Debris

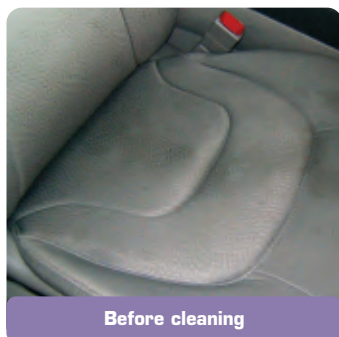
Before cleaning

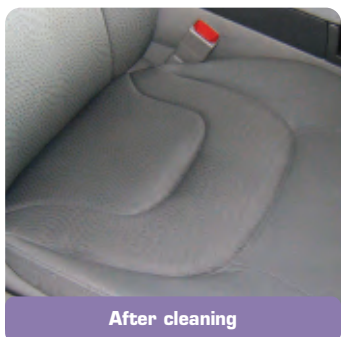
After cleaning

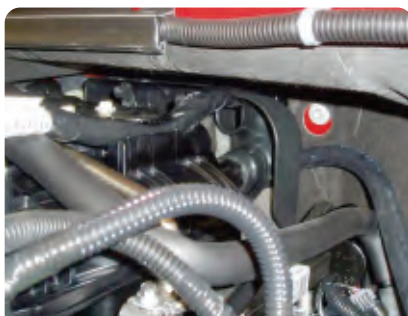
Some owners of a 2007 Chevrolet Silverado or GMC Sierra may comment on a rattle from the dash area. This rattle could be caused by the engine cover contacting the front of dash/cowl area.

An engine harness that is not properly seated in its U-channel can obstruct

the engine cover from going into its C-retainers. This will push the rear of the engine cover up and contact the front of dash/cowl area.

Harness not properly seated in U-channel

To correct this concern, fully seat the

engine harness into the U-channel. Reinstall the engine cover, making sure it is retained properly in the C-retainer.

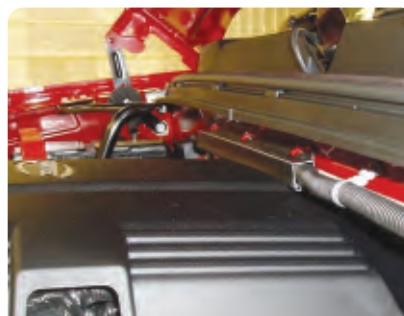
Cover contacting cowl

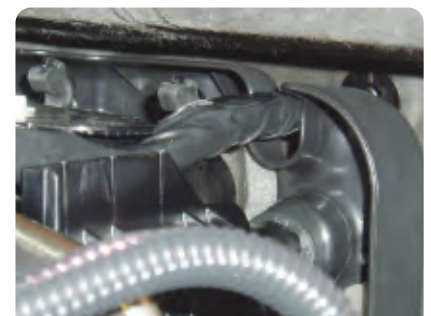
Harness in U-channel

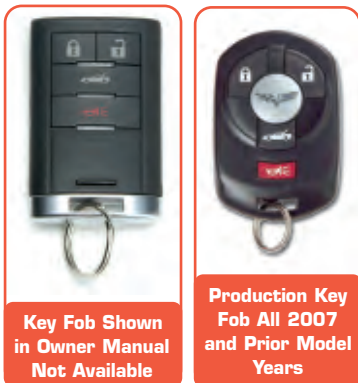
Owners of some 2007 Cadillac XLR, V-Series, Chevrolet Corvette and Z06 models may comment that the key fob they received with their new 2007 vehicle does not match the photo shown in the owner manual.

The key fob (left illustration) shown in the owner manual never went into production vehicles. The key fob in the right illustration is the correct production key fob for all 2007 and prior model vehicles. An insert was placed in all owner manuals stating this change. Do not attempt to order the new style key fob as it is not available

**TIP:** When attempting to order the key fob shown in the owner manual, the same key fob used in prior model years will be received from SPO.
