Navigating the Upgrades in SI for 2005

Techline News

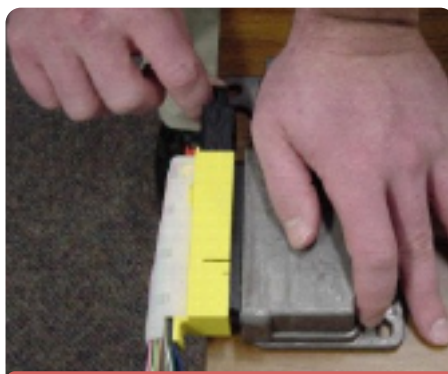
TIP: Be careful not to twist or rotate excessively when removing the connector, which could cause damage.

Connector position assurance (CPA)

4. Remove the SDM connector from the SDM while carefully maintaining axial alignment.

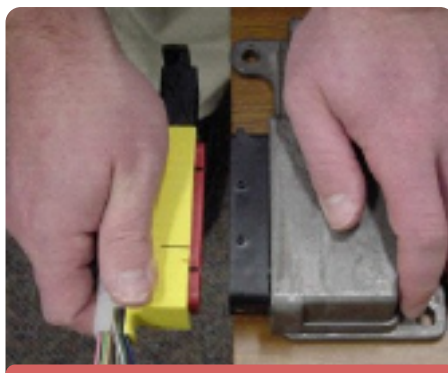
SDM connector alignment

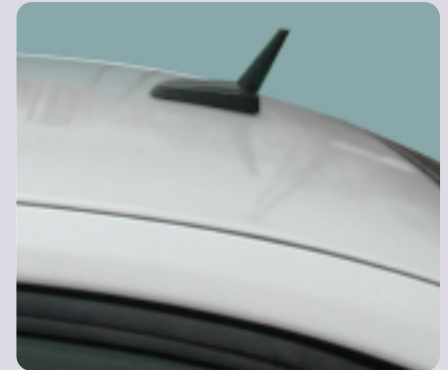
Quad-Band Antenna

A new antenna will appear on the Cadillac SRX beginning this month. It has a plastic base and a stubby 3-inch (7.6 cm) mast. It is expected that this antenna will see widespread use in future model years.

TIP: Do NOT apply paint or clear coat to the radio antenna. This will damage the function of the antenna, causing poor reception or loss of reception of the XM digital signal.

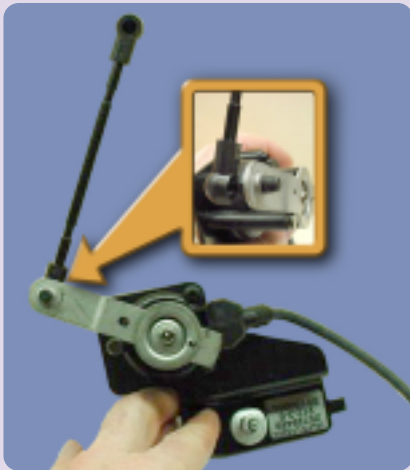
Customers may comment about a creak noise that can be heard coming from the rear end of the vehicle when driving at low speeds and making turns. This noise can also be heard when performing parking-lot type maneuvers.

The noise may be caused by the electronic level control sensor link ball sockets. Clean and lubricate the sockets with a non-water soluble type grease to eliminate the noise.

GM Vehicle Care Lubriplate	89021668 (89021674 in Canada)
GM Vehicle Care Super Lube	12346241 (10953474 in Canada)
