EVAP System Operation

2000-02 Chevrolet Prizm
2003 Pontiac Vibe

Techline News

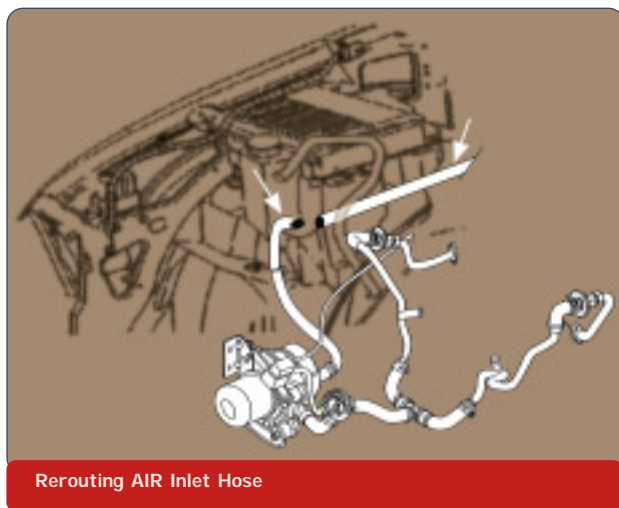
Retrouting AIR Inlet Hose

If you do not find an issue with the exhaust side of the system, water may be getting into the AIR system through the inlet hose and/or the pump itself.

Along the right side of the engine compartment, ending at the evaporator core housing. Cut the hose at a 45° angle, with the angle pointing downward. This is a dry area, and it prevents kinking of the inlet hose, which can cause a restriction.

To prevent this, cut the existing inlet hose near the bend and attach a 2 foot (6 m) length of heater hose, using a coupling.

TIP: For 1999 and early 2000 vehicles you will need 5/8-inch (15.9 mm) heater hose and coupling. For late 2000 and early 2001 you will need a 3/4-inch (19 mm) heater hose and coupling.

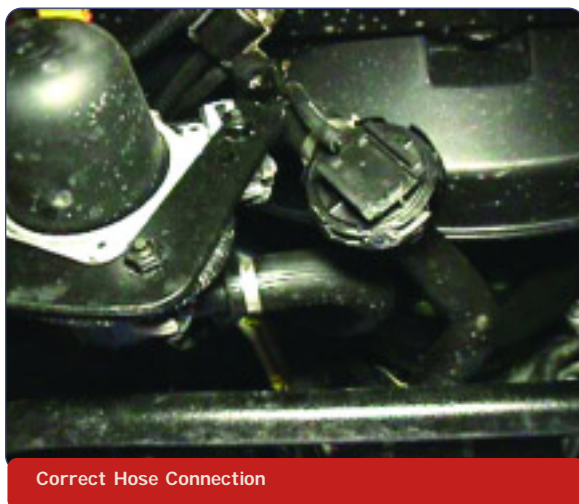
Correct Hose Connection

If the pump has been previously replaced, verify that the inlet and exhaust hoses are connected correctly before performing any additional diagnosis. Repeat failures have occurred because of these hoses being switched.

TIP: The inlet port on the pump is marked IN. As the hoses lie unconnected, it is very possible to assume that the reverse hose connection is correct.

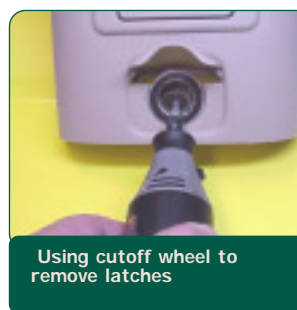
Using cutoff wheel to remove latches

Insert a small grinding tool with a cutoff wheel into the socket. Remove the plastic latches in the 3 mm (0.11 in.) square windows.

With the tabs removed, use J-42059 as directed above to remove the socket.

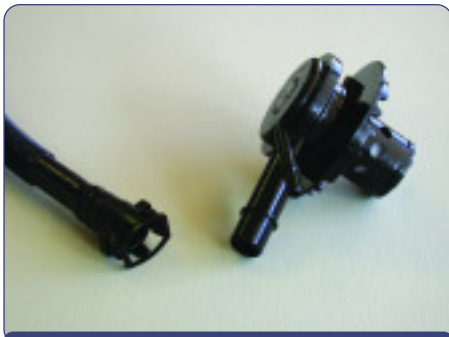
Vapor line between fuel tank and canister

TIP: One known place to check for leaks using the "smoke machine" was covered in the October 2002 TechLink. This involves the corrugated plastic vapor line between the top of the fuel tank and

If you find it necessary to use the J-41413-200 EVAP Tester (the "smoke machine"), you will need to plug the canister drain hose. Use plug J-41413-301 for this purpose. If you do not, smoke will blow from the opening. The check

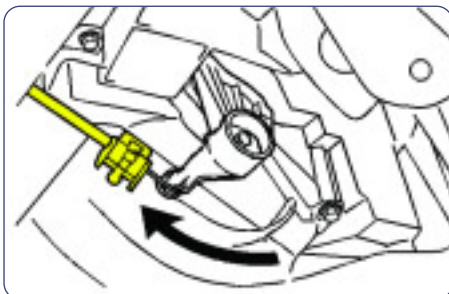
On the Pontiac Vibe, the A/C temperature control is cable operated. In the case of a customer concern of insufficient cooling, check and adjust the cable. The procedure is located in SI, document 841682.

Check this adjustment before replacing the compressor.

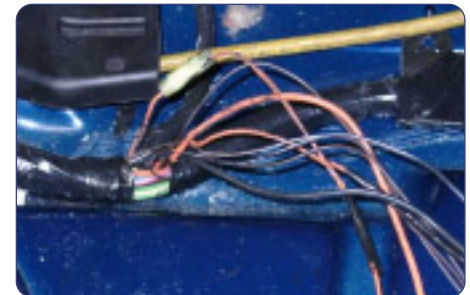
Chafed wires under the driver and passenger seats may cause these conditions. These wires carry battery voltage. If the wires are damaged, it can lead to

open fuses, or circuit breakers, and/or battery discharge. On base vehicles, passenger seat wires are located under the carpet.

To correct these conditions, repair

damaged wires and replace any fuses or open circuit breakers.
