Pontiac Vibe Tips

Chevrolet Aveo Tips

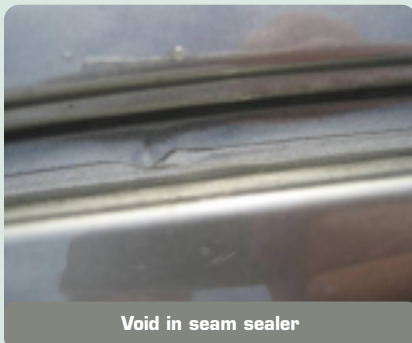
Owners may comment that there is water dripping from the front A-pillars or the headliner. The source of the leak may be an improperly sealed roof seam. The roof seam is located under the black rubber seal that runs from the front to the rear of the vehicle.

Void in seam sealer

2. After the molding has been removed, inspect the roof seam for skips or voids in the seam sealer.

TIP: To help speed the diagnostic time, run water along the complete length of the seam. You may be able to see the skip in the body seam sealer.

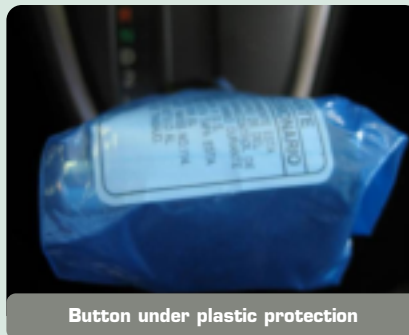
PDI Tips – Two key items are still being overlooked during the Vibe's PDI process: installation of the shifter override plastic button and the rear body plugs. See Service Bulletin 03-00-89-004.

Button under plastic protection

1. The shifter override release button is attached to the paper tag under the plastic protection for the shifter knob.
2. Plugs must be installed in the holes used for shipping hooks during transportation of the vehicle. If the shipping hole plugs are not installed, owners may comment that the vehicle has excessive road noise, or the rear passenger's carpet gets wet.

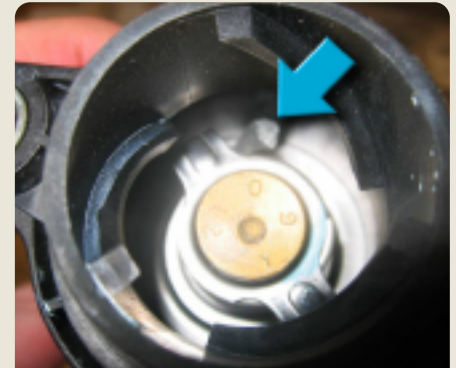
The cause may be a stuck thermostat due to aluminum flashing from the cylinder head. To correct this concern, remove the loose piece of aluminum from the thermostat.

Flashing stuck in thermostat

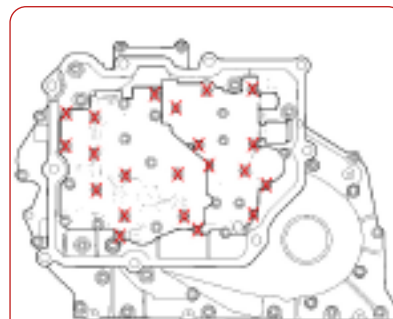
Do not remove bolts marked X

To remove the valve body with the channel plate, remove all of the attached bolts except the bolts indicated by an X.

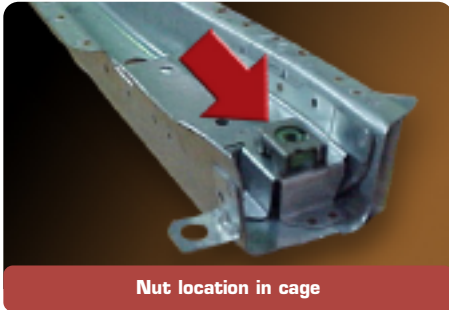
Nut location in cage

The caged nuts that provide attachment for the rear suspension system have a potential for coming out of the cage when removing the front or rear suspension mounting bolts.

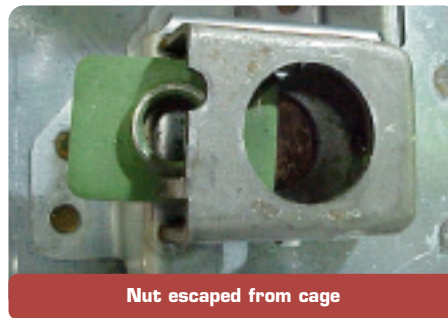
When the attaching bolt is removed, the nut is free to escape the cage. This may happen if the vehicle is jostled or moved, as could occur during collision repair.

Nut escaped from cage

TIP: To prevent the nuts from dislodging, put the bolts back into the nuts as soon as the suspension is lowered away from the bottom of the vehicle.

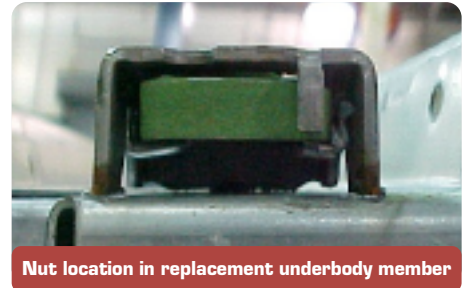
Nut location in replacement underbody member

TIP: If a replacement underbody member is purchased, the nut is temporarily suspended in the cage by deformable retainers. The first time the bolt is installed and tightened, the nut is drawn

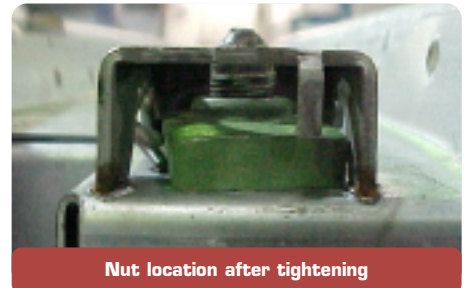
Nut location after tightening

out of the retainers. If the bolt is later removed, the nut is loose within the cage, as described above.

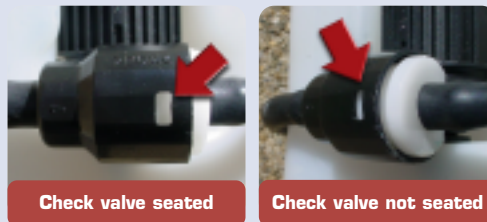
On some 2005 Chevrolet Equinox vehicles, windshield washer fluid may leak from the windshield washer pump assembly.

Check valve seated

Check valve not seated

TIP: There should be an audible click sound when the cover snaps into the pump body. If there is no audible click sound, replace the washer fluid pump.
