## OnStar® Upgrade

OnStar Upgrade	1
Rear Bumper Thump	2
Sunroof Operation	2
Fuel Level Calibration	2
Hinge Repair	3
No Forward or Reverse	3
Hybrid Service Information (SI)	3
Buzz or Static in Radio	3
Field Product Reporting	3
Cylinder Head Removal Revisited	4
Seat Recall or Exit Recall	4
Articulating Running Boards Reminder	4
Erratic Speedometer Operation	4
GM Top Engine Cleaner Replaced	5
Airbag Diagnostic Codes	
After Collision Repair	5
Heated Windshield Washer Fluid	5
Fuel Level Sending Units Revisited	6
Power Liftgate Inoperative	6
Cadillac DTS Professional Vehicles	6
Pickup Truck Designation	7
Erratic RKE Operation	7
"No Fobs Detected" Message	7
Intake Manifold Tuning Valve	7
Fix It Right the First Time	8
Know How Broadcasts for December	8

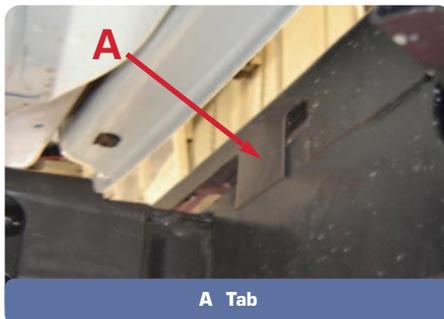
Owners of some 2007 full-size utilities may comment on a clunk or thump noise from the rear of the vehicle when driving on rough roads or over bumps. The noise may be coming from the rear bumper assembly.

There are two metal tabs (right and left side) which fold over the front of the lower bumper reinforcement. The tabs can be seen by raising the vehicle. The noise can be caused by contact between the metal tab and lower bumper reinforcement.

To correct this concern, bend both the left and right tabs away (forward) from the lower reinforcement.

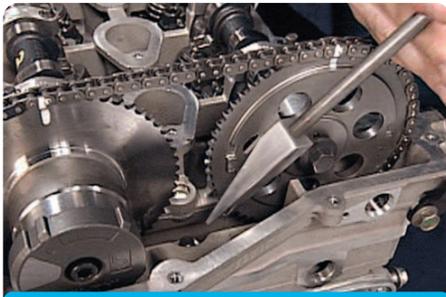
EN-48464 Lower Timing Gear Tensioner Holding Tool

The August 2006 issue of *TechLink* contained an article on a new procedure for removing the cylinder head from the 2.8L (LK5) and 3.5L (L52) engines. It contained an incorrect tool number.

The correct tool number is EN-48464 Lower Timing Gear Tensioner Holding Tool.

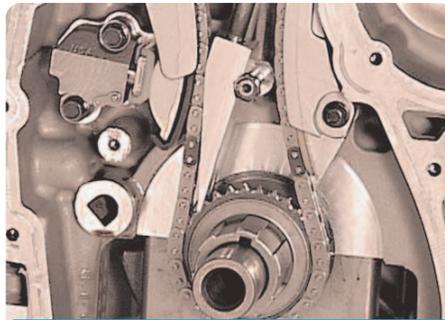
Tool installed

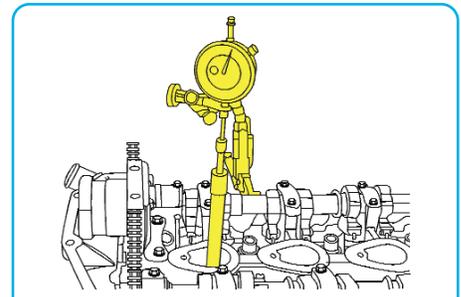
Using dial indicator to establish TCD

Using a dial indicator is the only precise method for establishing piston TDC. Any other method may result in incorrect cam-to-crankshaft timing. This will cause misfire codes, which requires partial disassembly to correct.

After installing the cylinder head, it is absolutely necessary to check cam timing during reassembly.

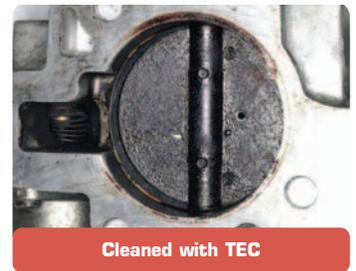
**Characteristics of GM Top Engine Cleaner (TEC)** — TEC does not mix with gasoline containing 10% or more ethanol. Higher concentrations lead to ineffective fuel injector cleaning as explained in bulletin 03-06-04-030A.

Cleaned with TEC

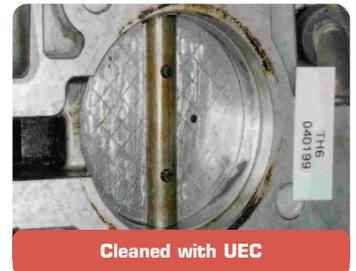
**Characteristics of NEW GM Upper Engine and Fuel Injector Cleaner (UEC)** — UEC is specially formulated to provide superior cleaning properties, meet VOC compliance, mix with fuels containing up to 30% ethanol, and not affect fuel system gaskets and seals.

Cleaned with UEC

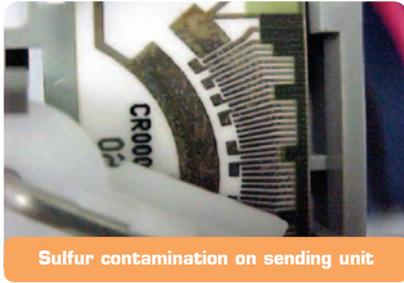
Sulfur contaminants found in some of today's gasolines can form deposits on the sending unit, resulting in higher-than-intended resistance (*TechLink*, Jan. 2006). The high resistance from the deposits could be misinterpreted as a high fuel level, when in fact the fuel level is low. The driver may run out of fuel, even though the fuel gauge is not indicating low or empty.

To offset this effect, engineering has begun "flipping" fuel senders, reversing the circuitry. This means that high resistance now indicates low fuel level and low resistance indicates high

fuel level. So, if deposit build-up adds to sender resistance, the gauge will err in the direction of indicating less fuel than is actually in the tank.

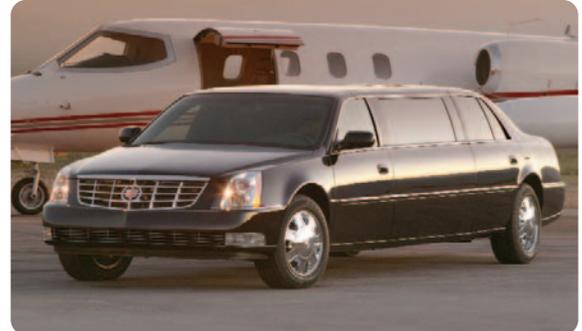
Concerns that are suspected to be caused by upfitter installed electrical components can be isolated by disconnecting the appropriate inline connectors. See the list below. All required service information can be found in SI by selecting Cadillac DTS. Detailed information regarding these harnesses can be found in the Wiring Systems subsection.

- C209 Body Harness to Cargo Door Harness (B9Q)
- C322 Body Harness to Courtesy Lamp Harness (V4U)
- C323 Left Middle Window Harness to Body Harness (V4U)
- C324 Left Middle Window Harness to Left Middle Trim Harness (V4U)
- C333 Right Middle Window Harness to Body Harness (V4U)
- C334 Right Middle Window Harness to Right Middle Trim Harness (V4U)
- C335 Body Harness to Left Middle Trim Harness (V4U)
- C336 Body Harness to Right Middle Trim Harness (V4U)

If the concern IS resolved by disconnecting one of these connectors, contact Technical Assistance for further directions.
