New Pre-Delivery Inspection Form

Techline News

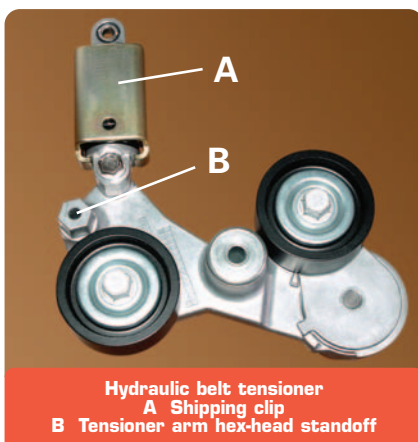
Hydraulic Belt Tensioner Service Tips

The generator with starter unit on the Saturn VUE Hybrid engine uses an Aramid cord belt and a hydraulic belt tensioner to ensure reliable transfer of torque for both motoring and generating (see September 2006 *Techlink*).

Due to its unique design, the tensioner requires specific service procedures, included in SI document 1810716. Here are some details.

TIP: There are two ways to relieve tension on the drive belt, depending on whether the shipping clip is still in place (new tensioner) or the shipping clip has been removed (used tensioner).

CAUTION: To avoid personal injury, the shipping clip should be removed only after the tensioner has been installed on the vehicle and the drive belt is installed and correctly routed.

- DO NOT do any sort of prying to remove the shipping clip. With the belt in place, relieve tension with a wrench on the tensioner arm hex-head standoff and remove the clip by hand.
- The tensioner is designed to withstand one un-restrained extension from the shipping clip position to fully open.
- An un-restrained extension after the first event could result in part failure (either internal and/or external).
- External failure of the tensioner could lead to personal injury.

- A tensioner left in the fully extended position is safe to handle. There is no need to use a shipping clip for storage of removed parts.
- The tensioner should be compressed slowly when using the EN-48079 special tool and a socket and ratchet (NO air tools).
- **TIP:** DO NOT use the tensioner arm hex-head standoff in place of the EN-48079 for collapsing a tensioner that does not have a clip.
- *Thanks to Matthew Moore*

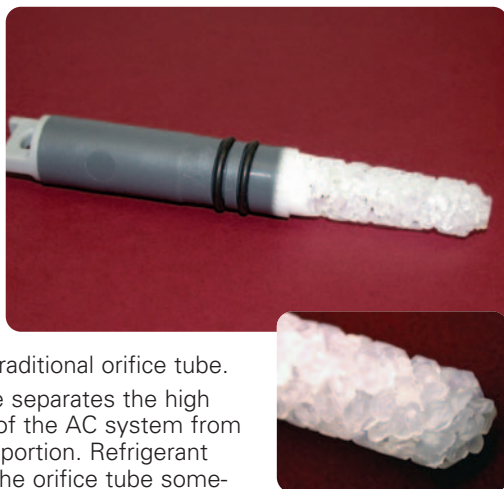
Orifice Tube Appearance

In September 2005, the orifice tube used in AC systems in full-size utilities changed to a design called a porous plastic orifice tube (PPOT). Pickups adopted the design mid-year 2006. It is quieter than the traditional orifice tube.

The orifice tube separates the high pressure portion of the AC system from the low pressure portion. Refrigerant passing through the orifice tube sometimes causes an audible noise, described as a gurgle or water spattering.

In the porous orifice tube, noise muting is provided by a granular polypropylene plastic filter, which looks somewhat like melted wax. This is normal appearance for the porous orifice tube, and is not a defect.

TIP: The tube may change color after being subjected to oil and refrigerant and used for some time.

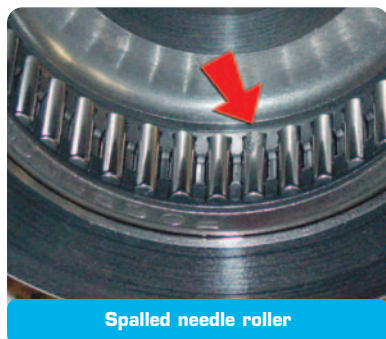
Shift to Drive, apply the brakes and raise the engine rpm. The noise should diminish (may not go away). If the noise is diminished or eliminated, suspect the drive or driven sprocket support bearings, or gear bearing. The most common cause is the drive sprocket support bearing.

Visually inspect the drive sprocket support needle bearing for spalled needle rollers.

Replace the drive sprocket support item 522 (includes 521/523).

Follow appropriate SI repair steps to access the drive and driven sprocket supports for inspection and if the condition is found, replace the appropriate parts.
