GM TechLink is a monthly magazine for all GM retail technicians and service consultants providing timely information to help increase knowledge about GM products and improve the performance of the service department.

Steering Wheel Off Center

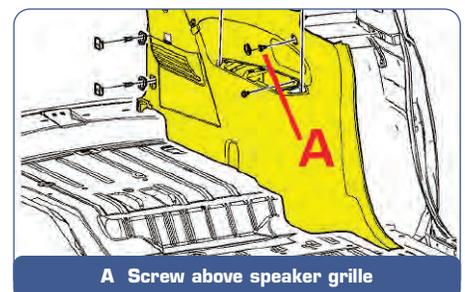
On the Acadia, Outlook and Enclave, the quarter trim panel has screw fasteners around the cargo screen retainer hook just above the speaker grille that must be removed before attempting to remove the panel. If the screws are not removed, the panel will crack in the area around the fastener location.

A Screw above speaker grille

The location of the fasteners can be found in SI document 1903783 for Acadia and Outlook and 1899889 for the Enclave.
