Tire Tips

Techline News

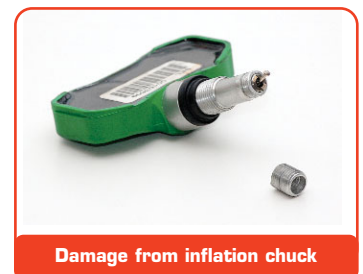
It is also important to avoid applying lateral pressure to the head of the valve stem with the air chuck while inflating tires. Excessive lateral pressure can cause the stem to crack or break off, or cause the core to become damaged and begin to leak.

Be extra careful because these stems are made of aluminum and are fastened solidly to the wheel. They are not as flexible as a regular rubber valve stem and cannot absorb the lateral pressure.

Damage from inflation chuck

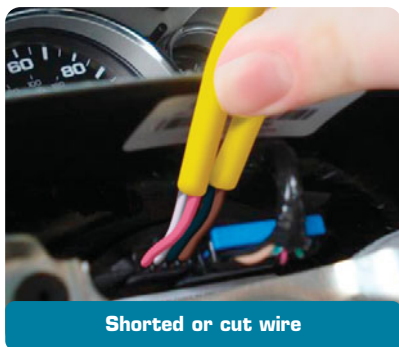
On a 2007-08 Escalade, Avalanche, Silverado, Suburban, Tahoe, Sierra, Yukon, Yukon Denali, Yukon XL, or Yukon Denali XL, the SIR lamp may be on with DTC B0012 and/or B0013 Symptom 02, 04, or 0E set in the SDM. This can be caused by a shorted or cut wire behind the driver's side air bag.

Shorted or cut wire

Remove the driver's side air bag and inspect the wire harness between the air bag and the SIR coil for chafed or cut wires. If the wiring is cut or chafed, replace the SIR coil, which includes the harness.

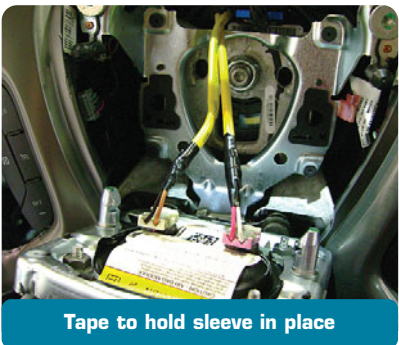
Tape to hold sleeve in place

It is necessary to make sure the protective tubing (yellow sleeve) on the new harness is pushed all the way down to the SIR coil. This will ensure the wiring does not get cut or chafed again. Add electrical tape to the other end of the yellow protective tubing to hold it in place.

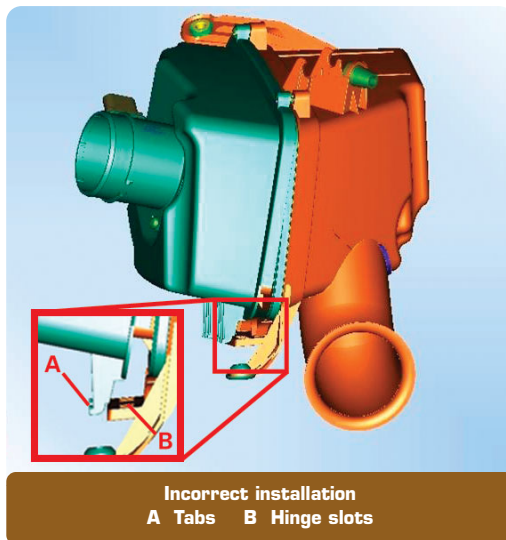
Incorrect installation
A Tabs B Hinge slots

To reduce the risk of an improperly sealed air cleaner assembly, verify that the cover is seated correctly in the housing before reinstalling the cover bolts.

TIP: To inspect that cover is properly seated once the cover bolts have been torqued down, gently pull up on the cover/MAF Sensor adapter. This gives a positive indication that the tabs of the cover are seated in the hinge slots.
