## Diagnosing Class 2 Data Bus Conditions

GM TechLink is a monthly magazine for all GM retail technicians and service consultants providing timely information to help increase knowledge about GM products and improve the performance of the service department. This magazine is a companion to the GM Edge publication.

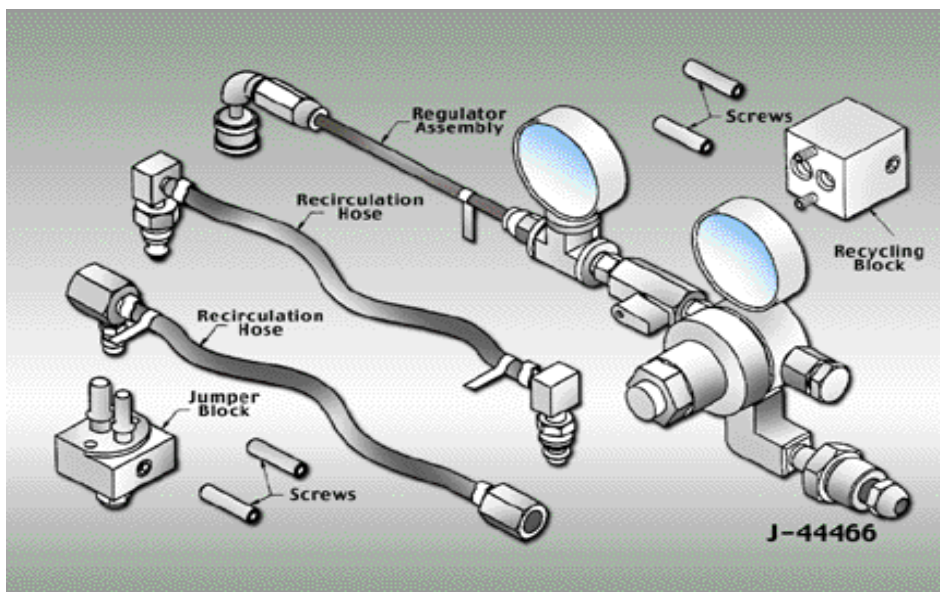
## Fuel Injector Cleaning

In certain areas of the country, impurities in the fuel supply can be deposited on the injector poppet balls, seats or pintles. When an injector sticks either open or closed, the engine may be hard to start or won't start, and may have rough idle after start. The SES light may also come on. Injector replacement is not a correction for this concern.

A new Injector Cleaner kit J-44466 and Fuel System Cleaner canister J-35800-A have been released to help service fuel injectors in affected vehicles. The kit includes hookup hoses for the CPI systems and hookup hoses and blocks for the CSFI systems.

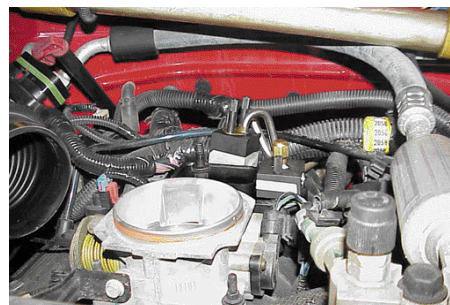
**Using recycling block -- Jumper block attached to metering body; recycling block attached to fuel supply and return lines**

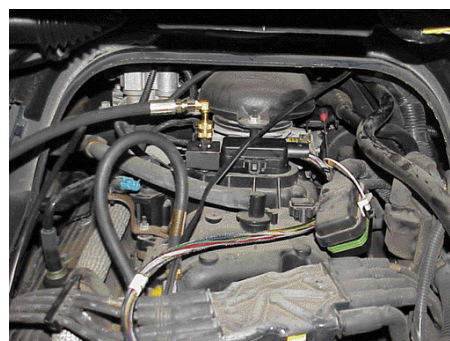
**Using recirculation hose -- Jumper block attached to metering body; recirculation hose visible in foreground**

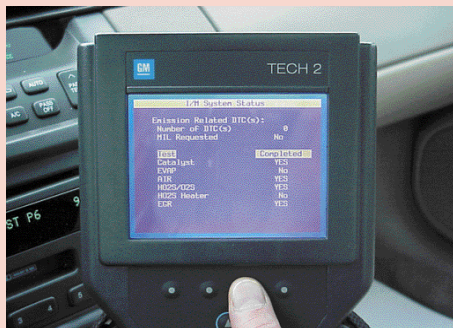
**According to the I/M System Status screen, with a mixture of Yes and No indications, this vehicle is not ready to be tested by an I/M station.**

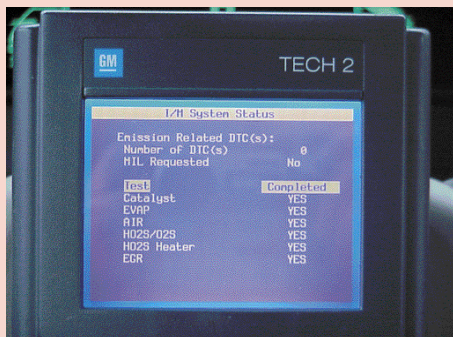
**With all 'flags' set to YES, this vehicle is ready for I/M testing.**
