#### A Monthly Publication for GM Dealership Service Professionals

#### **Techline News**

#### Tech 2 Replacement – Fact or Fiction?

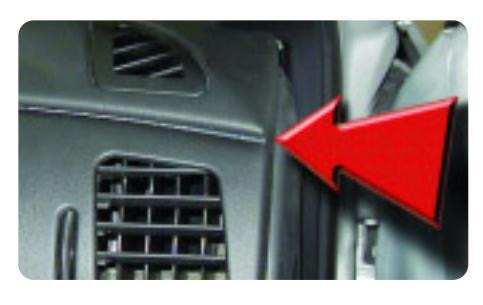
# **Instrument Panel Top Pad Gap**

On 2002-03 Impala and Monte Carlo, a gap condition may exist between the Upper I/P pad to I/P trim plate, which may be objectionable to a customer.

It is possible to correct or improve the appearance of the Upper I/P pad without replacement. Loosen the attachment screws at or near the area of the gap and retighten while firmly holding the Upper I/P Pad down, closing the area of the gap. Repositioning the I/P Upper Pad in this fashion should eliminate the gap, without requiring the replacement of the I/P Pad.

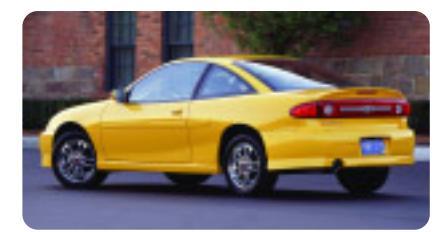
## Increased Steering Effort

This condition affects 2003 Chevrolet Cavalier, Pontiac Sunfire, Grand Am, Oldsmobile Alero equipped with 2.0 Litre L61 EcoTech engine (VIN Code F).

It may be difficult to confirm this condition, as it may be somewhat intermittent. Normal testing of the steering system (flow meter, test drive, etc.) after vehicle warm up may also be inconclusive. The cause of this condition is a priming issue with the power steering pump. The problem is not within the steering rack. The correct repair procedure is to replace the power steering pump.

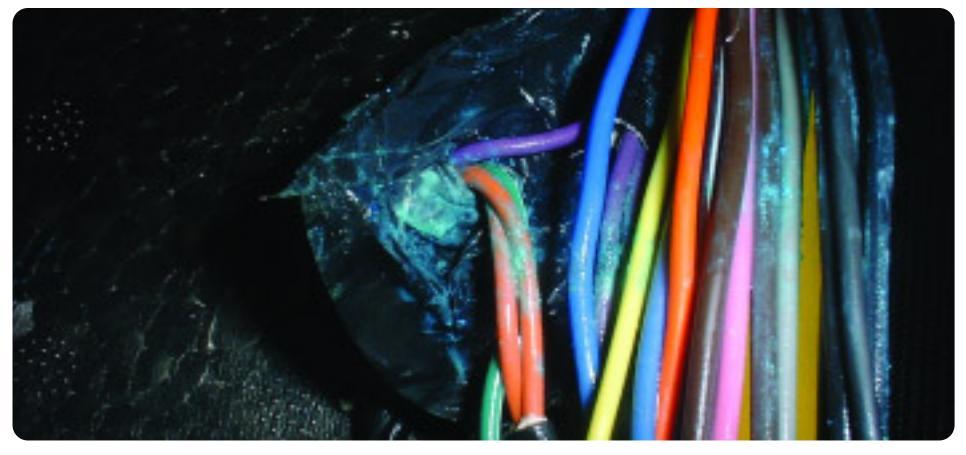
# **Splice Corrosion**

The forward electrical harness has splices that may be inadequately sealed from corrosive elements. Road splash, especially during winter months may force water into the harness causing increased resistance and eventual separation of the splices.

In the case of dim high beam, investigate splice 107 (pink) and splice 108 (dark blue) for corrosion. These splices are located next to the windshield wiper reservoir and are associated with circuit 593. High resistance in these splices can cause the driver side headlamp to dim.

In the case of dim fog lamps, investigate splice 213 (purple) and splice 113 (orange). see visual signs of corrosion. If evidence of corrosion is found, re-splice the connection in the same manner as the other wires.

Strip back the wires until clean noncorroded wire is available.

Resplice the wires, using GM crinp and seal connectors P/N 12089189 only. These connectors are equipped with an

internally knurled crimp joint and heat shrink tubes.

Using the J-38125-5 Ultra Torch from your J-38125-C Terminal Repair Kit, progressively heat the connector by waving the torch quickly over both the plastic shrink tube (to activate it) and body of the connector to get the internal sealant to flow.

Cut a 3M® Electrical Moisture Sealant Patch in half. Apply the patch to the splice as indicated on the package.

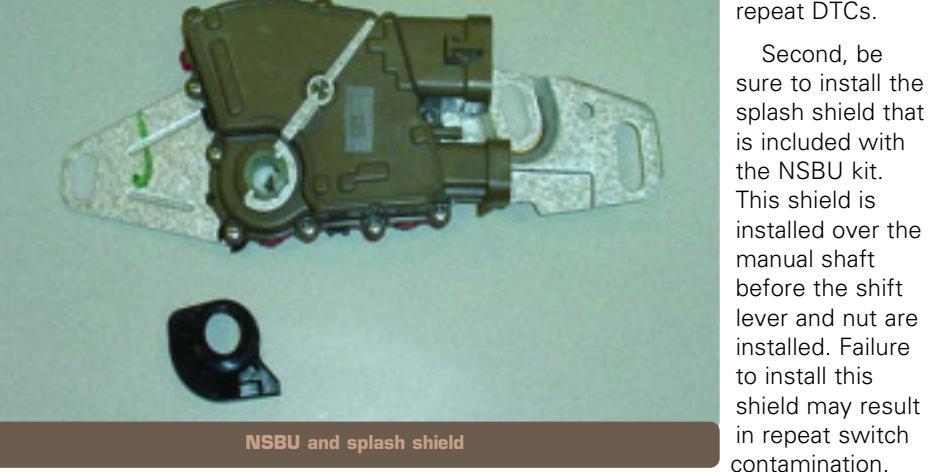
# Neutral Start Backup Switch

Some 2001-2003 Sierra and Silverado trucks equipped with Allison Series 1000 Automatic Transmission (M74) may have multiple DTCs including any or all of the following: P0708, P0847, P0872, P0875, When replacing this switch, observe these important points.

P1711, P1713; partial or no PRNDL display; and no movement.

This condition may be caused by water contamination and corrosion inside

First, if the NSBU does not easily slide off the selector shaft, use a file to remove any burrs or raised metal where the selector lever seats against the shoulder of the shaft. If the new NSBU is forced over this raised metal, it may fit

the shaft loosely, causing possible repeat DTCs.

Install a new NSBU, P/N 29540479 that has better sealing to resist internal corrosion. Replacement procedures can be found in SI document 652003. Adjustment procedures can be found in SI document 652060 . Finally, before starting the vehicle, be sure to clear all DTCs.
