## Chevrolet Equinox Pre-Delivery and Unique Service Features

To help understand the unique service features of the new 2005 Chevrolet Equinox, refer to bulletin 04-00-89-006. It provides the complete pre-delivery procedure and important service tips. Here are some highlights.

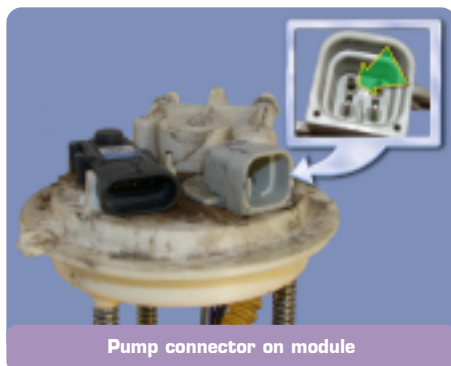
Pump connector on module

Before condemning a fuel pump, check the terminals in the wiring harness connector and in the connector on the pump module. If a harness terminal is spread apart, it will cause excessive resistance, which leads to overheating of the terminal.

If you discover this condition, replace the harness connector and terminals with the appropriate service pigtail, available from GMSPO.

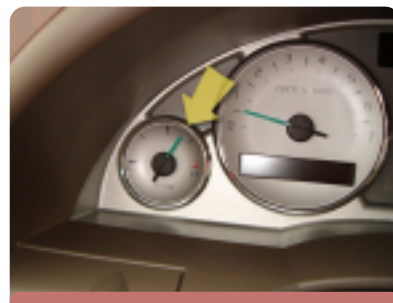
Starting in January 2004, the Buick Rendezvous is available with a new 3.6L LY7 engine. Customers may notice the engine temperature gauge reading slightly past the mid point under heavy loads, in high ambient temperatures, in stop and go traffic, and mountain driving. This condition is a normal operating characteristic of this powertrain.

perature sensor is located in an area subjected to higher engine temperatures and more temperature fluctuations during normal operation of the cooling system.

**Normal reading with LY7 engine**

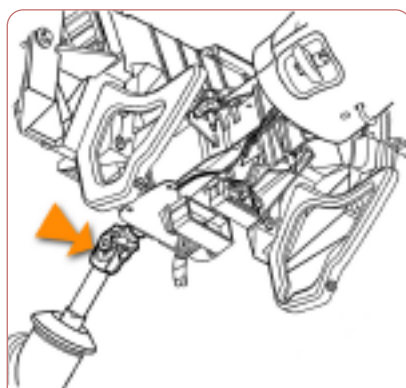
Owners of some 2002-03 Chevrolet TrailBlazers, GMC Envoys and Oldsmobile Bravadas may comment on a squeak noise coming from the steering column while turning the steering wheel. Some customers may also comment on a rubbing or scrubbing type noise or feel in the steering wheel during low speed turns or parking maneuvers. The condition may be more pronounced in cold temperatures.

Spray lubricant through top of hollow end of intermediate shaft

006A provides details for lubricating the serration (slip) joint of the upper intermediate shaft to address the squeak noise.

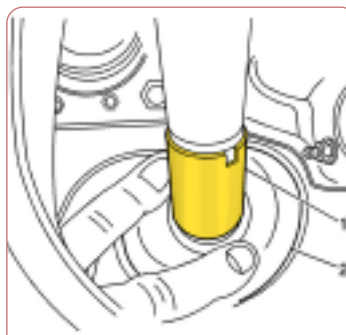
Pressing shaft boot seal down to expose shaft bushing

The rubbing or scrubbing type noise may be addressed by removing material from the upper intermediate shaft bushing to alleviate an interference fit between the upper intermediate shaft boot seal and the intermediate shaft bushing.
