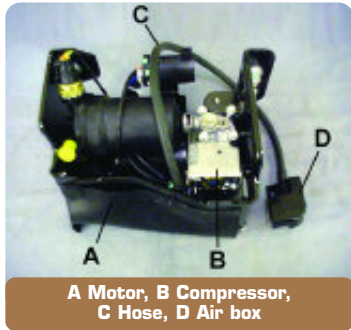
A Motor, B Compressor,  
C Hose, D Air box

A revised compressor has been released with two improvements to protect against water intrusion.

The first is a coating applied to the internal solenoid wires to better protect them from water entry into the compressor.

The new compressor is supplied with a hose that has the new air box attached. When you install the replacement compressor, it's important to install the complete compressor

assembly, including the hose and air box.

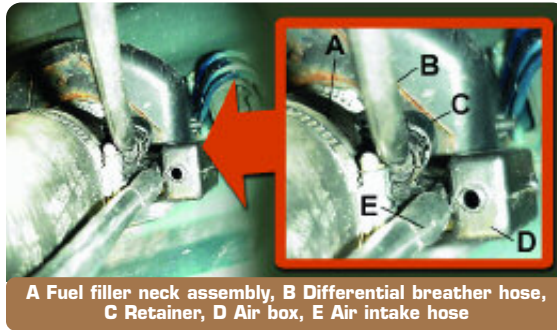
A Fuel filler neck assembly, B Differential breather hose,  
C Retainer, D Air box, E Air intake hose

The second is a new design for the plastic air intake box that is mounted near the fuel filler. The new design prevents water entry into the compressor and eventual internal corrosion.

The airbox/hose and the differential breather hose are attached at the same location to the fuel tank filler neck. The attachment of these components requires a common plastic barbed "Christmas tree" retainer.

Be sure to include the old air box and air hose with the compressor when you package them for warranty return.

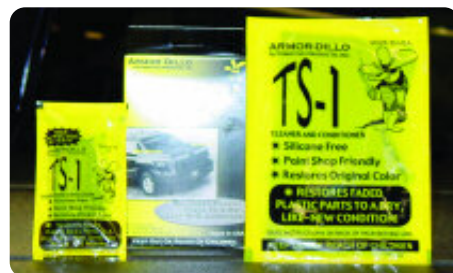
Bulletin 04-08-111-001B explains how to deal with discolored or chalky body cladding and cargo covers on the Avalanche and Cadillac Escalade EXT, using a product called Armor-Dillo TS-1.

This is a one-time warranty repair and future coatings are the customer's responsibility. A retail maintenance pack is available

for resale by your parts department. See the bulletin for ordering information.

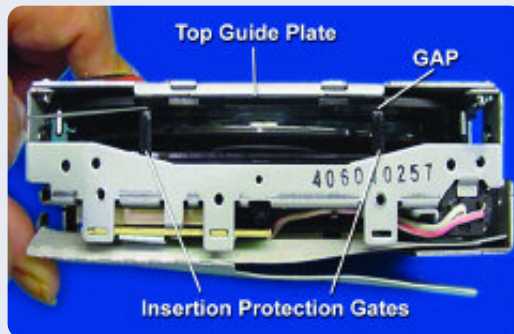
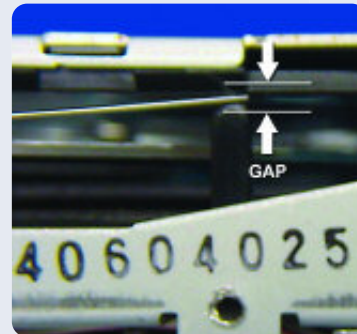
A customer may comment that the CD player will not accept a CD, will not play, or will not eject a CD.

The condition may result when the gap between the insertion protection gates and the top guide plate is

larger than specification. This was caused by a warped top guide, which has been corrected in production.

Exchange the audio unit, so the top guide plate can be inspected. Do not attempt to remove a stuck CD.
