A Monthly Publication for GM Dealership Service Professionals

Fuse News

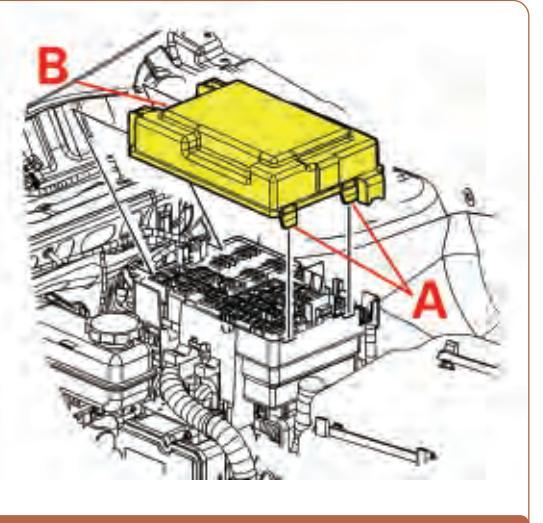
A Front B Rear (closest to dash)

On the 2007 Chevrolet Equinox and Pontiac Torrent, here's how to remove the Underhood Electrical Center/Junction Block Cover without damage.

To remove the junction block cover, push in on the two locking tabs located on the rear of the cover and lift.

To install, fit together the tabs located on the front of the cover and push down on the cover until the tabs on the rear of the cover (closest to dash) click into place.

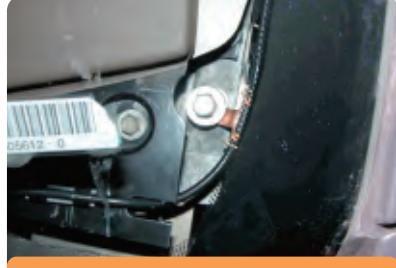
Ground ring terminal location

When the vehicle was driven down the road, static electricity could build up and discharge (electrostatic discharge), which could damage the RCDLR. This could cause the signal reception range to drop to 20 ft (6 m) instead of the designed 250 ft (76 m).

When replacing the RCDLR for this condition, install a new coax antenna according to the following information.

The part number of the new coax antenna is 25837954 for Impala and 25845987 for Monte Carlo.
