A Monthly Publication for GM Dealership Service Professionals

Getting the Most from Your Digital Remote Pressure Gauge

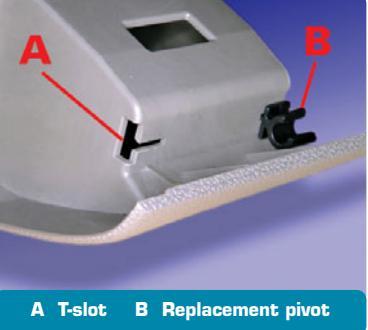
On a 2007-08 Sierra and Silverado with the base I/P, the ashtray may not close properly. The pivot on one side of the ashtray may come off the pivot bar.

Ashtray does not close correctly

It is not necessary to replace the entire assembly. A new service p/n 25918822 (package of 2) is now available for the pivot ("eagle claw").

Simply slide out the original pivot and slide a new part into the T-slot on the bottom side of the ash tray.

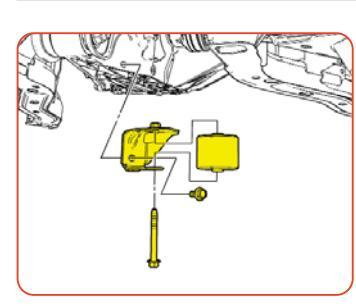
Some owners of a 2008 Cadillac CTS may experience a creak noise coming from the rear underside of the vehicle, especially at low ambient temperatures. The cause may be the rear suspension toe adjustment link inner and outer bushings. The noise is

produced by the relative motion between the outer flange of the bushing and the outer can of the link.

Characteristics of the rear suspension toe adjustment link bushing noise:

- Coming from under the rear of the vehicle.
- Occurs when the vehicle is driven over bumps, curbs, or twist ditches, events where the rear suspension sees medium to large amounts of vertical travel/motion.
- Squeak, creak, or squawk.
- Gets worse in cold weather.
- Might go away if the bushing is wet (for instance, if the vehicle is driven in the rain).

Application of GM Super Lube to the bushings can reduce or eliminate the noise until

a re-designed toe link assembly is available.

- 1. Raise and support the vehicle.
- Hold a piece of paper or cardboard between the toe link outboard bushing and the brake rotor/caliper to prevent overspray of lube onto the brake rotor/caliper. If necessary, remove the tires and wheels.

- 3. Spray GM Super Lube (p/n
 - 12346241) (10953474 in Canada) on the flanges of the outboard toe link bushing, both at the knuckle-side and the bolt-head-side of the bushing. Use enough Super Lube to cover the bushing flanges.
- 4. Spray Super Lube on the flanges of the inboard toe link bushing. Use enough Super Lube to cover the both of the bushing flanges.
- 5. Install the tires and wheels if removed.
- 6. Remove the support and lower the vehicle.
- Thanks to Michael Ciarkowski

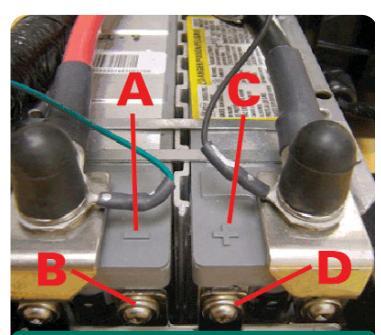
This information applies to the AURA, VUE and Malibu Hybrid vehicles. The polarity symbol embossed onto the top of the battery DOES NOT indicate the polarity of the adjacent battery cable terminal. Here's why.

Battery polarity symbols A Negative symbol B Negative terminal on end C Positive symbol D Positive terminal on end

IMPORTANT: The symbol that is visible on each battery DOES NOT indicate the polarity of the cable terminal adjacent to it. In fact, in each case, the symbol showing on the battery top is THE OPPOSITE of the

polarity of the cable terminal adjacent to it.

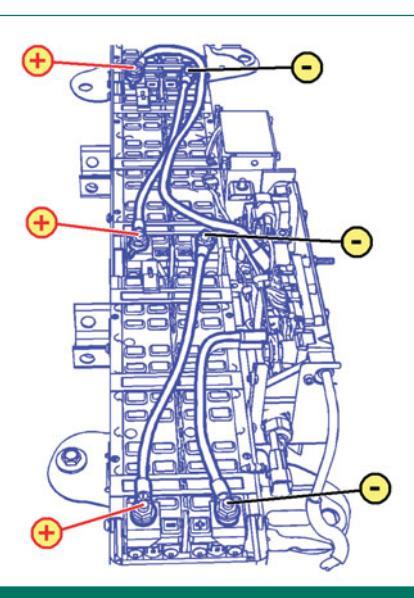
Cable terminals and routings

This illustration shows the locations of the + and - cable terminals and cable routings.

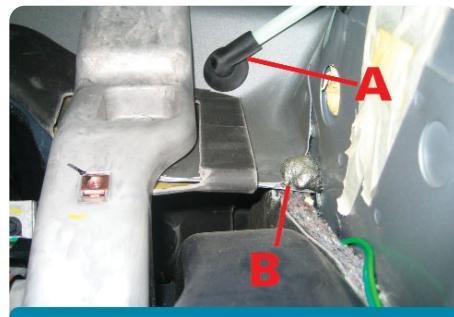
Source of water leak A Water exits through drain hose B Water reenters and drips onto **IP BEC** from sheet metal

start. This may be the result of water intruding into the instrument panel (IP) BEC. Before proceeding with other diagnosis and repairs, here are some suggestions.

Water from the right front sunroof drain hose exits the vehicle. If it then re-enters the vehicle through the front of dash sheet metal, it can drip from the right side dash onto the IP BEC.

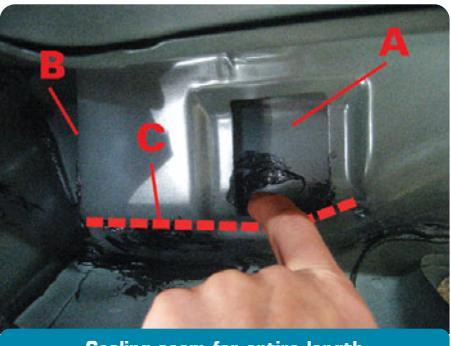
The seam must be properly sealed between the plenum upper and plenum reinforcement. This may be inspected from underhood through the opening in

Sealing seam for entire length A Access opening **B** Access opening C Length of seam seal

the cowl panel. If there are voids in the bead of sealant, use medium-bodied sealant p/n 12378500 to reseal.

The area to be sealed may be reached through two openings, and the seam must be sealed for its entire length.

TIP: Sealant may be applied with the fingertip or with a plastic trim tool.

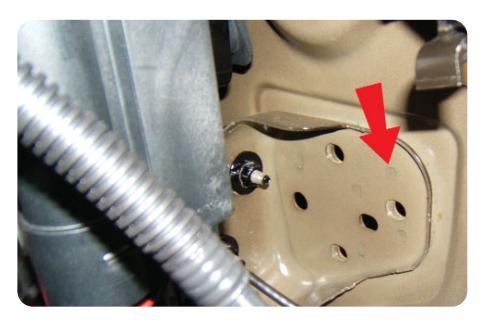
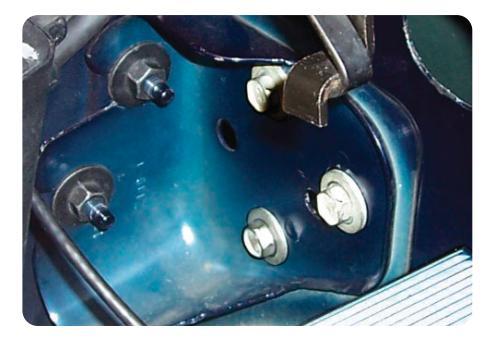
Some owners of a 2007-08 Escalade. Avalanche, Silverado, Suburban, Tahoe, Sierra, or Yukon may experience a pop or tick type noise from the left front dash area when driving over bumps. The noise may occur when backing out of a parking spot or going over small speed bumps in a parking lot. The noise is worse when the vehicle is cold and may go away at higher temperatures.

The condition may be caused by a loose spot weld that attaches the L-bracket from the left inner fender panel to the front bulkhead.

Add three bolts with nuts through existing holes in the left fender bracket and the fender inner panel. The fender bracket is spot welded to the inner panel and attaches to the front-of-dash with two nuts and studs through the dash panel.

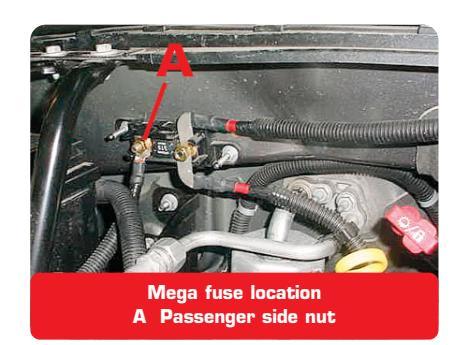
This information applies to 2007-08 C/K trucks with no-starts, intermittent electrical issues, and battery charging issues. The vehicle does not have issues with parasitic current draw.

Check for proper torque on the passenger side nut of the 175 amp mega fuse during the diagnostic procedure. The torque specification is 9 N-m or 80 lb-in. If the nut has lost torque, check for corrosion on the fuse, cable and stud.

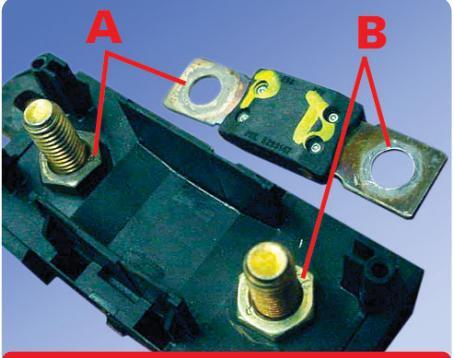
Corrosion (resistive deposit) on mega fuse terminal A Corrosion on stud with loose nut B No corrosion on stud with tight nut

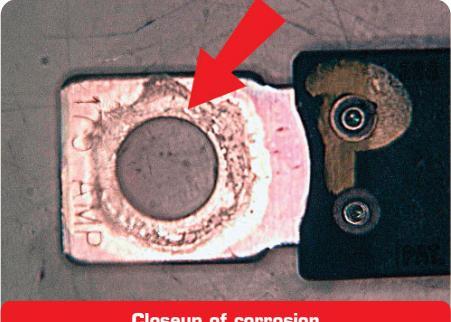
Closeup of corrosion
