## Cam Phasing Technology

**2002 4.2L RPO LL8  
(VIN S)**

| <div style="display: flex; justify-content: space-between; align-items: center;"> <span style="font-size: 1.5em;">TECHLink</span> </div> | |

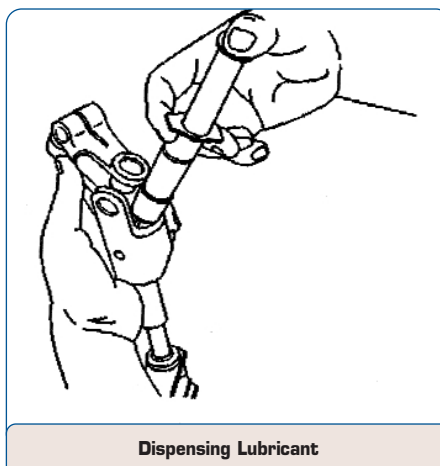
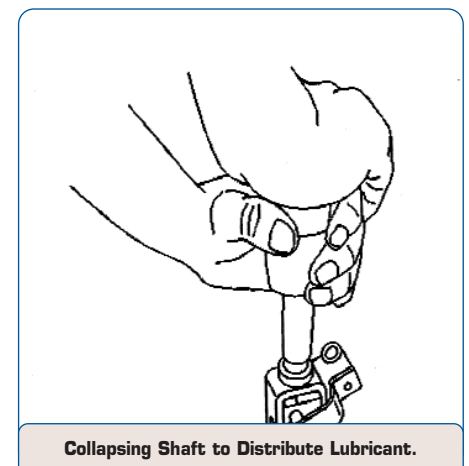
Some customers may comment on a clunk noise from the front of the vehicle when turning. This condition may also be felt through the steering wheel when turned from stop to stop with the vehicle stationary. The clunk may be heard at 180° or 360° of wheel rotation in either direction.

This condition is commonly misdiagnosed as originating in the steering gear. Actually, it may be caused by inadequate lubrication of the steering intermediate shaft.

**TIP:** Stroke and extend the shaft at least 15 times before installing to the vehicle.
