A monthly publication for GM Dealership Service Professionals

## Quadrasteer™ Rear Wheel Steering Introduced

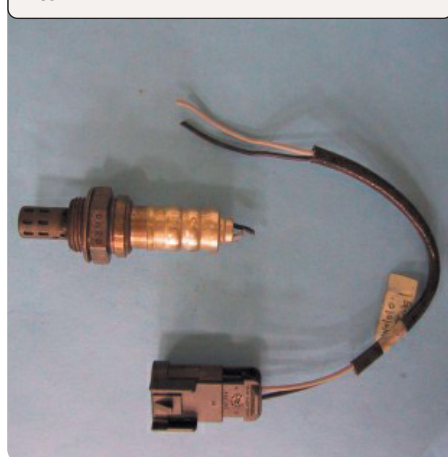
Typical Cut Wire

In one recent sampling of 27 returns, 7 sensors had the wiring pigtail cut off at or near the grommet. An additional 9 sensors had wires torn or damaged from use of a conventional socket during removal. With these damaged sensors, analysis was impossible, defeating the purpose of the Warranty Parts Return program.

There are a variety of special tools and slotted sockets available for oxygen sensor removal which will not damage the pigtail. If space allows, a crowfoot wrench is also appropriate. A suitable tool is needed for installation of the new sensor; using it for removal as well will eliminate damage the wires on the sensor being removed.

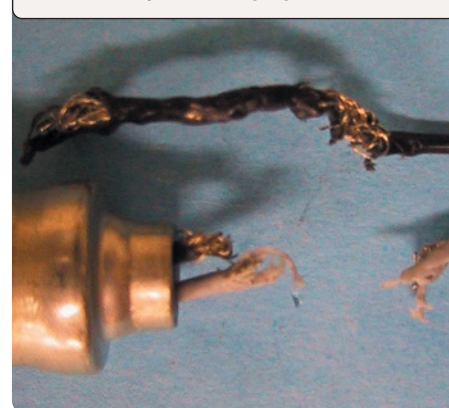
Wire Torn by Use of Improper Socket
