## Do You Really Need a VCI Number ?

## Submission of all OBDII P-Codes with Warranty Claims Will Enhance Product Quality Feedback

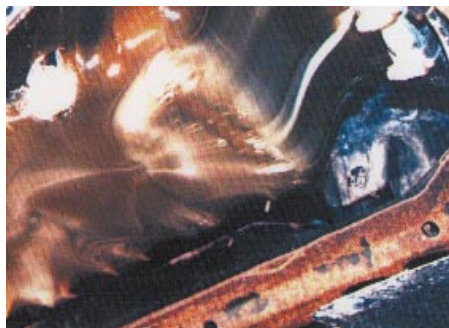
Water in oil, resulting from extreme short-trip driving, photographed through a transparent oil pan.

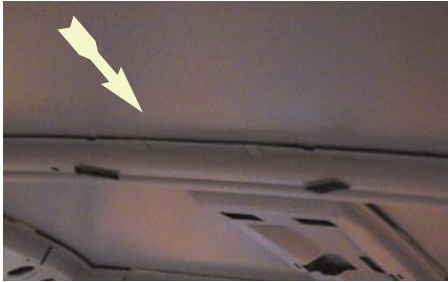
**Roof Bow**

The 2000 model year Chevrolet Silverado and GMC Sierra extended-cab pickups have a sound deadening material applied to the B-pillar roof bow during production to eliminate a rattle between the B-pillar bow and the roof. On some mod-

els, a slight roof depression located over the B-pillar may be noticeable. This depres-

sion in the roof is caused by the sound deadening material adhering to the roof.
