Dealing With Battery Parasitic Drains

Techline News

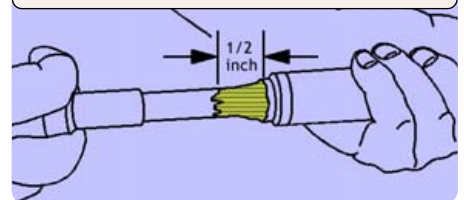
Grease visible on shaft splines
