A Monthly Publication for GM Dealership Service Professionals

Sleep Mode Feature Added to Tech 2

Blank Display on Driver Information Center

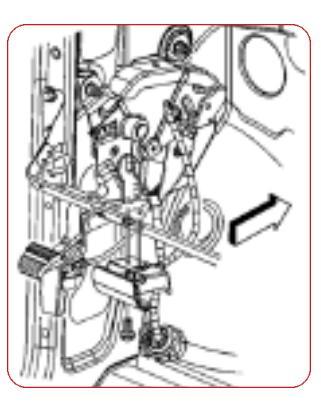
All 15 and 25 series pickups and utility vehicles (1999 - 2001) have a very low-effort park brake apply pedal that allows any driver the ability to apply the park brake and hold the vehicle on a 30% grade. Due to the low effort, some customers may think the brakes are not operating correctly.

If the truck will hold on a 30% grade after the park brake is applied, then no adjustment is necessary. If adjustment is needed, apply and release the park brake pedal 3 times (be sure parking brake shoe clearance is set to specs). There is no cable adjustment provision on these vehicles.

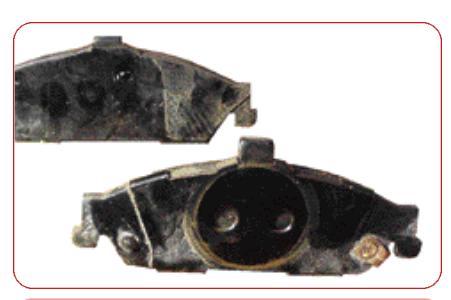
Inner pad (foreground) with wear indicator

inboard position (against the piston) in the brake caliper. When properly installed, the wear indicator will point upward with the caliper installed on the car. If the pad with wear indicator is installed in the outboard position in the caliper, interference between the spare wheel and the brake caliper may occur when the spare tire is installed, and premature front brake lining wear may result.

When installing front brake pads on the above vehicles, the pad with the wear indicator must be installed in the

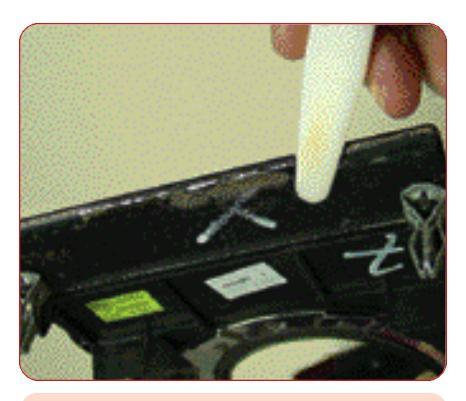
Console Trim Plate viewed from below to show proper prying technique

When loosening the console plate along the full length, carefully press the console sides away from the wood. Slowly and carefully work up each side. When the trim plate is clear of the soft vinyl, disconnect the electrical connectors and slide the trim plate rearward to disengage the front portion from the instrument panel.

Hook up the electrical wiring. Slide the ash tray end of the console trim into the instrument panel, using care not to damage the vinyl trim on each side. Then align the clips and press down to engage the clips while easing the trim between the vinyl edges of the console. Press the rear clips into place. Do not pound.
