## Compression Sense Ignition

## Techline News

## Bulletins – May 2002

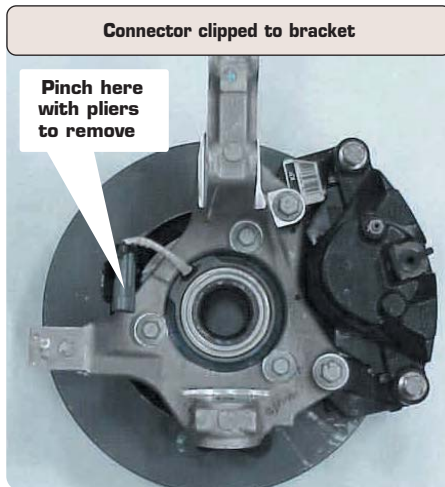
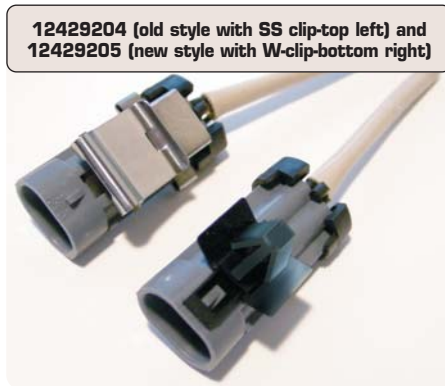
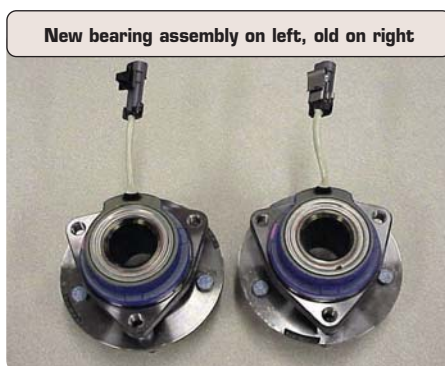
The wiring from the wheel speed sensor is a pigtail, about 4 inches (100 mm) long, terminated with a connector. The connector clips to a bracket on the steering knuckle. During the 2001 model year, the sensors were changed.

Early production used a stainless steel (SS) clip on the wiring connector, which could be removed from the bracket simply by pulling. Later production uses a plastic W-clip, which requires ordinary pliers for removal.

**TIP:** Do not replace either style of clip with the other. They are not interchangeable.

When you replace a wheel speed sensor/wheel bearing assembly (for bearing noise, WSS code, etc.), you must determine which type of sensor is on the vehicle and replace it with the same kind. Check the parts book for details.

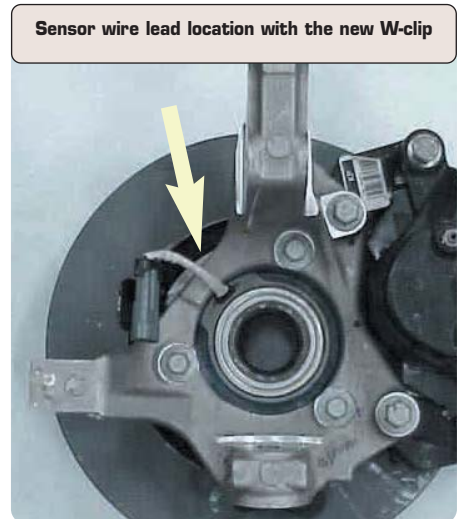
At the time the clips were changed, the mounting orientation of the sensor was also changed. Sensors with the old SS clip were mounted with the wire lead near the 6:00 o'clock position. New sensors with the W-clip are mounted with the wire lead near the 2:00 or 10:00 o'clock position, depending on which side of the vehicle it's mounted. This moves the lead away from the lower ball joint attachment, as shown in the accompanying photo.

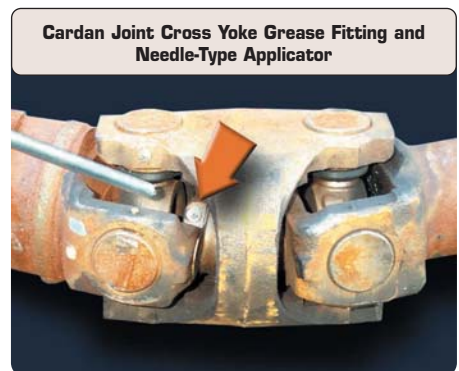
Some 1994-2002 trucks, such as the Chevrolet S-10 and GMC Sonoma extended cab with L35 V-6, use a propeller shaft that has double cardan type U-joints. A similar shaft is used as a service replacement on 1999-2002 2-wheel drive, automatic, extended cab Sierra and Silverado trucks. Premature wear of the cardan joint ball and socket can result in noise and vibration at road speeds.

Premature wear may be caused by inadequate lubrication. A grease passage in each cross yoke should be lubricated at normal chassis lubrication intervals.

You will need a needle-type grease gun adapter such as Plew's/Stant 99-009 or 05-025, available locally. Use Chassis Lubricant, P/N 12377985 (88901242 in Canada) or equivalent. The slip yoke should also be

greased at the zerk fitting. SI 2000 will be updated to include propshaft lubrication service.
